## Seismic Evaluation - Tier 1 Cupertino City Hall 10300 Torre Ave Cupertino, California

MME Job No. 21143.P5

April 19, 2021

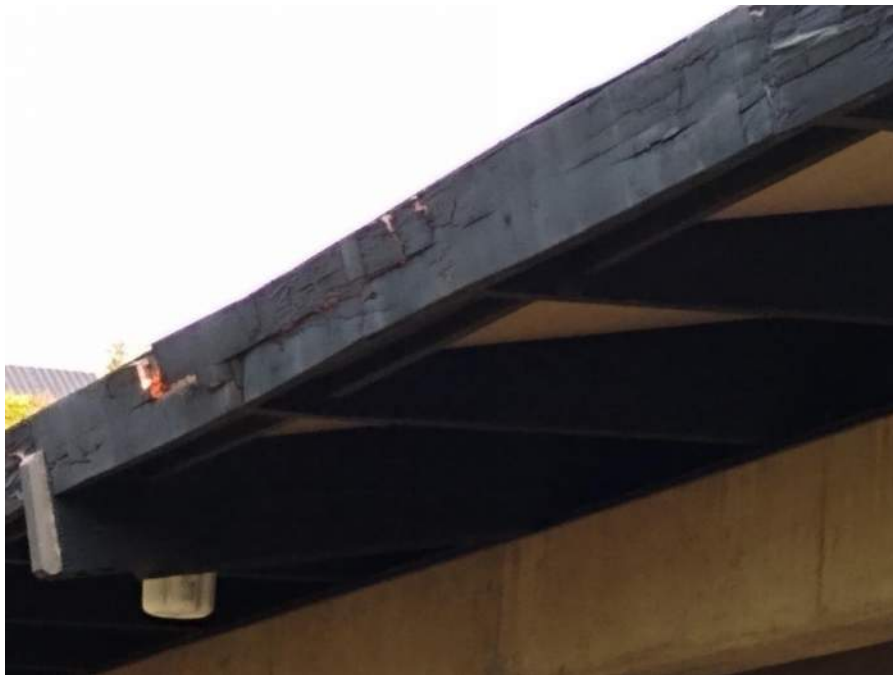
The veranda fascia on the south elevation has significant wood deterioration, Photo 4. The extent of the deterioration and if it affects the structural members should be investigated during the Tier 2 evaluation.

*Photo 3 Damaged Veranda Fascia*

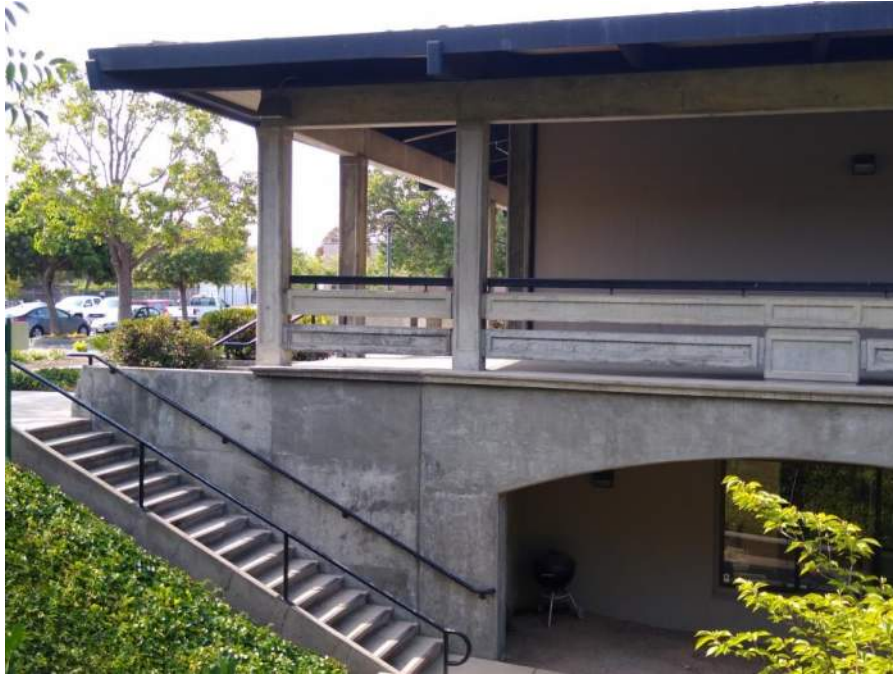
*Photo 4 Veranda*

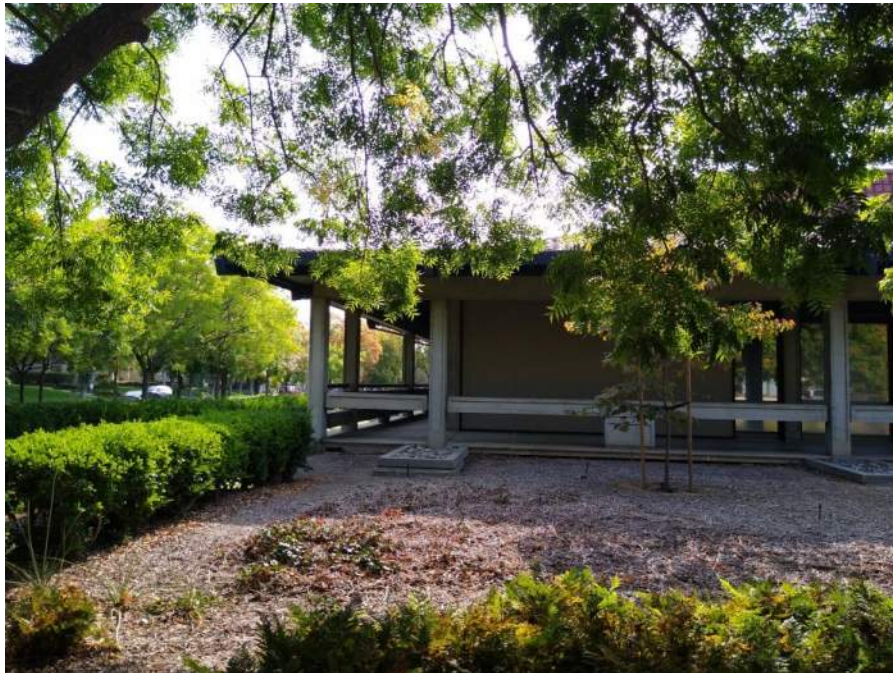
*Photo 5 Veranda*

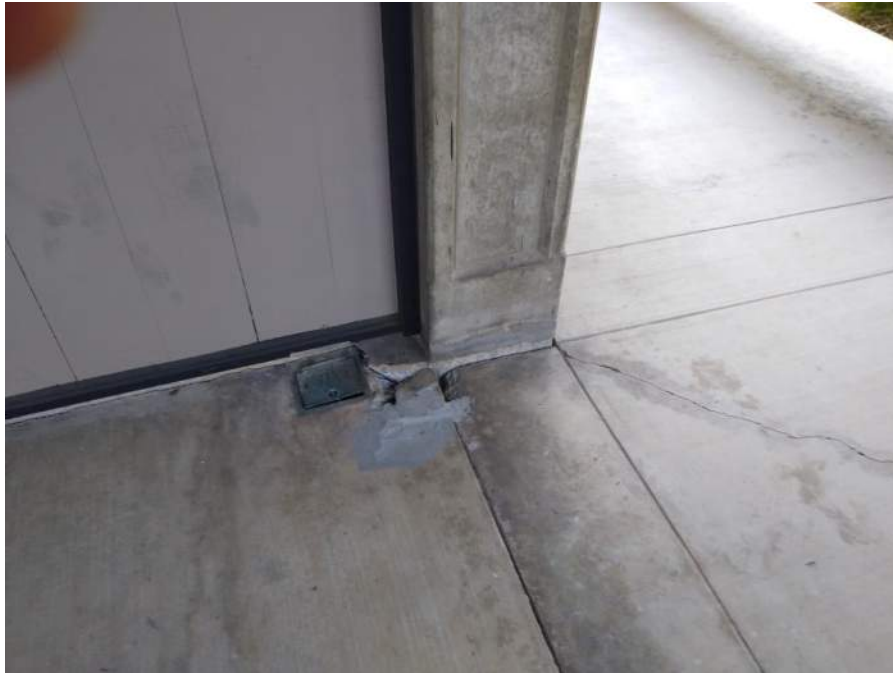
The veranda slab at the southwest corner has a significant crack and spalling adjacent to the building corner column, Photo 5. The most likely reason is the differential settlement between the building and the slab on grade.

*Photo 6 Veranda Damaged Slab on Grade*

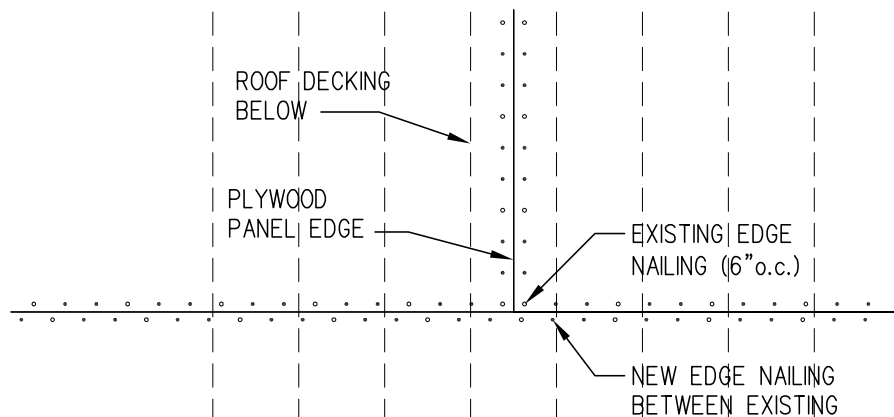
**Figure 3.G: PLAN OF PLYWOOD PANEL EDGE NAILING**

1. Roof Diaphragm Shear Capacity: The AKH evaluation determined that the shear capacity of the roof diaphragm was over-stressed. They determined that even if the clay tile roof was removed and replaced with a lighter roofing system, the plywood nailing would need to be upgraded.

Recommendation: The plywood nailing should be upgraded.

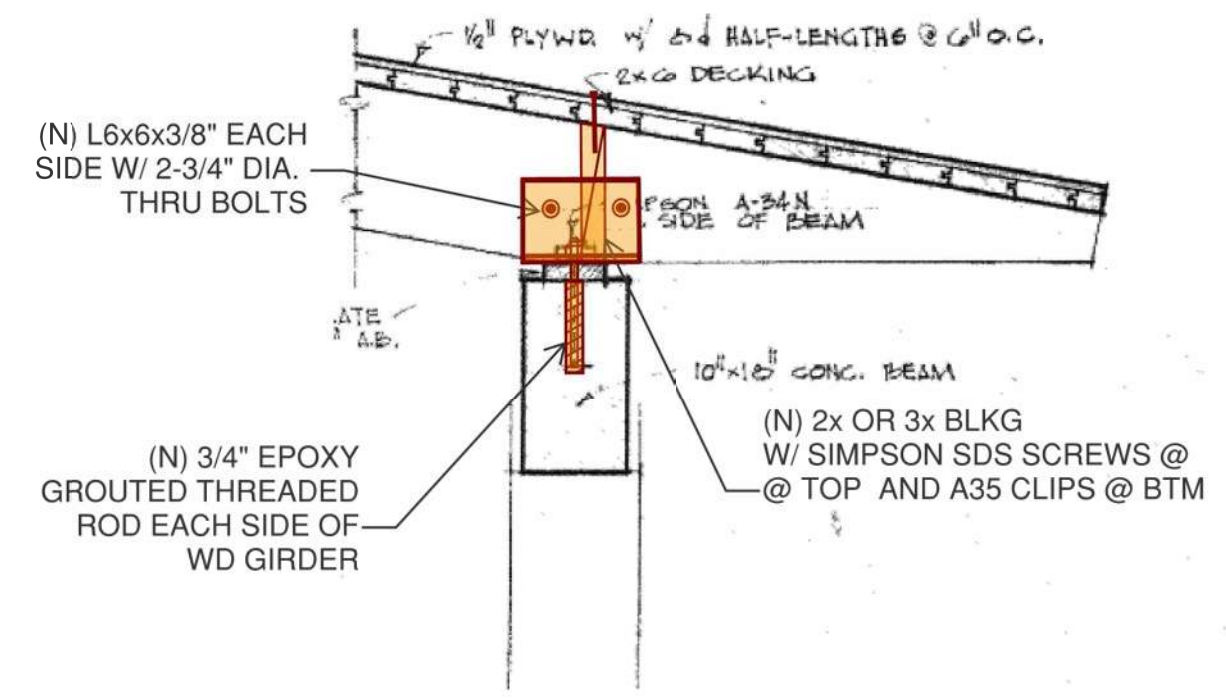
DETAIL 4 - COLONNADE TO ROOF ANCHORAGE

4. Out of Plane Connection of Veranda Beam: The Tier 1 evaluation determined that the connection from the veranda beam to the roof framing is inadequate for out-of-plane loads.

Recommendation: The out of plane connection at the veranda should be upgraded.
