CITY OF CUPERTINO

AMERICANS WITH DISABILITIES ACT

self evaluation and transition plan

APPENDICES

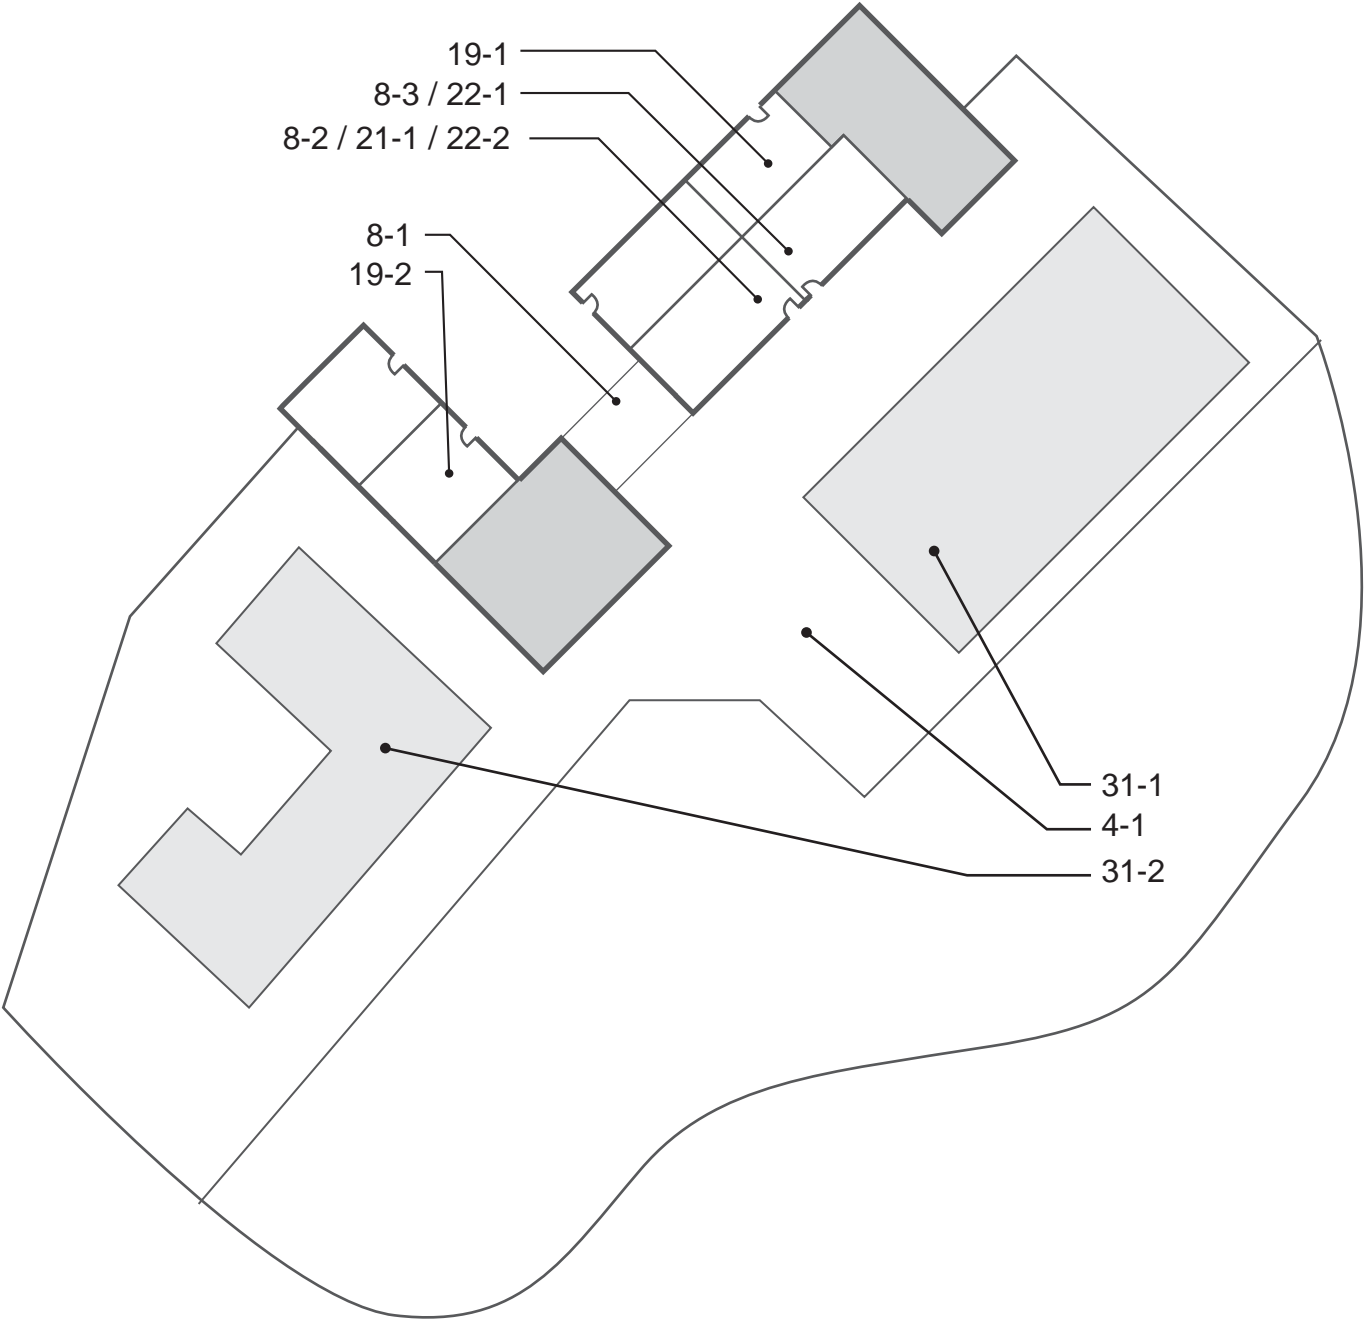
Blackberry Farm Pool Facilities
21975 San Fernando Ave
Cupertino, CA

4 - 1	Walk	Category: 2	
Regrade surface			\$0
Notes: Cross slope of concrete path is up to 2.8% on the pool deck (2.0% max).			
CBC: 11B-403.3			
Other: ADA 403.3			
8 - 1	Door/Gate	Category: 1	
Adjust door closer			\$125
Notes: Door opening force is 16 lbs (5 lbs max).			
CBC: 11B-404.2.9			
Other: ADA 404.2.9			
8 - 2	Door/Gate	Category: 2	
Adjust door closer			\$125
Notes: Door opening force is 11.5 lbs (5 lbs max).			
CBC: 11B-404.2.9			
Other: ADA 404.2.9			
8 - 3	Door/Gate	Category: 2	
Adjust door closer			\$125
Notes: Door opening force is 11 lbs (5 lbs max).			
CBC: 11B-404.2.9			
Other: ADA 404.2.9			
19 - 1	Multiple User Restroom	Category: 2	
Provide an accessible lavatory			\$3,000
Notes: Centerline of the lavatory is 17.5" from side wall (18" min).			
CBC: 11B-606.6			
Other: -			
19 - 2	Multiple User Restroom	Category: 2	
Install restroom sign			\$250
Notes: Federal sign is located on the hinge side of the door (required federal sign is to be mounted on the latch side of the door).

22 - 1 Bathing Facility		Category: 2
Replace water controls		\$500
Notes: Water controls are located 32" from the seat on the rear wall in the men's shower (19" min to 27" max).		
CBC: 11B-608.5.2		
Other: -		
22 - 2 Bathing Facility		Category: 2
Replace water controls		\$500
Notes: Water controls are located 31.5" from the seat on the rear wall in the women's shower (19" min to 27" max). Showerhead mounted higher than 48" max allowed.		
CBC: 11B-608, 11B-608.5.2		
Other: ADA 608		
31 - 1 Swimming Pool / Wading Pools / Spas (int. or ext.)		Category: 2
Install handrail		\$5,000
Notes: The clear width between the handrails is 51" (33"min to 38" max).		
CBC: 11B-1009.3.3		
Other: ADA 1009.3.3		
Raise or lower existing handrail		\$0
Notes: Handrail top surface is mounted 33" AFF (34" min to 38" max).		
CBC: 11B-1009.3.3		
Other: ADA 1009.3.3		
31 - 2 Swimming Pool / Wading Pools / Spas (int. or ext.)		Category: 2

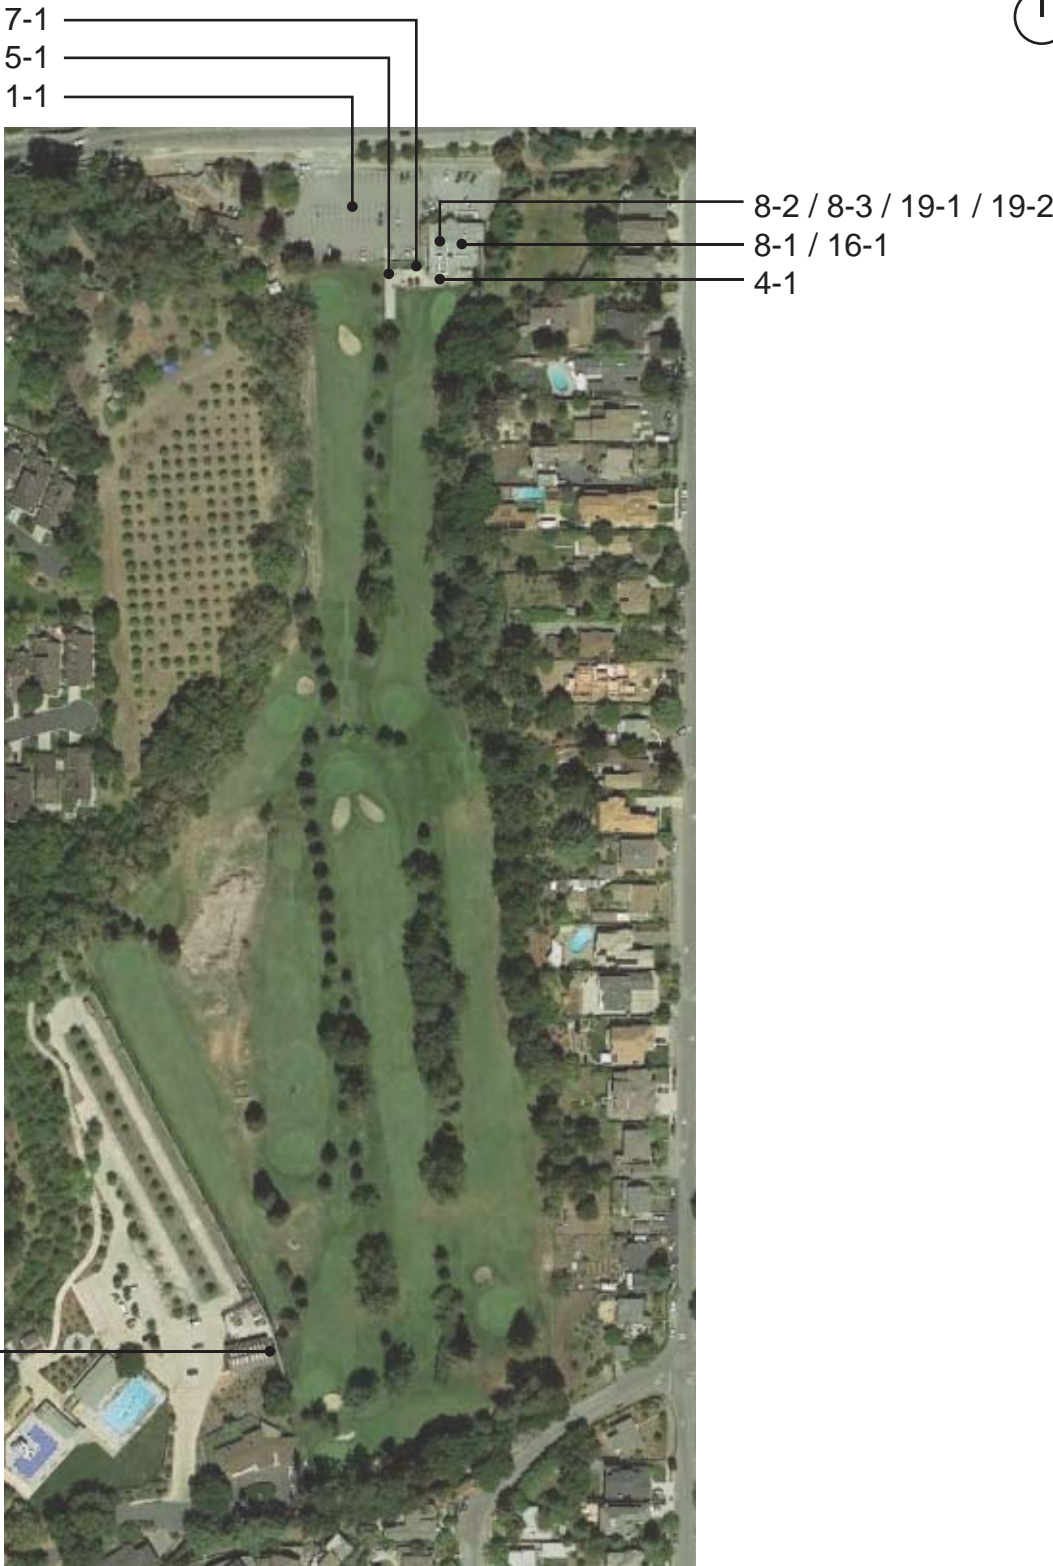
Blackberry Farm Golf Course
22100 Stevens Creek Boulevard
Cupertino, CA

Remove overhanging or protruding objects		\$125
Notes: Air conditioner overhangs 16.5" from the wall at 70.5" AFF (80" min).		
CBC: 11B-307.4 Other: ADA 307.4		
8 - 1	Door/Gate	Category: 1
Adjust door closer		\$125
Notes: Door opening force is 7 lbs (5 lbs max).		
CBC: 11B-404.2.9 Other: ADA 404.2.9

19 - 1	Multiple User Restroom	Category: 2
Provide or replace compartment door hardware		\$175
Notes: Compartment door does not have handle on inside (Compartment door must have U-shaped handles both inside and outside of the door and be self-closing).		
CBC: 11B-604.8.1.2		
Other: ADA 604.8.1.2		
Replace toilet or adjust toilet seat height		\$3,000
Notes: Water closet seat height is 16" AFF (17" min to 19" max).		
CBC: 11B-604.4		
Other: ADA 604.4		
Replace or modify grab bars		\$300
Notes: Side grab bar extends 51" from the rear wall (54" min).		
CBC: 11B-604.5.1		
Other: ADA 604.5.1		
19 - 2	Multiple User Restroom	Category: 2
Provide or replace compartment door hardware		\$175
Notes: Compartment door does not have handle on inside (Compartment door must have U-shaped handles both inside and outside of the door and be self-closing).		
CBC: 11B-604.8.1.2		
Other: ADA 604.8.1.2		
20 - 1	Single User Restroom	Category: 2

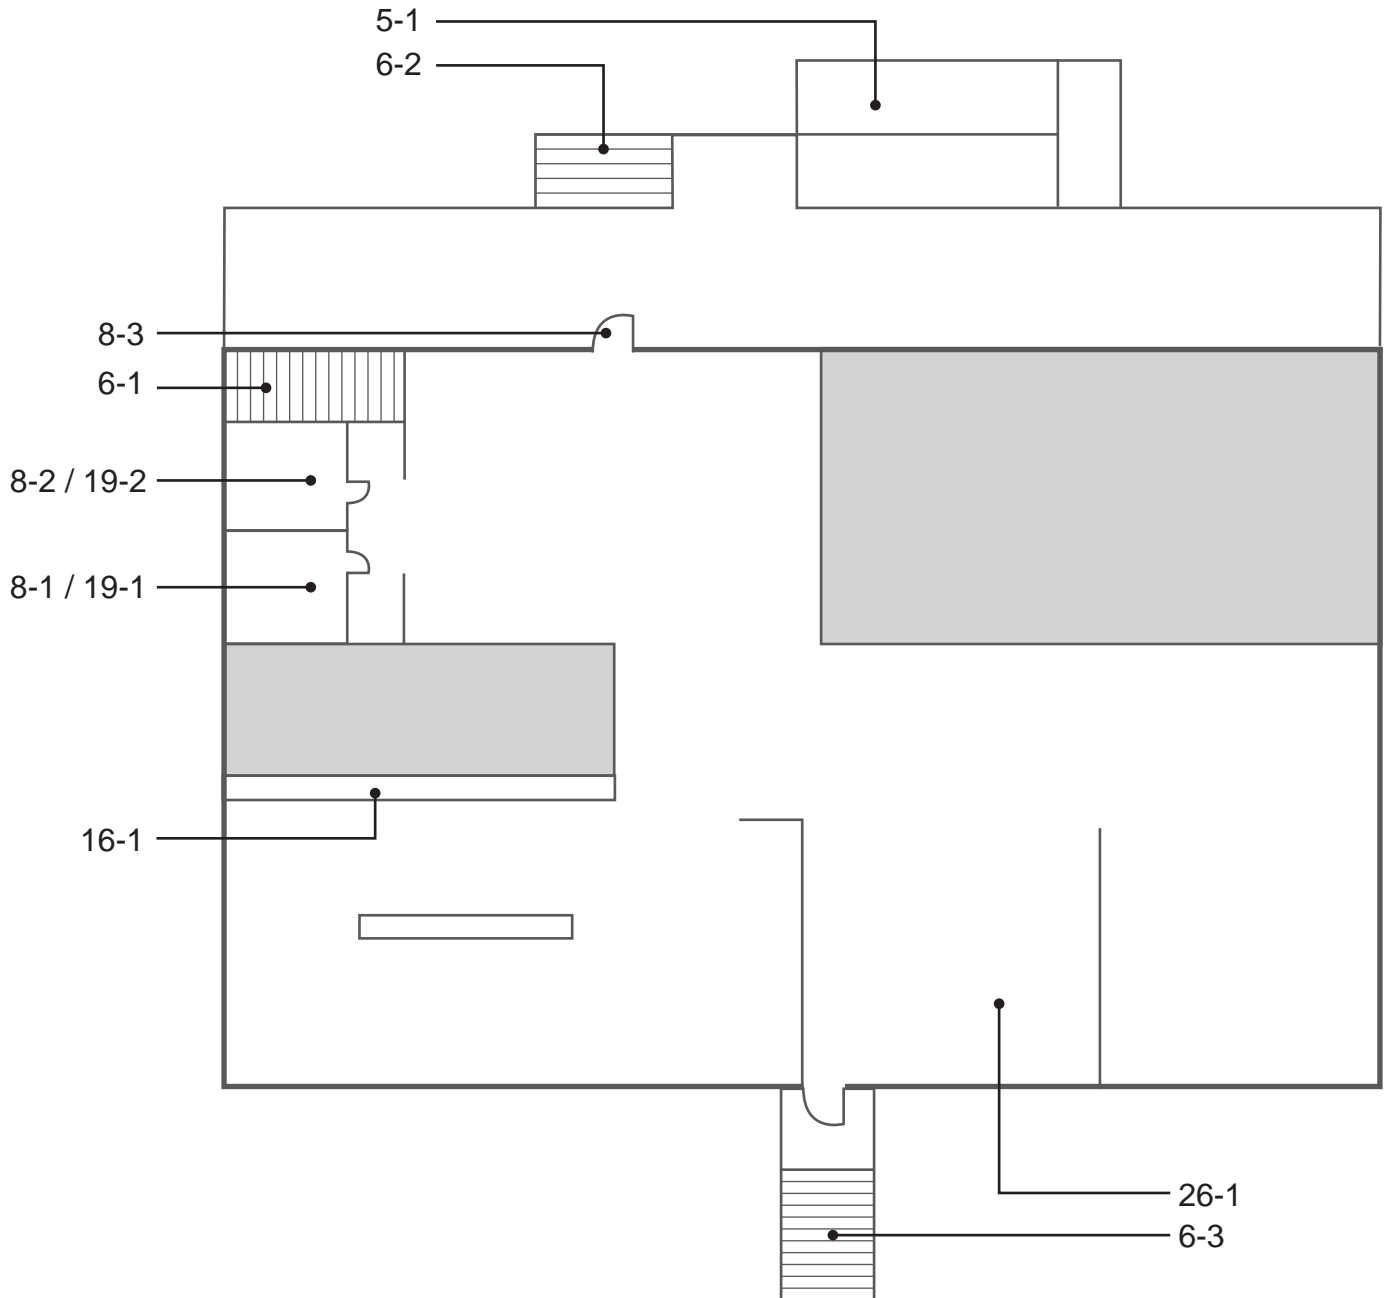
Blue Pheasant Restaurant
22100 Stevens Creek Boulevard
Cupertino, CA

6 - 3	Stairway	Category: 4
Install tread striping		\$240
Notes: No tread striping provided on 16 risers.		
CBC: 11B-504.4.1		
Other: -		
Install a handrail		\$125
Notes: Handrail gripping surface is obstructed by spindle hatch.		
CBC: 11B-505.6		
Other: ADA 505.6		
Repair stair nosing		\$2,000
Notes: Tread nosing overhangs riser horizontally at 90 degrees (30 degrees max) at a depth of .5".		
CBC: 11B-504.5		
Other: ADA 504.5		
8 - 1	Door/Gate	Category: 4
Adjust door closer		\$125
Notes: Door opening force at women's restroom is 10 lbs (5 lbs max).		
CBC: 11B-404.2.9		
Other: ADA 404.2.9		
Provide strike edge clearance		\$2,500
Notes: Front approach strike-edge clearance on the pull side of the door is 5.5" (18" min).		
CBC: 11B-404.2.4.1		
Other: ADA 404.2.4.1		
Increase maneuvering space		\$1,000
Notes: Front approach maneuvering clearance on the pull side of the door is 58.5" (60" min).		
CBC: 11B-404.2.4		
Other: ADA 404.2.4.1

19 - 1	Multiple User Restroom	Category: 4
Provide or replace compartment door hardware		\$175
Notes: Compartment door does not have a handle on inside the door (Compartment door must have U-shaped handles both inside and outside of the door and be self-closing).		
CBC: 11B-604.8.1.2		
Other: ADA 604.8.1.2		
Reposition toilet flush controls		\$750
Notes: Flush control is not located on wide side of fixture (flush control is required to be located on the open side of the fixture).		
CBC: 11B-604.6		
Other: ADA 604.6		
Replace or reposition dispenser		\$125
Notes: Toilet paper is mounted 7" behind the front of the fixture. (7" min.-9" max. in front of fixture).		
CBC: 11B-604.7		
Other: ADA 604.7		
19 - 2	Multiple User Restroom	Category: 4
Provide or replace compartment door hardware		\$175
Notes: Compartment door does not have a handle on inside the door and is not self-closing (Compartment door must have U-shaped handles both inside and outside of the door and be self-closing).

CBC: 11B-604.8.1.2		
Other: ADA 604.8.1.2		
Modify stall partitions		\$500
Notes: Water closet compartment is 59.5" wide (60" min).		
CBC: 11B-604.8.1.1		
Other: ADA 604.3.1		
Replace or reposition fixtures		\$1,250
Notes: Centerline of water closet is 18.75" from side wall (17"min. -18" max).		
CBC: 11B-604.2		
Other: ADA 604.2

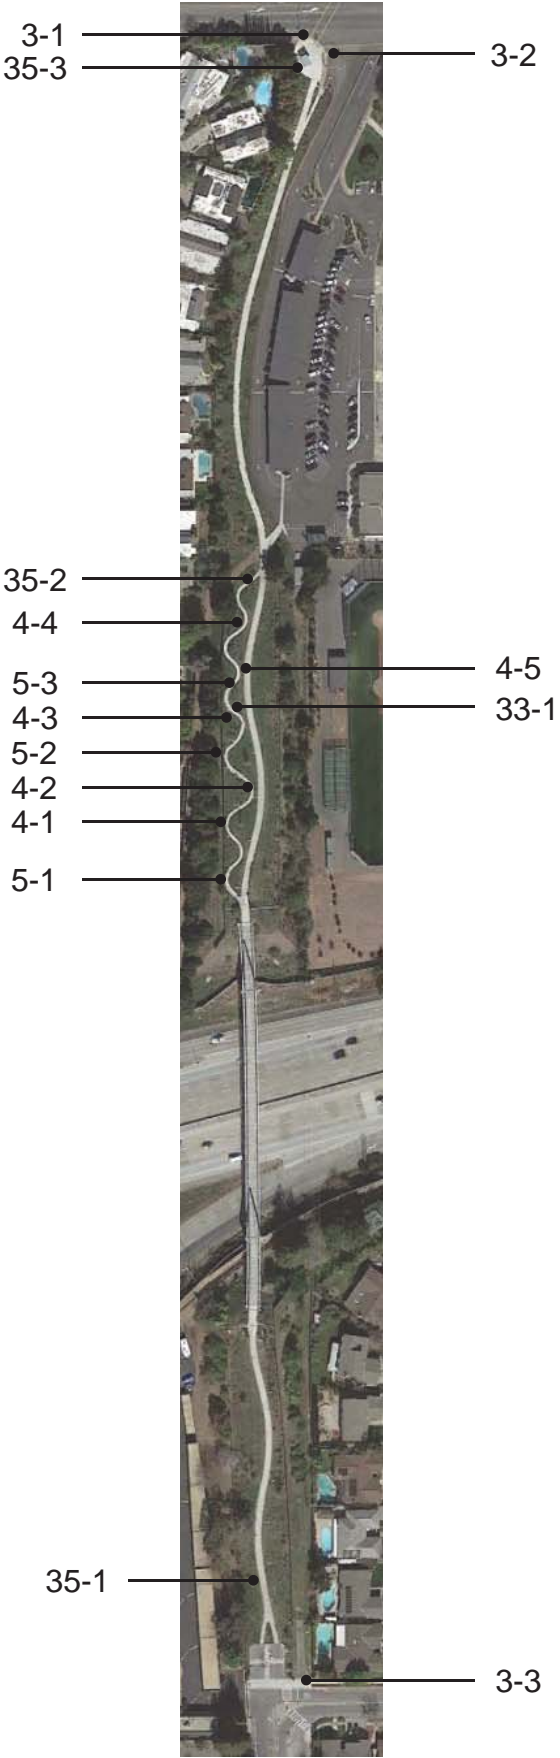
Burnett Pedestrian Bridge and Trail
Mary Avenue and Meteor Drive
Cupertino, CA

3 - 1	Curb Ramp	Category: 1	
Install, replace or modify curb ramp			\$2,460
Notes: Slope of the curb ramp is 8.6% (8.33% max).			
CBC: 11B-405.2, 11B-406			
Other: ADA 405.2, ADA 406.1			
Provide a level landing			\$2,500
Notes: Counter slope at the base of the curb ramp is 5.9% (5.0% max).			
CBC: 11B-406.5.8			
Other: ADA 406.2			
3 - 2	Curb Ramp	Category: 1	
Provide a level landing			\$2,500
Notes: Counter slope at the base of the curb ramp is 6.5% (5.0% max).			
CBC: 11B-406.5.8			
Other: ADA 406.2			
3 - 3	Curb Ramp	Category: 1	
Provide a level landing			\$90
Notes: Top landing has a slope of 2.6% (2% max).			
CBC: 11B-406.5.3			
Other: ADA 406.4, ADA 406.7			
4 - 1	Walk	Category: 1	
Regrade surface			\$760
Notes: Cross slope of concrete path is up to 2.9% for 19 linear feet (2.0% max).			
CBC: 11B-403.3			
Other: ADA 403.3			
4 - 2	Walk	Category: 1	
Regrade surface			\$6,040
Notes: Running slope of concrete path is up to 5.5% for 151 linear feet (5.0% max) and cross slope is up to 5% for 60 linear feet (2.0% max).

5 - 3 Ramp Category: 1		
Regrade or replace ramp		\$9,350
Notes: Ramp cross slope is up to 5.3% for 22 linear feet (2.0% max).		
CBC: 11B-405.3		
Other: ADA 405.3		
33 - 1 Outdoor Constructed Features Category: 2		
Increase or provide clear floor area		\$700
Notes: A clear floor space is not provided adjacent to the bench (36" by 48" min).		
CBC: -		
Other: AGODA 1011.2.1		
35 - 1 Other Category: 3		
Reposition controls		\$200
Notes: Mutt Mitt is 47" AFF and located 20" off the path of travel (46" max when between 10" to 24" off path of travel).		
CBC: 11B-308.3		
Other: ADA 308.3, ADA 308.3.1, ADA 308.3.2		
35 - 2 Other Category: 3		
Reposition controls		\$200
Notes: Mutt Mitt is 51" AFF located 24" off the path of travel (46" max when between 10" to 24" off path of travel).		
CBC: 11B-308.3		
Other: ADA 308.3, ADA 308.3.1, ADA 308.3.2		
35 - 3 Other Category: 3		
Reposition controls		\$200
Notes: Mutt Mitt is located 54" AFF (46" max when between 10" to 24" off path of travel).

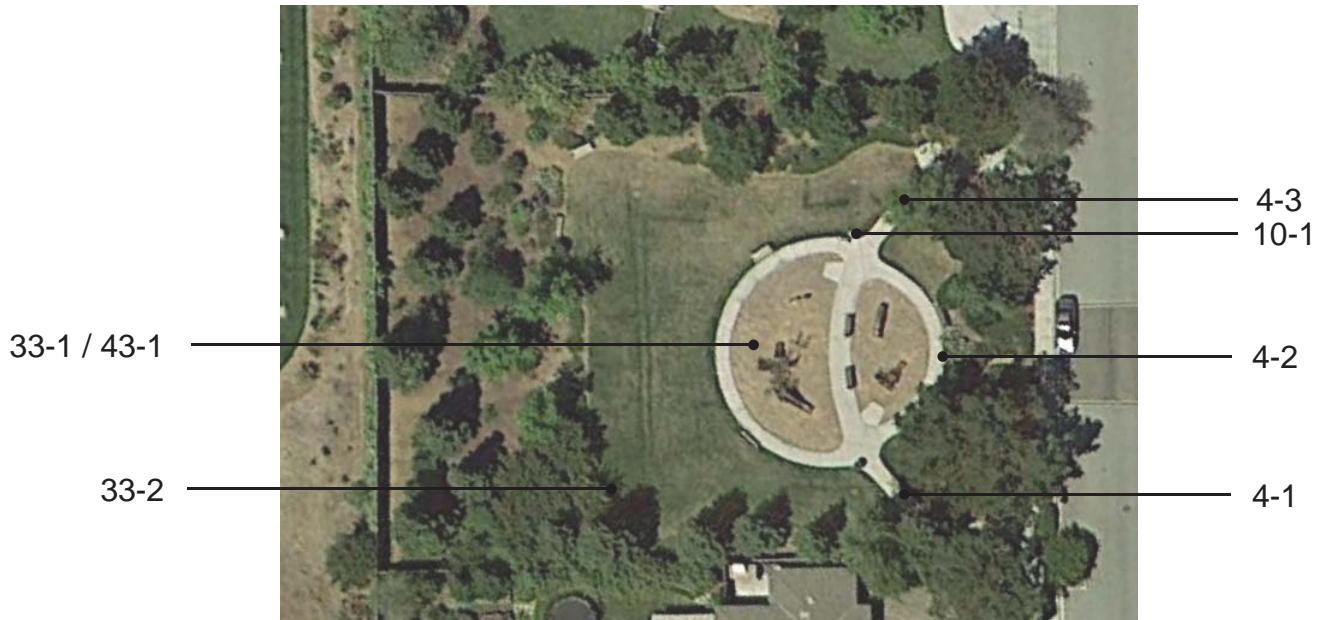
Canyon Oaks Park
21140-21150 Canyon Oak Way
Cupertino, CA

4 - 1	Walk	Category: 1
Regrade surface		\$880
Notes: Cross slope of concrete path is up to 4.1% for 22 linear feet (2.0% max).		
CBC: 11B-403.3		
Other: ADA 403.3		
4 - 2	Walk	Category: 2
Widen walk		\$125
Notes: Width of walk is 32" for 60" due to a protruding shrub at 24" AFF (48" min clear width). (Cut back shrub).		
CBC: 11B-403.5.1.3		
Other: ADA 403.5.1		
4 - 3	Walk	Category: 1
Regrade surface		\$1,240
Notes: Cross slope of concrete path is up to 2.8% for 31 linear feet (2.0% max).		
CBC: 11B-403.3		
Other: ADA 403.3		
10 - 1	Drinking Fountain	Category: 3
Replace fountain		\$3,000
Notes: Bubbler height is 37" AFF. Fountain provided is neither standing person nor accessible fountain. (Accessible fountain is to be located at 36" max. above floor; standing fountain has an allowable range of 38"-43" above floor)		
CBC: 11B-602.4, 11B-602.7		
Other: ADA 602.4, ADA 602.7		
Provide wing walls		\$1,000
Notes: Drinking fountain is 23" from vertical support at 28.75" AFF (protrusion more than 4" must be mounted below 27" or above 80").

CBC: 11B-602.8, 11B-602.9		
Other: ADA 307		
Replace or adjust water controls		\$125
Notes: Operating effort of control is 7 lbs (5 lbs max).		
CBC: 11B-309		
Other: ADA 309

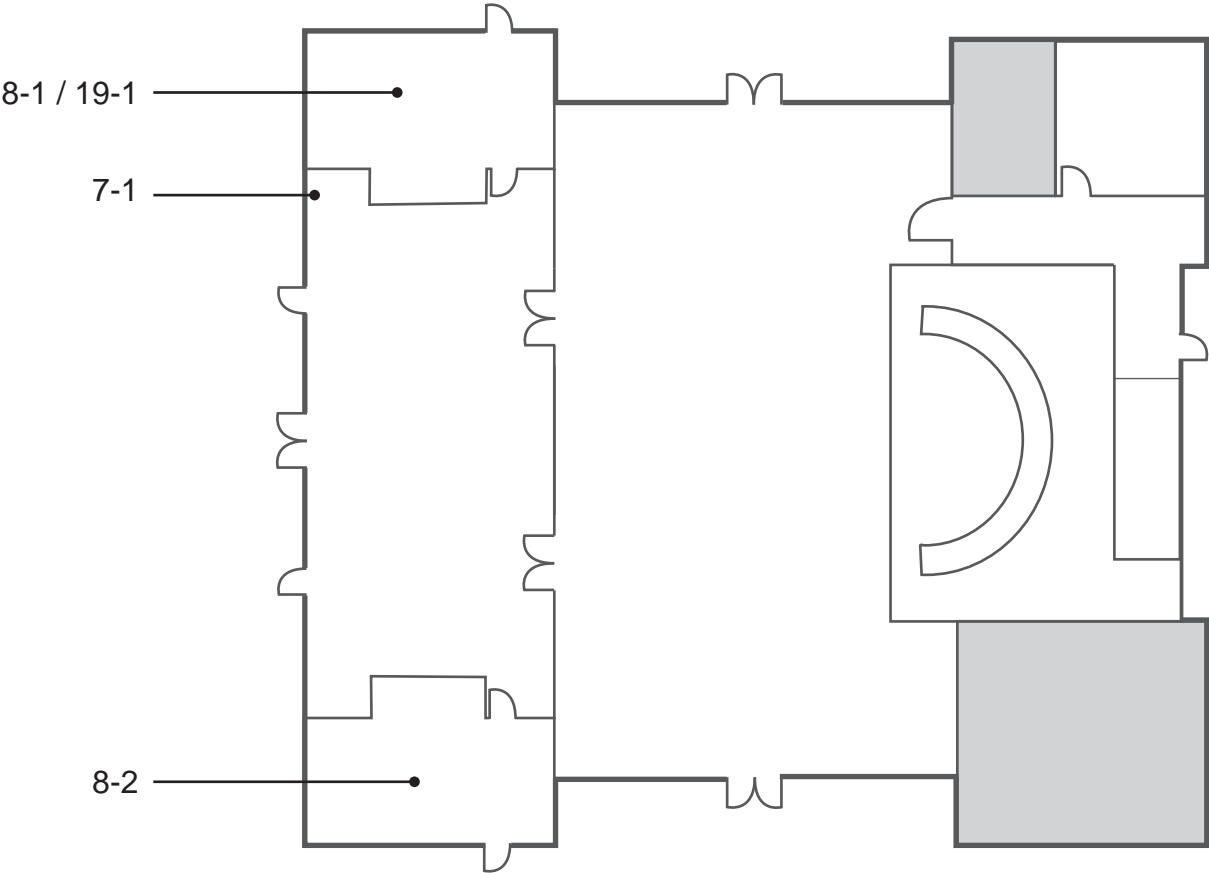
City Council Chambers
10400 Torre Ave
Cupertino, CA

7 - 1	Hazard	Category: 1	
Remove overhanging or protruding objects			\$0
Notes: AED protrudes 7.5" from wall and at 46" AFF (protrusion more than 4" must be mounted below 27" or above 80").			
CBC: 11B-307.4			
Other: ADA 307.4			
8 - 1	Door/Gate	Category: 2	
Adjust door closer			\$125
Notes: On the day of survey the automatic door was locked from the outside of the building. Door's closing force and closing time not surveyed.			
CBC: 11B-404.2.8.1, 11B-404.3			
Other: ADA 404.2.8.1, ADA 404.3			
8 - 2	Door/Gate	Category: 2	
Adjust door closer			\$125
Notes: On the day of survey the automatic door was locked from the outside of the building. Door's closing force and closing time not surveyed.			
CBC: 11B-404.2.8.1, 11B-404.3			
Other: ADA 404.2.8.1, ADA 404.3			
19 - 1	Multiple User Restroom	Category: 2	
Replace or reposition fixtures			\$1,250
Notes: Centerline of water closet is 19" from side wall (17" min to 18" max).

CBC: 11B-604.2			
Other: ADA 604.2

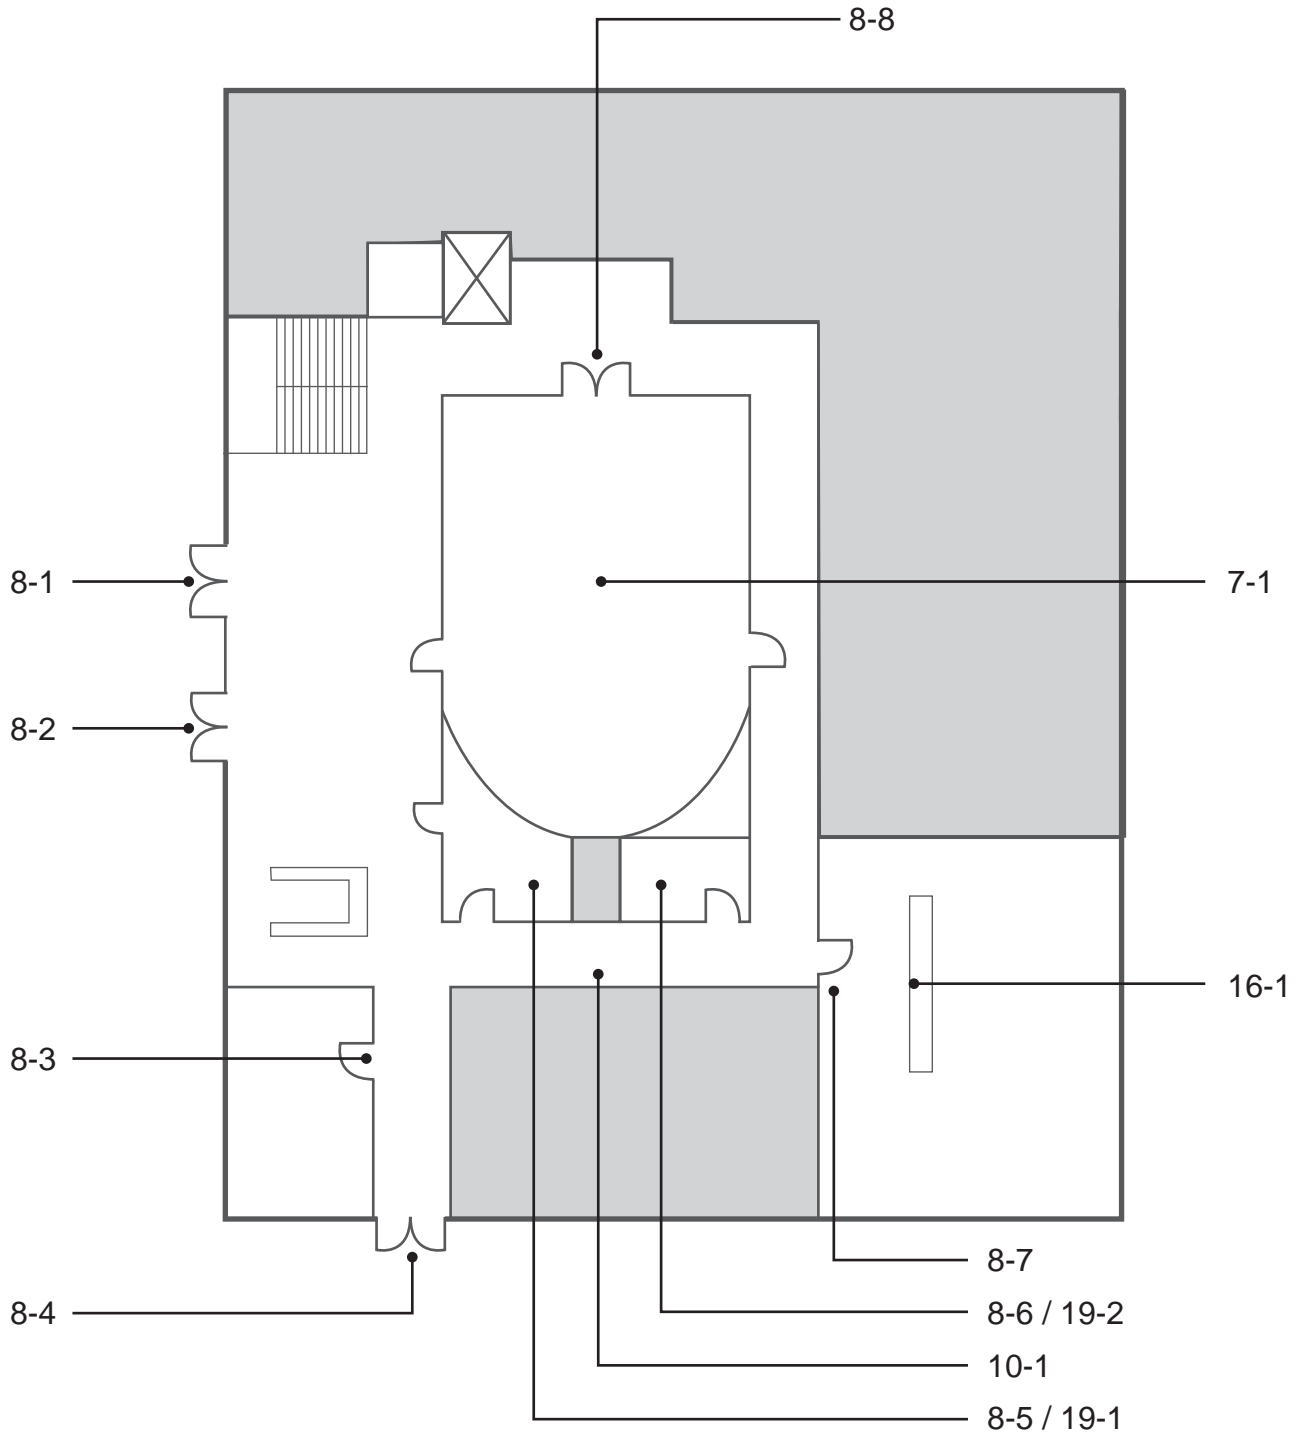
City Hall - Main Floor
10300 Torre Ave
Cupertino, CA

Floor 1	
7 - 1	Hazard Category: 4
Remove overhanging or protruding objects	\$500
Notes: Four video cameras protrude 18" from the wall at 59" AFF in the conference room (protrusion more than 4" must be mounted below 27" or above 80").	
CBC: 11B-307.2	
Other: ADA 307.2	
8 - 1	Door/Gate Category: 1
Provide an International Symbol of Accessibility	\$250
Notes: Accessible entry is not marked by the International Symbol of Accessibility.	
CBC: 11B-216.6	
Other: ADA 216.6, ADA 703.7.2.1	
Install or modify sign	\$250
Notes: A tactile and Braille EXIT sign is not provided for emergency exit.	
CBC: 1011	
Other: ADA 216.4.1, ADA 703.4.1	
Regrade surface	\$2,500
Notes: Slope of the maneuvering clear area is 4.5% (2% max).	
CBC: 11B-404.2.4.4	
Other: ADA 404.2.4.4	
8 - 2	Door/Gate Category: 1
Provide an International Symbol of Accessibility	\$250
Notes: Accessible entry is not marked by the International Symbol of Accessibility.

Floor 1	
8 - 8	Door/Gate Category: 2
Adjust door closer	\$125
Notes: On the day of survey the automatic door was locked from the outside of the building. Door's closing force and closing time not surveyed.	
CBC: 11B-404.2.8.1, 11B-404.3	
Other: ADA 404.2.8.1, ADA 404.3	
10 - 1	Drinking Fountain Category: 3
Replace fountain	\$3,000
Notes: Bubbler height is 30.75" AFF. A standing person drinking fountain is not provided (38"min to 43" max for a standing person fountain).	
CBC: 11B-602.7	
Other: ADA 602.7	
Raise or lower fountain	\$1,500
Notes: Space between floor/ground and bottom of fountain is 26.25" (27" min).	
CBC: 11B-306.3	
Other: ADA 306.3, ADA 306.3.1	
16 - 1	Built-in Elements Category: 2
Provide an accessible counter	\$1,500
Notes: Counter is 42" AFF, no accessible counter provided (34" max).	
CBC: 11B-904.4	
Other: ADA 904.4.1

Floor 1	
19 - 1 Multiple User Restroom	Category: 2
Install restroom sign	\$250
Notes: Federal sign is not provided in the men's restroom. State sign is centered at 65" AFF (60"AFF).	
CBC: 11B-216.8, 11B-703.7.2.6	
Other: ADA 703	
Replace or reposition mirror	\$150
Notes: Bottom of the mirror's reflecting surface is 40.5" AFF (40" max).	
CBC: 11B-603.3	
Other: ADA 603.3	
Reposition clothing hooks	\$125
Notes: Height of coat hook is 69" (48" max).	
CBC: 11B-603.4	
Other: ADA 308	
Modify lavatory or counter clearances	\$1,500
Notes: Clear space beneath the lavatory is 28.25" to front apron (29" min). Knee space measured at 8" deep from the centerline of the lavatory is 26.5" AFF (27" min).	
CBC: 11B-306.3.1, 11B-306.3.3	
Other: ADA 306.3, ADA 306.3.3	
Provide clear floor or turning space	\$3,000
Notes: Clear space in front of the urinal is 27.25" wide (30"min). No turning space provided (turning space of 60" min).

CBC: 11B-305, 11B-603.2.1	
Other: ADA 304.3, ADA 305.5, ADA 603.2.1	
Provide or replace compartment door hardware	\$175
Notes: Compartment door does not have handle on the inside of the door and is not self-closing (Compartment door must have U-shaped handles both inside and outside of the door and be self-closing).	
CBC: 11B-604.8.1.2	
Other: ADA 604.8.1.2	
Modify stall partitions	\$500
Notes: Water closet compartment is 57.5" wide (60" min).	
CBC: 11B-604.8.1.1	
Other: ADA 604.3.1	
Replace toilet or adjust toilet seat height	\$3,000
Notes: Water closet seat height is 15.75" AFF (17" min to 19" max).	
CBC: 11B-604.4	
Other: ADA 604.4

Floor 1	
19 - 1 Multiple User Restroom	Category: 2
Replace or reposition dispenser	\$125
Notes: Centerline of the toilet paper is positioned 1" in front of the water closet (7" min to 9" max).	
CBC: 11B-604.7	
Other: ADA 604.7	
Install or modify visible fire alarm	\$250
Notes: Visible fire alarm is not provided.	
CBC: 11B-702.1	
Other: ADA 702.1

Floor 1	
19 - 2 Multiple User Restroom	Category: 2
Install or modify visible fire alarm	\$250
Notes: A visible fire alarm is not provided.	
CBC: 11B-702.1	
Other: ADA 702.1	
Replace or reposition mirror	\$150
Notes: Bottom of the mirror's reflecting surface is 40.5" AFF (40" max).	
CBC: 11B-603.3	
Other: ADA 603.3	
Reposition clothing hooks	\$125
Notes: Height of coat hook is 58.75" AFF (48" max).	
CBC: 11B-308	
Other: ADA 308	
Modify lavatory or counter clearances	\$1,500
Notes: Clear space beneath the lavatory is 28.5" to front apron (29" min).	
CBC: 11B-306.3.1	
Other: -	
Provide or replace compartment door hardware	\$175
Notes: Compartment door does not have handle on the inside of the door and is not self-closing (Compartment door must have U-shaped handles both inside and outside of the door and be self-closing).	
CBC: 11B-604.8.1.2	
Other: ADA 604.8.1.2	
Modify stall partitions	\$500
Notes: Water closet compartment is 57.5" wide (60" min).

CBC: 11B-604.8.1.1	
Other: ADA 604.3.1	
Reposition toilet flush controls	\$750
Notes: Flush control is not located on the wide side of the water closet (flush control is required to be located on the open side of the fixture).	
CBC: 11B-604.6	
Other: ADA 604.6	
Replace toilet or adjust toilet seat height	\$3,000
Notes: Water closet seat is 15.75" AFF (17" min to 19" max).	
CBC: 11B-604.4	
Other: ADA 604.4

Floor 1	
19 - 2	Multiple User Restroom
	Category: 2
Replace or reposition dispenser	\$125
Notes: Coin slot at sanitary napkin dispenser is 48" AFF (40" max).	
CBC: 11B-603.5	
Other: -

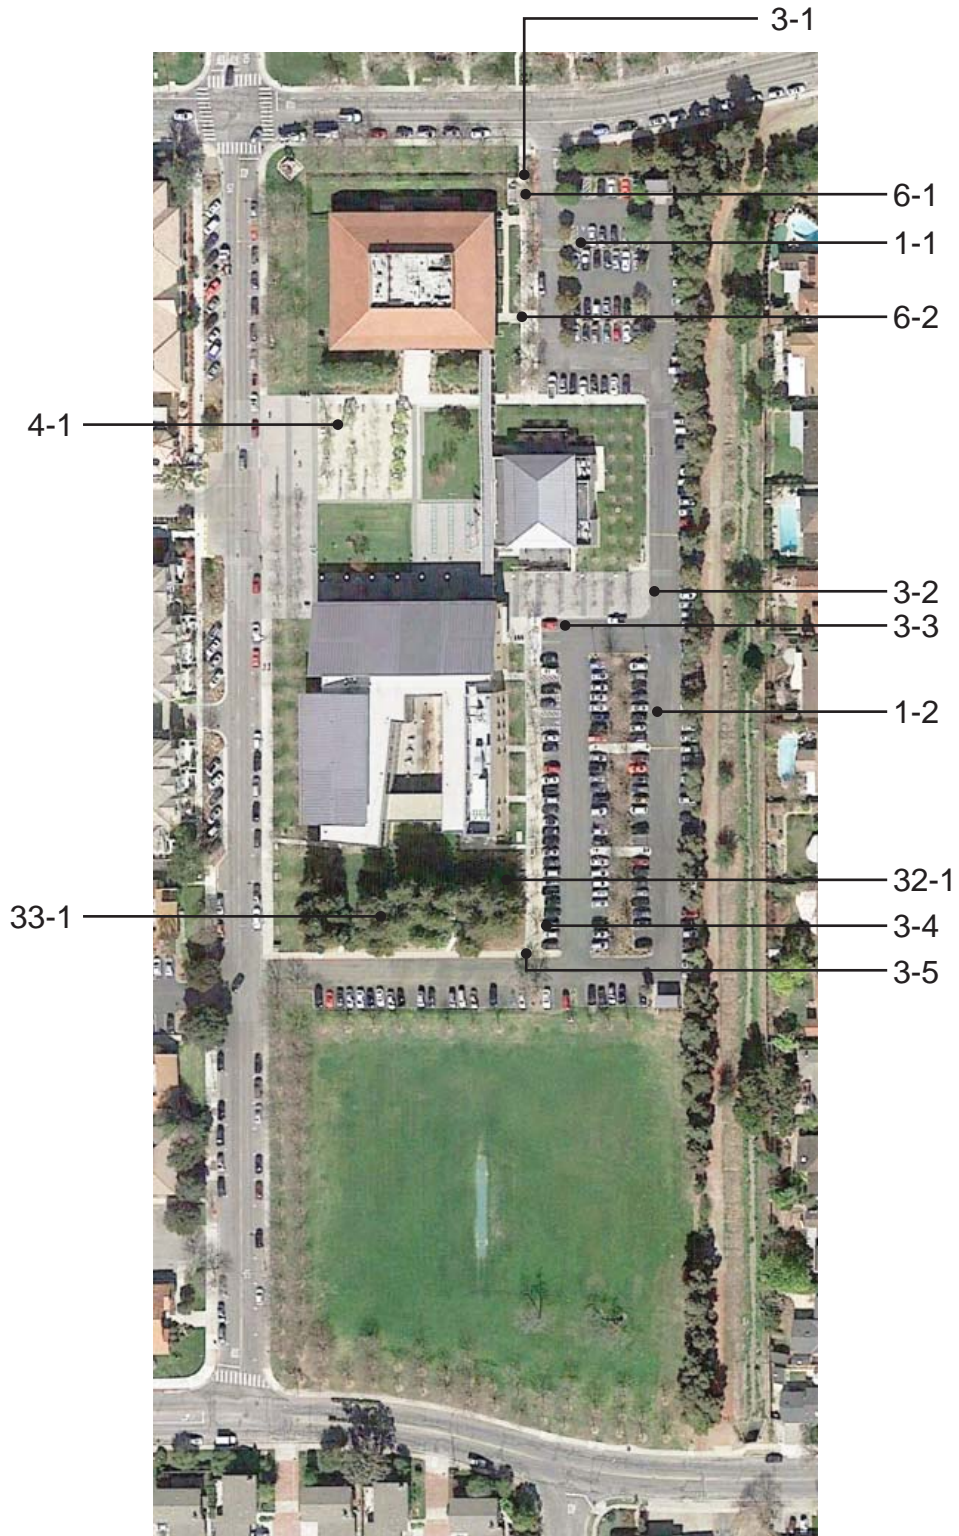
Civic Center Complex
10800 Torre Ave
Cupertino, CA

1 - 1		Parking Area	Category: 1
Install van accessible sign			\$375
Notes: A "Van Accessible" sign is not provided. Required: A "Van Accessible" sign is posted at stalls striped and designated to be van accessible.			
CBC: 11B-502.6			
Other: ADA 208.2.4			
Provide adequate striping			\$100
Notes: The words "No Parking" are not painted in the access aisle.			
CBC: 11B-502.3.3			
Other: -			
Provide or modify accessible access aisles			\$210
Notes: Van access aisle width is 80" (96" min). Second access aisle width is 58" (60" min).			
CBC: 11B-502.2, 11B-502.3.1			
Other: ADA 502.3.1			
Provide adequate striping			\$100
Notes: Accessible parking space is 16'-8" long (18' min).			
CBC: 11B-502.2			
Other: ADA 502.2			
1 - 2		Parking Area	Category: 1
Provide adequate striping			\$100
Notes: The lettering for the "No Parking" is 8" tall (12" min).			
CBC: 11B-502.3.3			
Other: -			
Provide or modify accessible access aisles			\$210

3 - 1 Curb Ramp			Category: 1
Install, replace or modify curb ramp			\$2,460
Notes: Slope of the curb ramp is 9.8% (8.33% max).			
CBC: 11B-405.2, 11B-406			
Other: ADA 405.2, ADA 406.1			
Provide detectable warnings			\$0
Notes: Detectable warnings not provided.			
CBC: 11B-247.1.2, 11B-406.5.12			
Other: -			
3 - 2 Curb Ramp			Category: 1
Provide detectable warnings			\$1,000
Notes: Detectable warnings not provided.			
CBC: 11B-247.1.2, 11B-406.5.12			
Other: -			
Provide a level landing			\$2,500
Notes: Counter slope at the base of the curb ramp is 8.8% (5.0% max).			
CBC: 11B-406.5.8			
Other: ADA 406.2			
3 - 3 Curb Ramp			Category: 1
Provide detectable warnings			\$1,000
Notes: Detectable warnings not provided.			
CBC: 11B-247.1.2, 11B-406.5.12			
Other: -			
Provide a level landing			\$2,500
Notes: Counter slope at the base of the curb ramp is 10.6% (5.0% max).			
CBC: 11B-406.5.8			
Other: ADA 406.2			
3 - 4 Curb Ramp			Category: 1

Install, replace or modify curb ramp			\$2,460
Notes: Slope of the curb ramp is 10% (8.33% max).			
CBC: 11B-405.2, 11B-406			
Other: ADA 405.2, ADA 406.1			
Provide detectable warnings			\$0
Notes: Detectable warnings not provided.			
CBC: 11B-247.1.2, 11B-406.5.12			
Other: -

3 - 5 Curb Ramp			Category: 1
Install, replace or modify curb ramp			\$2,460
Notes: Slope of the curb ramp is 9.6% (8.33% max).			
CBC: 11B-405.2, 11B-406			
Other: ADA 405.2, ADA 406.1			
Provide detectable warnings			\$0
Notes: Detectable warnings not provided.			
CBC: 11B-247.1.2, 11B-406.5.12			
Other: -			
4 - 1 Walk			Category: 1
Grind or patch vertical change of grade			\$250
Notes: Change in level at transition from concrete path to DG surface exceeds .25". Maintain DG. (1/4" max, up to 1/2" with a bevel).			
CBC: 11B-303.2			
Other: ADA 303.2, ADA 303.3			
6 - 1 Stairway			Category: 1
Raise or lower existing handrail			\$300
Notes: Handrail top surface is mounted 28" above 6 stair nosings (34" min to 38" max).			
CBC: 11B-505.4			
Other: ADA 505.4			
6 - 2 Stairway			Category: 1
Raise or lower existing handrail			\$250
Notes: Handrail top surface is mounted 33" above the stair nosing (34" min to 38" max).

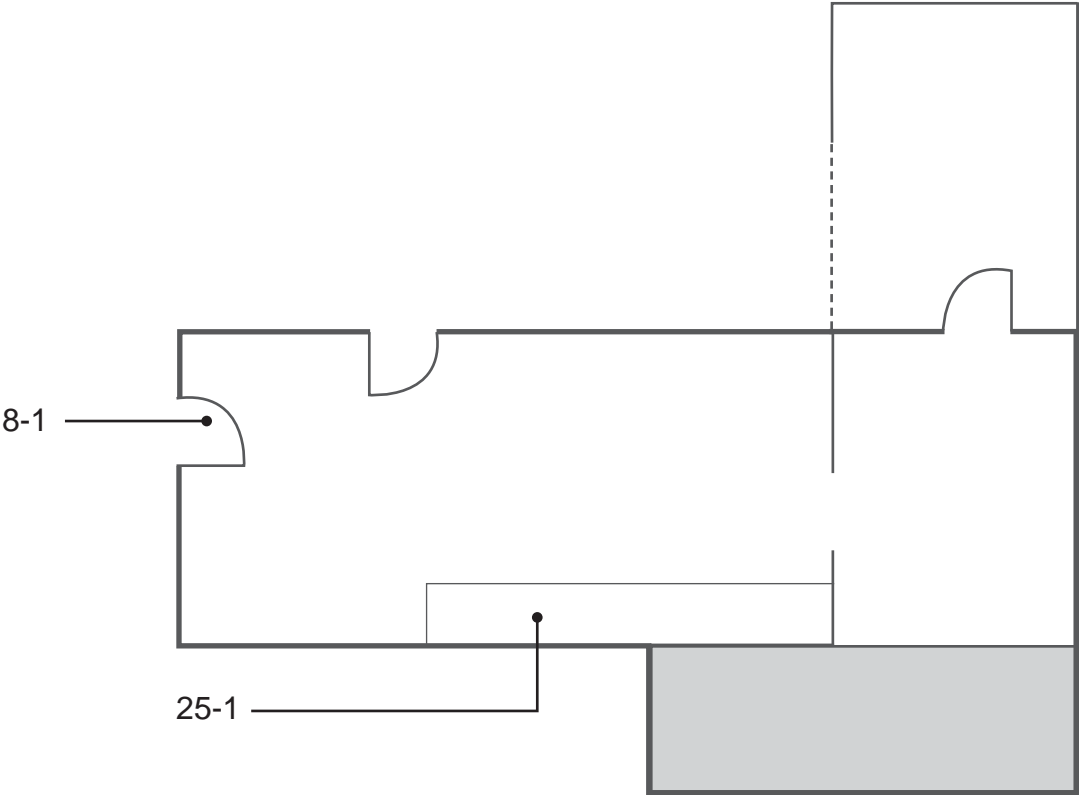
McClellan Ranch 4H Building
22221 McClellan Rd
Cupertino, CA

Building	
8 - 1	Door/Gate Category: 1
Replace or modify door threshold	\$125
Notes: Threshold has a vertical change of 1" (1/4" max, up to 1/2" with a bevel).	
CBC: 11B-404.2.5	
Other: ADA 404.2.5	
Regrade surface	\$2,500
Notes: Slope on the push side of the door is 7.1% (2.0% max).	
CBC: 11B-404.2.4.4	
Other: ADA 404.2.4.4	
25 - 1	Kitchen Category: 4
Provide accessible sink	\$3,000
Notes: Sink is 8 inches deep (6.5 inches max).	
CBC: 11B-606.7	
Other: -	
Insulate water lines	\$125
Notes: Insulation on hot water pipe is not attached.	
CBC: 11B-606.5	
Other: ADA 606.5	
Provide knee and toe clearance	\$0
Notes: Knee clearance underneath the sink is 26" (27" min). Knee space is obstructed by cleaning supplies.	
CBC: 11B-306.3.3	
Other: ADA 306.3, ADA 306.3.3	
Modify counter height	\$1,500
Notes: Height of kitchen work surface is 34.25" AFF (28" min to 34" max).	
CBC: 11B-804.3.2	
Other: ADA 804.3.2

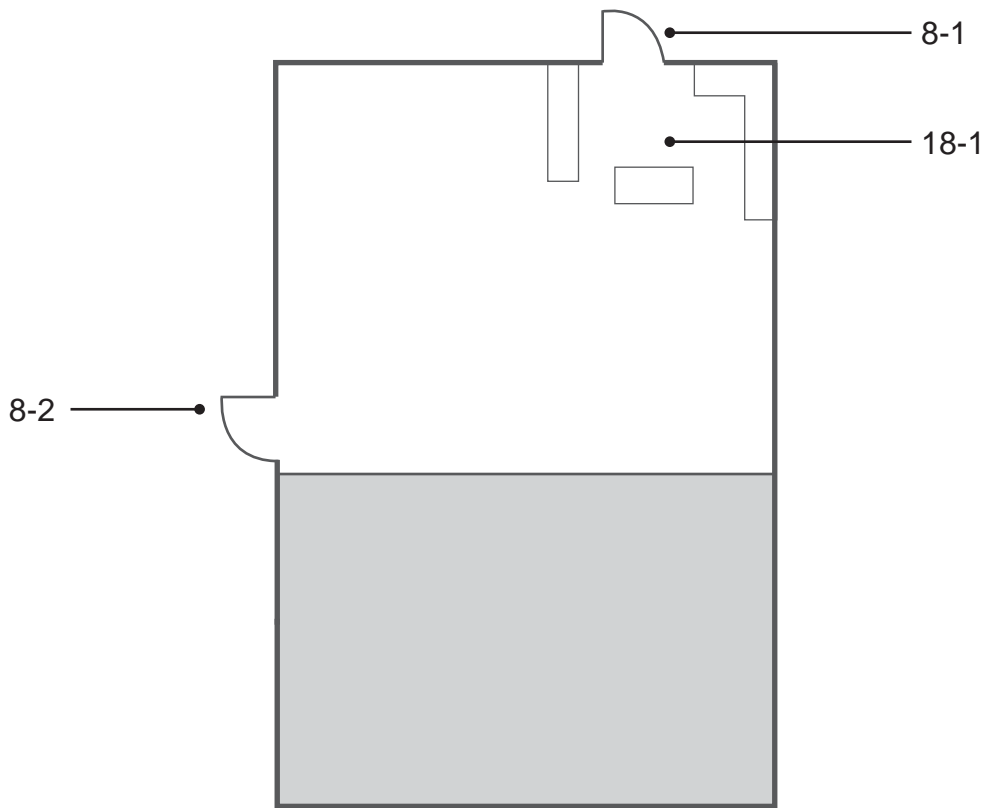
McClellan Ranch Nature Museum
22221 McClellan Rd
Cupertino, CA

Building		
8 - 1	Door/Gate	Category: 4
Regrade surface		\$2,500
Notes: Slope on the swing side of the door is 15.2% for 36" (2.0% max).		
CBC: 11B-404.2.4.4		
Other: ADA 404.2.4.4		
8 - 2	Door/Gate	Category: 4
Replace or modify door threshold		\$125
Notes: Threshold has a vertical change of 1.5" (0.25" max, up to 0.5" with a bevel).		
CBC: 11B-404.2.5		
Other: ADA 404.2.5		
Replace door hardware		\$425
Notes: Door knob requires grasping and twisting to operate.		
CBC: 11B-309.4, 11B-404.2.7		
Other: ADA 309.4		
18 - 1	Room	Category: 4
Widen Corridor		\$0
Notes: Path of travel from door into the room is 27" wide due to a moveable table or 34" wide due to moveable furniture (36" wide min; down to 32" wide for 24" max). Relocate furniture.		
CBC: 11B-403.5.1		
Other: ADA 403.5.1

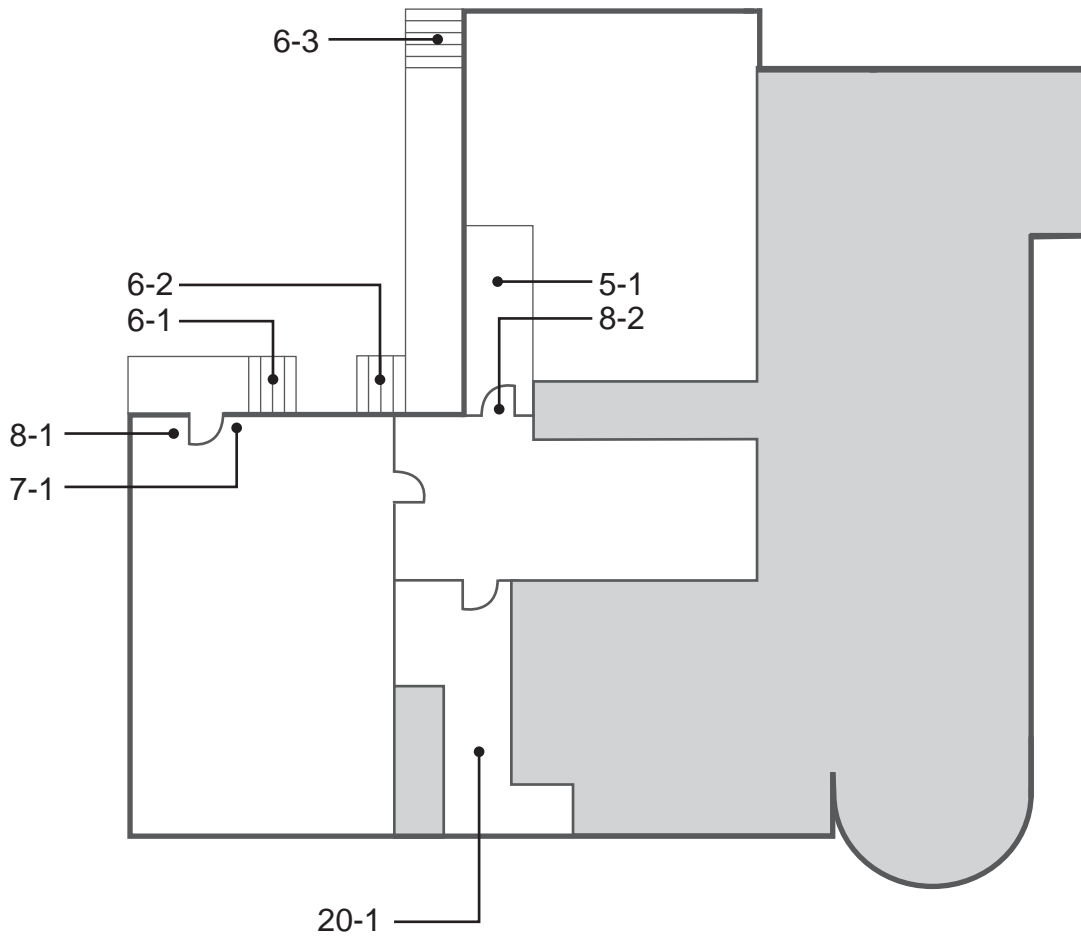
Building	
5 - 1	Ramp Category: 2
Install a handrail	\$750
Notes: Handrail is not provided on one side of the ramp to the conference room (required on both sides of ramp).	
CBC: 11B-505.2	
Other: ADA 405.8	
6 - 1	Stairway Category: 1
Install a handrail	\$250
Notes: Handrail on one side of the stairs has no parallel extension. A parallel extension of 6" is provided at the top of the handrail (12" min).	
CBC: 11B-505.10.2, 11B-505.10.3	
Other: ADA 505.10.2, ADA 505.10.3	
Replace stairs	\$1,200
Notes: Tread widths range from 11" to 12.5" (uniform widths required).	
CBC: 11B-504.2	
Other: ADA 504.2	
Install tread striping	\$60
Notes: No tread striping provided on 4 risers.	
CBC: 11B-504.4.1	
Other: -	
6 - 2	Stairway Category: 1
Install a handrail	\$1,250
Notes: Handrails are not provided on either side of the stairway (handrails required on both sides).	
CBC: 11B-505.2	
Other: ADA 505.2	
Install tread striping	\$75
Notes: No tread striping provided on 5 risers.

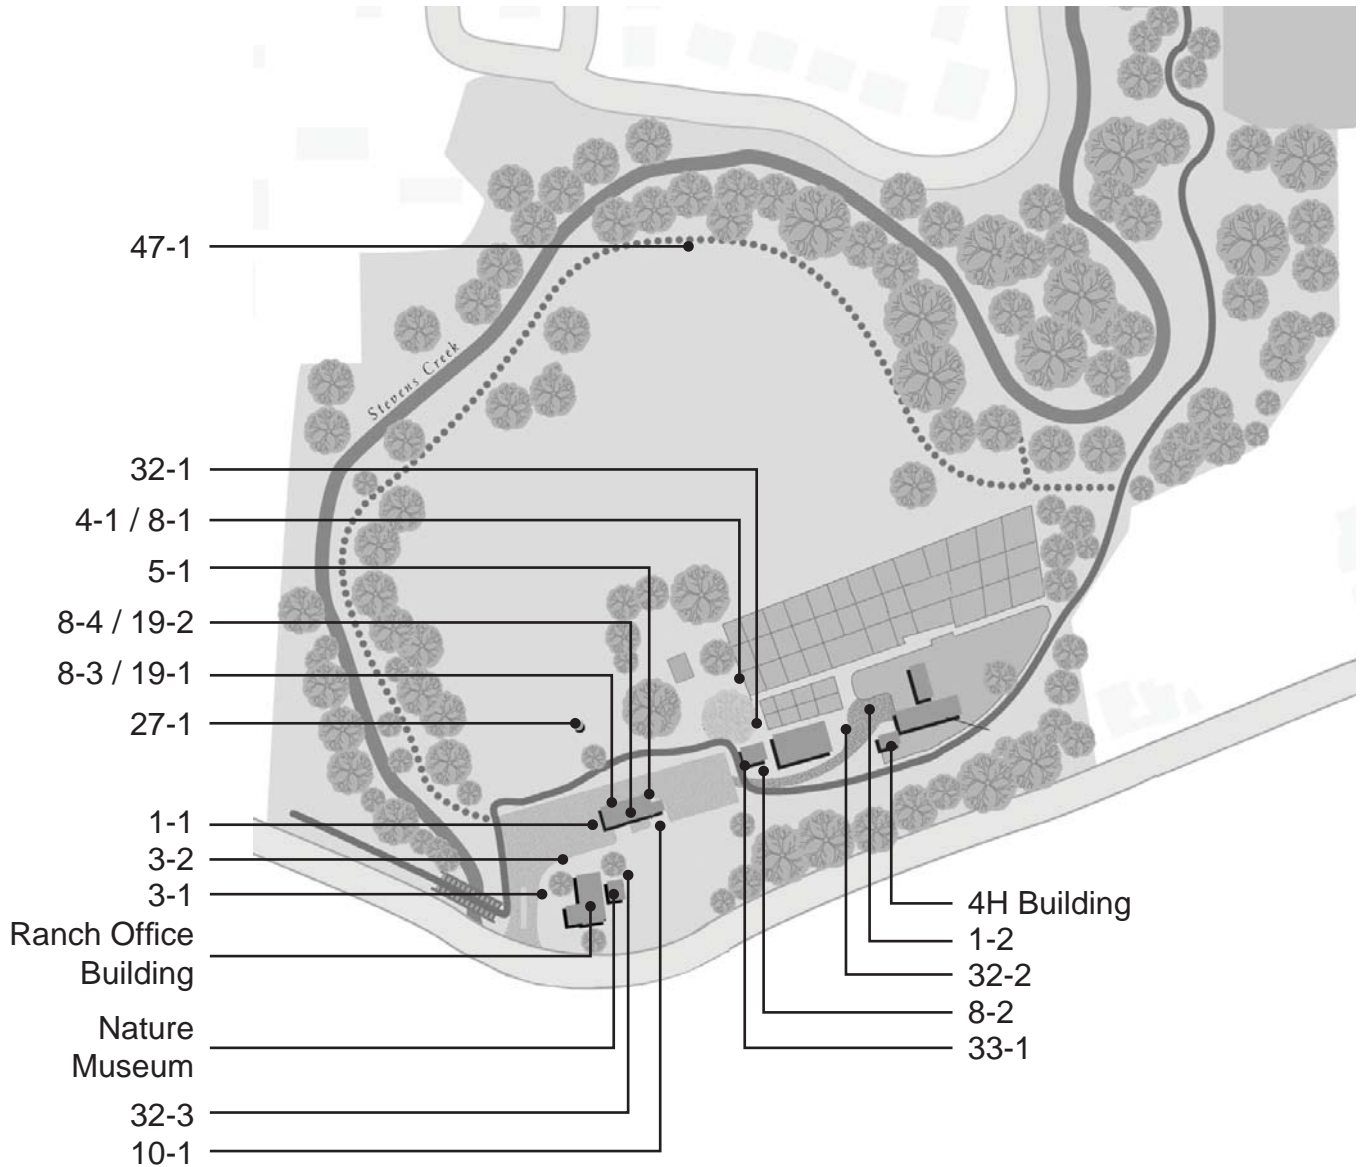
Park	
1 - 1	Parking Area Category: 1
Provide a pavement stencil	\$210
Notes: The ISA is a 24" from the bottom of the space (ISA must be flush with bottom of space).	
CBC: 11B-502.6.4.1, 11B-502.6.4.2	
Other: ADA 502.6	
Provide adequate striping	\$100
Notes: The words "No Parking" are not painted in the access aisle.	
CBC: 11B-502.3.3	
Other: -	
Provide or modify accessible access aisles	\$210
Notes: Access aisle does not have a blue border.	
CBC: 11B-502.3.2, 11B-502.3.3	
Other: ADA 502.3.3	
Install reserved parking sign	\$375
Notes: Parking signs are not located in front of designated accessible parking spaces.	
CBC: 11B-502.6, 11B-502.6.1	
Other: ADA 502.6	
Regrade accessible parking space or access aisle	\$1,600
Notes: Slope of parking spaces and access aisles is up to 4% (2.0% max).	
CBC: 11B-502.4	
Other: ADA 502.4	
1 - 2	Parking Area Category: 1
Install reserved parking sign	\$125
Notes: Contact information is not provided on tow-away warning sign.
