CITY OF CUPERTINO

AMERICANS WITH DISABILITIES ACT

self evaluation and transition plan

APPENDICES

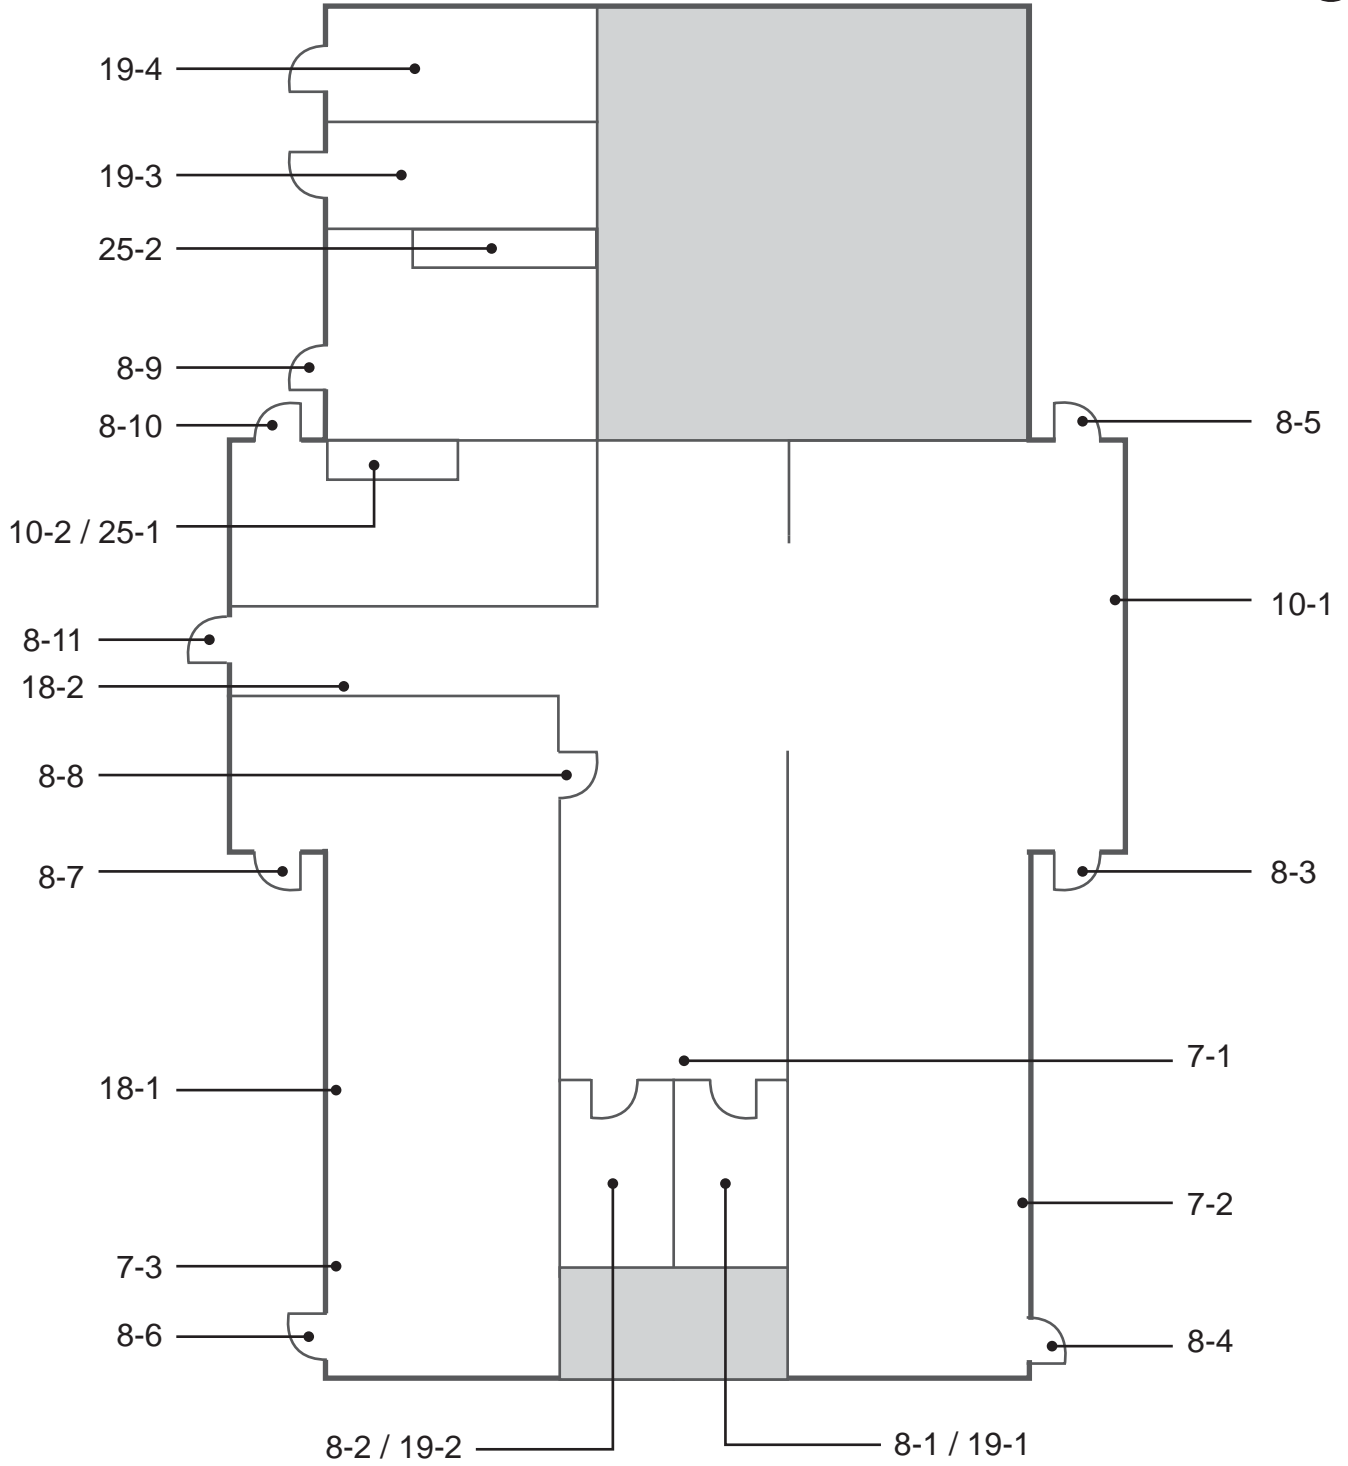
Monta Vista Park- Recreation Center
22601 Voss Avenue
Cupertino, CA

Building 1		
7 - 1	Hazard	Category: 2
Remove overhanging or protruding objects		\$125
Notes: AED and first aid kit protrudes 7.5" from the wall at 34.5" AFF (protrusion more than 4" must be mounted below 27" or above 80")		
CBC: 11B-307.4		
Other: ADA 307.4		
7 - 2	Hazard	Category: 2
Remove overhanging or protruding objects		\$125
Notes: Fire extinguisher protrudes 6" from the wall at 37.5" AFF (protrusion more than 4" must be mounted below 27" or above 80")		
CBC: 11B-307.2		
Other: ADA 307.2		
7 - 3	Hazard	Category: 2
Remove overhanging or protruding objects		\$125
Notes: Fire extinguisher protrudes 6.5" from the wall at 35.5" AFF (protrusion more than 4" must be mounted below 27" or above 80").		
CBC: 11B-307.2		
Other: ADA 307.2		
8 - 1	Door/Gate	Category: 2
Adjust door closer		\$125
Notes: Door opening force is 8 lbs (5 lbs max).		
CBC: 11B-404.2.9		
Other: ADA 404.2.9		
8 - 2	Door/Gate	Category: 3
Adjust door closer		\$125

Notes: Door opening force is 10 lbs (5 lbs max).		
CBC: 11B-404.2.9		
Other: ADA 404.2.9

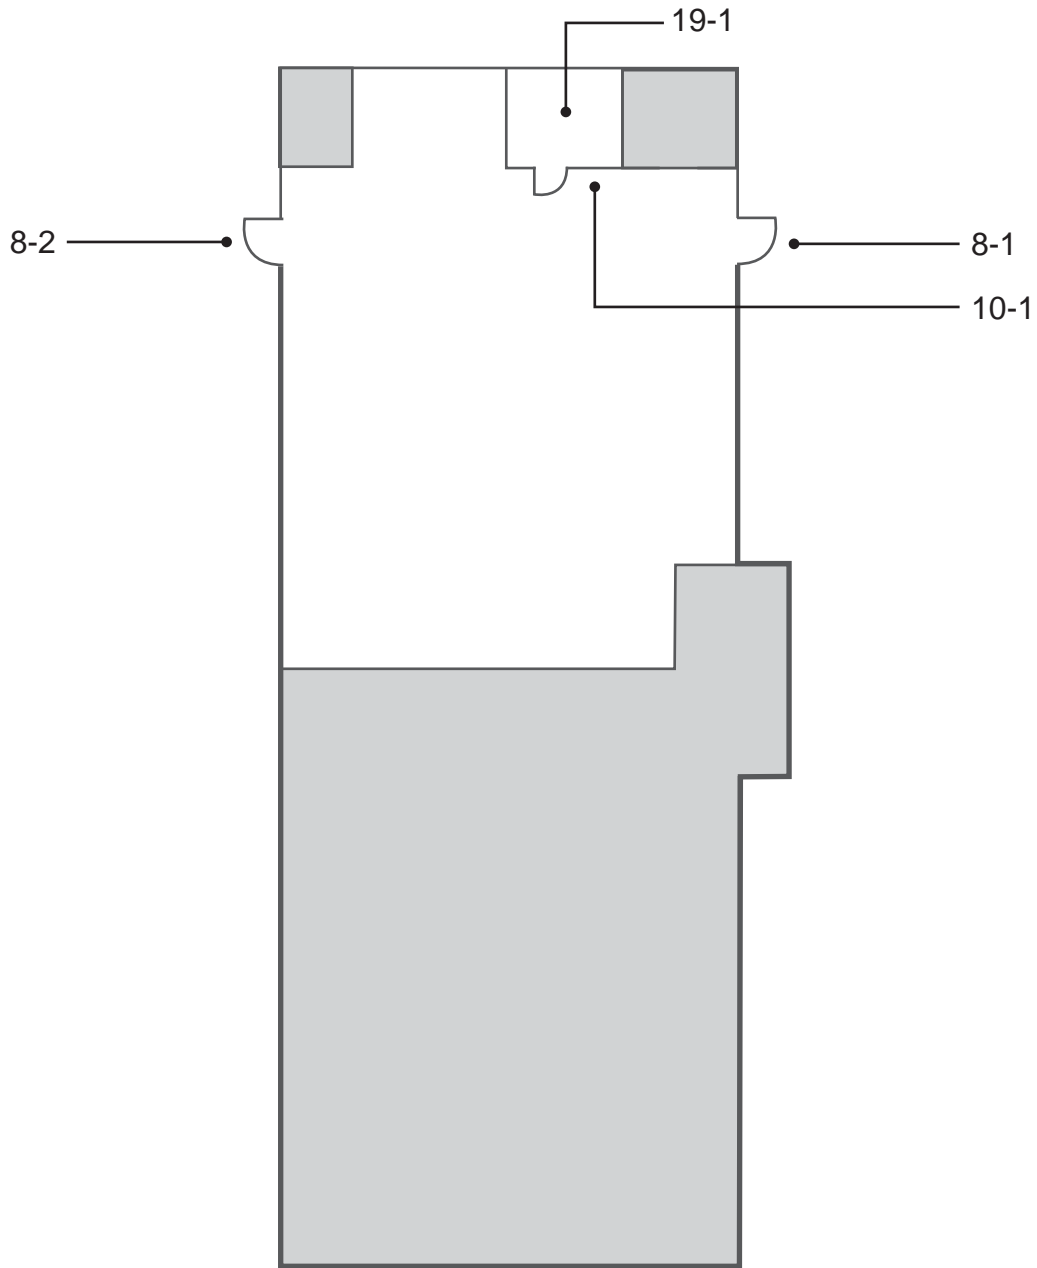
Building 2		
8 - 1	Door/Gate	Category: 1
Adjust door closer		\$125
Notes: Door opening force is 14 lbs (5 lbs max).		
CBC: 11B-404.2.9		
Other: ADA 404.2.9		
Install or modify sign		\$250
Notes: A tactile and Braille EXIT sign is not provided in passageway for emergency exit.		
CBC: 1011		
Other: ADA 216.4.1, ADA 703.4.1		
Provide or modify door kickplate		\$225
Notes: A smooth and uninterrupted kick plate surface is not provided. Panic hardware is located in the 10" space above the finished floor.		
CBC: 11B-404.2.10		
Other: ADA 404.2.10		
8 - 2	Door/Gate	Category: 1
Adjust door closer		\$125
Notes: Door opening force is 22 lbs (5 lbs max).		
CBC: 11B-404.2.9		
Other: ADA 404.2.9		
Install or modify sign		\$250
Notes: A tactile and Braille EXIT sign is not provided in passageway for emergency exit.		
CBC: 1011		
Other: ADA 216.4.1, ADA 703.4.1		
Provide or modify door kickplate		\$225
Notes: A smooth and uninterrupted kick plate surface is not provided. Panic hardware is located in the 10" space above the finished floor.

CBC: 11B-404.2.10		
Other: ADA 404.2.10		
10 - 1	Drinking Fountain	Category: 3
Adjust the water stream height or direction		\$125
Notes: The bubbler is attached to the sink and is 9" back from the front of the counter (5" max).		
CBC: 11B-602.6		
Other: ADA 602.6
