Re: Response to May 28, 2019 Administrative Citation and Notice of Violation

Response to Notice of Violation Regarding Stevens Creek Quarry Haul Road

Utility Road Grading Plan and Geotechnical Analysis

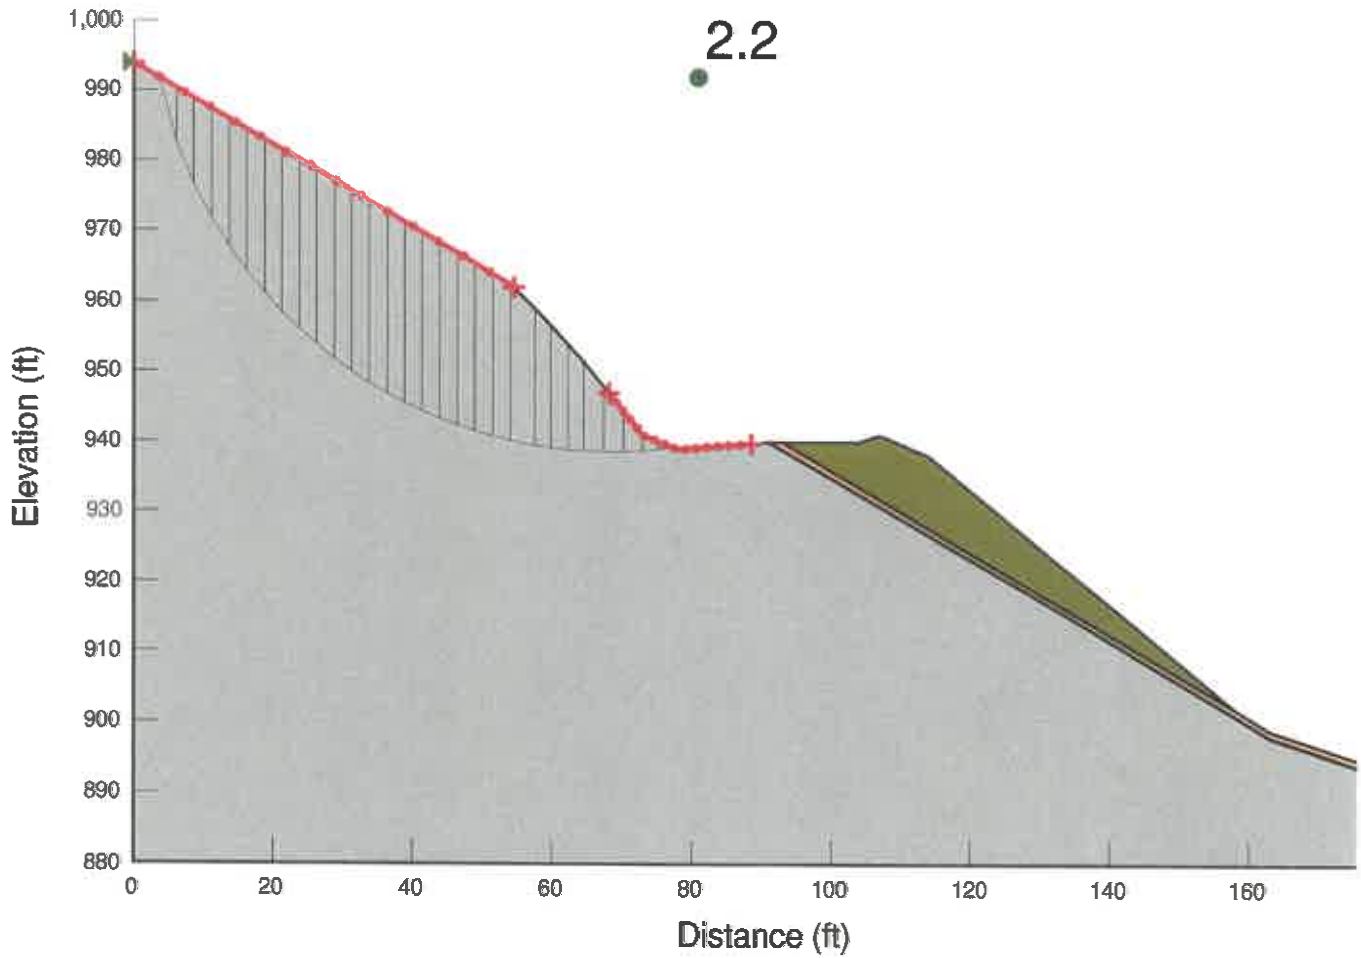
File Name: Existing Road.gsz
Name: 1. Cut Slope - Pseudo-static
Method: Spencer

Name: Waste Rock	Unit Weight: 125 pcf	Cohesion': 0 psf	Phi': 35 °
Name: Residual Soil	Unit Weight: 120 pcf	Cohesion': 200 psf	Phi': 30 °
Name: Greenstone	Unit Weight: 165 pcf	Cohesion': 1,400 psf	Phi': 23 °

Stantec modeled the slope stability factors of safety for static and pseudo-static conditions using the Slope/W 2012 (Version 8.14) computer program. Slope/W performs a two-dimensional, limit-equilibrium analysis to calculate the factor of safety. The pseudo-static analysis used a seismic coefficient of 0.15, which is consistent with previous analyses at the Lehigh property (Golder, 2011).

The slope stability results present the minimum factors of safety for each analysis, and these results are included in **Table 2** below and in **Attachment 1**. The results indicate that the cut slopes are stable (FOS>1.0) during both the static and pseudo-static conditions. The fill slope is stable under static conditions, but the FOS is less than 1.0 for pseudo-static conditions. This suggests that some sloughing is likely to occur during a seismic event but mitigating the slope movements would be limited to grading and revegetating the slope. There is no infrastructure or any sort of facility below the road that can be impacted by potential slope movements.

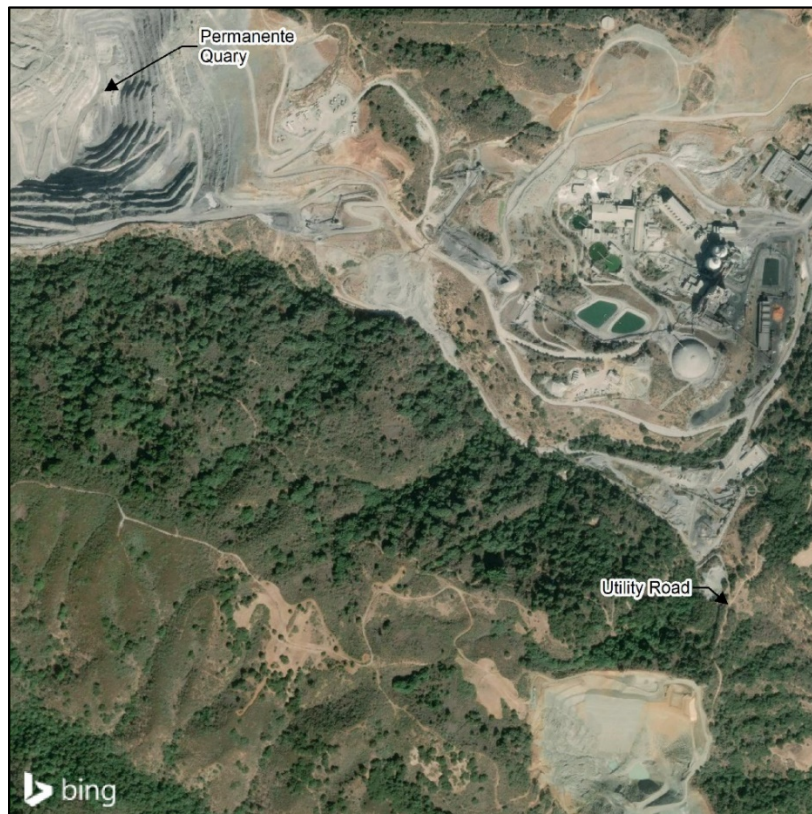
Figure 1 Utility Road Location

Lehigh Hanson (Lehigh) improved an approximately 800-foot long portion of an existing utility road that climbs southerly from the Permanente aggregate plant and continues along a ridge toward the neighboring quarry site (**Figure 1**). The alignment has been in use for 50 plus years and does not represent an engineered design. This roadway began as a narrow, bulldozed exploration and utility access road. It was subsequently used as a maintenance road to access this portion of the property, and by Pacific Gas and Electric Company (PG&E) to access power lines in the area. The road was improved in 2018 to allow for off-site materials transport. Lehigh plans to grade the utility road to decrease slope gradients while continuing to allow access by site personnel for maintenance and exploration purposes, PG&E maintenance vehicles, and potentially emergency response vehicles. No further hauling is planned for the road.

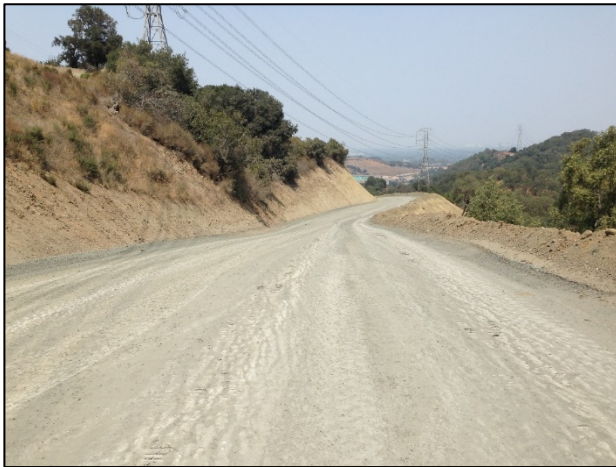
Figure 2 Utility Road Cross-Section

The utility road was improved along its preexisting alignment. While the road contains steep slopes and grades, it is within typical mining industry standards for grading, slopes, and drainage controls. A key consideration of this road is that it is an internal road that cannot be accessed by the public. It must remain serviceable as it serves the primary access to the southern property and as an easement for PG&E utility lines. Roads such as this are typically constructed following existing site practices that have been proven to work at the site. Photographs of the improved road are included below. **Figure 2** shows the road cross-section and presents the range of excavation heights. **Figure 3** shows the fill profile. It should be noted that the slopes pictured have been revegetated since these photographs were taken.

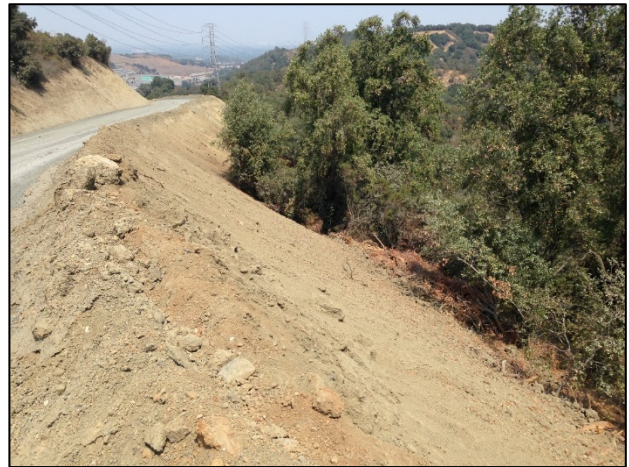
Figure 3 Utility Road Fill Profile

The road is steep compared to typical public roads, with grades up to 20%. These grades are common for unpaved mine access roads which are not intended for public use. These grades are also consistent with the grades for retained roads in the currently approved Reclamation Plan Amendment for the Permanente Quarry. The road is sloped toward the hillside, which directs stormwater to the inside of the road. Water flows either to the aggregate plant at Permanente Quarry to the north or Stevens Creek Quarry to the south, where it enters one of the existing stormwater management systems.

The utility road was constructed by placing a key at the toe of the fill slope. The key included excavating material from the toe of the fill area and backfilling it with compacted fill. Water was added to the fill to achieve optimal moisture content, and it was compacted with a vibratory sheep's foot roller. Once the key was constructed, the utility road was improved by cutting material from the uphill slope and placing compacted fill on the downhill slope above the key. The fill slope was cleared and grubbed, but the surface soil was not removed, except where the key was placed. The cut slopes vary, but they are generally steep at approximately 1:1 (45°), with cut heights are up to 30 feet. The fill slopes are also steep at approximately 1.2:1 (39°), with fill slopes up to 50 feet high. Internal mine roads are often constructed with cut and fill slopes in this range, and any erosion that occurs is managed by the site maintenance crews. A safety berm was

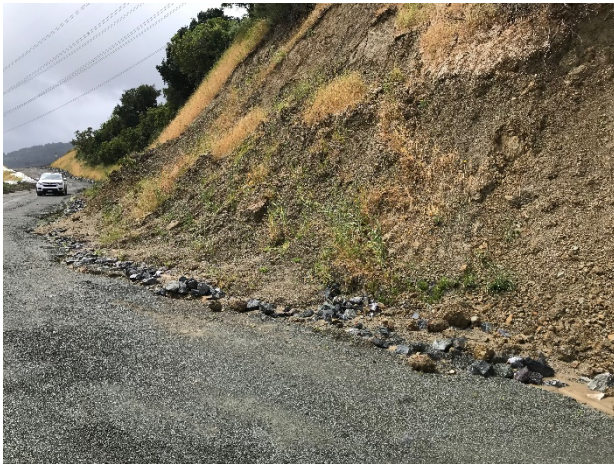
Figure 4 Road Cut at Cross-Section B-B'

A Stantec Certified Engineering Geologist (CEG) inspected the utility road in May 2019 to evaluate the lithology along the road cut. The inspection confirmed the road was constructed primarily in the Santa Clara Formation; however, the southern section (including C-C') was constructed in Franciscan Limestone and Greenstone. The limestone is not present at the two areas where a geotechnical assessment is required (see below). **Figures 4** and **5** show the Santa Clara Formation at the road cut at cross-section B-B' and Greenstone at the road cut at cross-section C-C', respectively. **Drawing 1** includes the cross-section locations, and the cross-sections are included as **Drawing 2**.

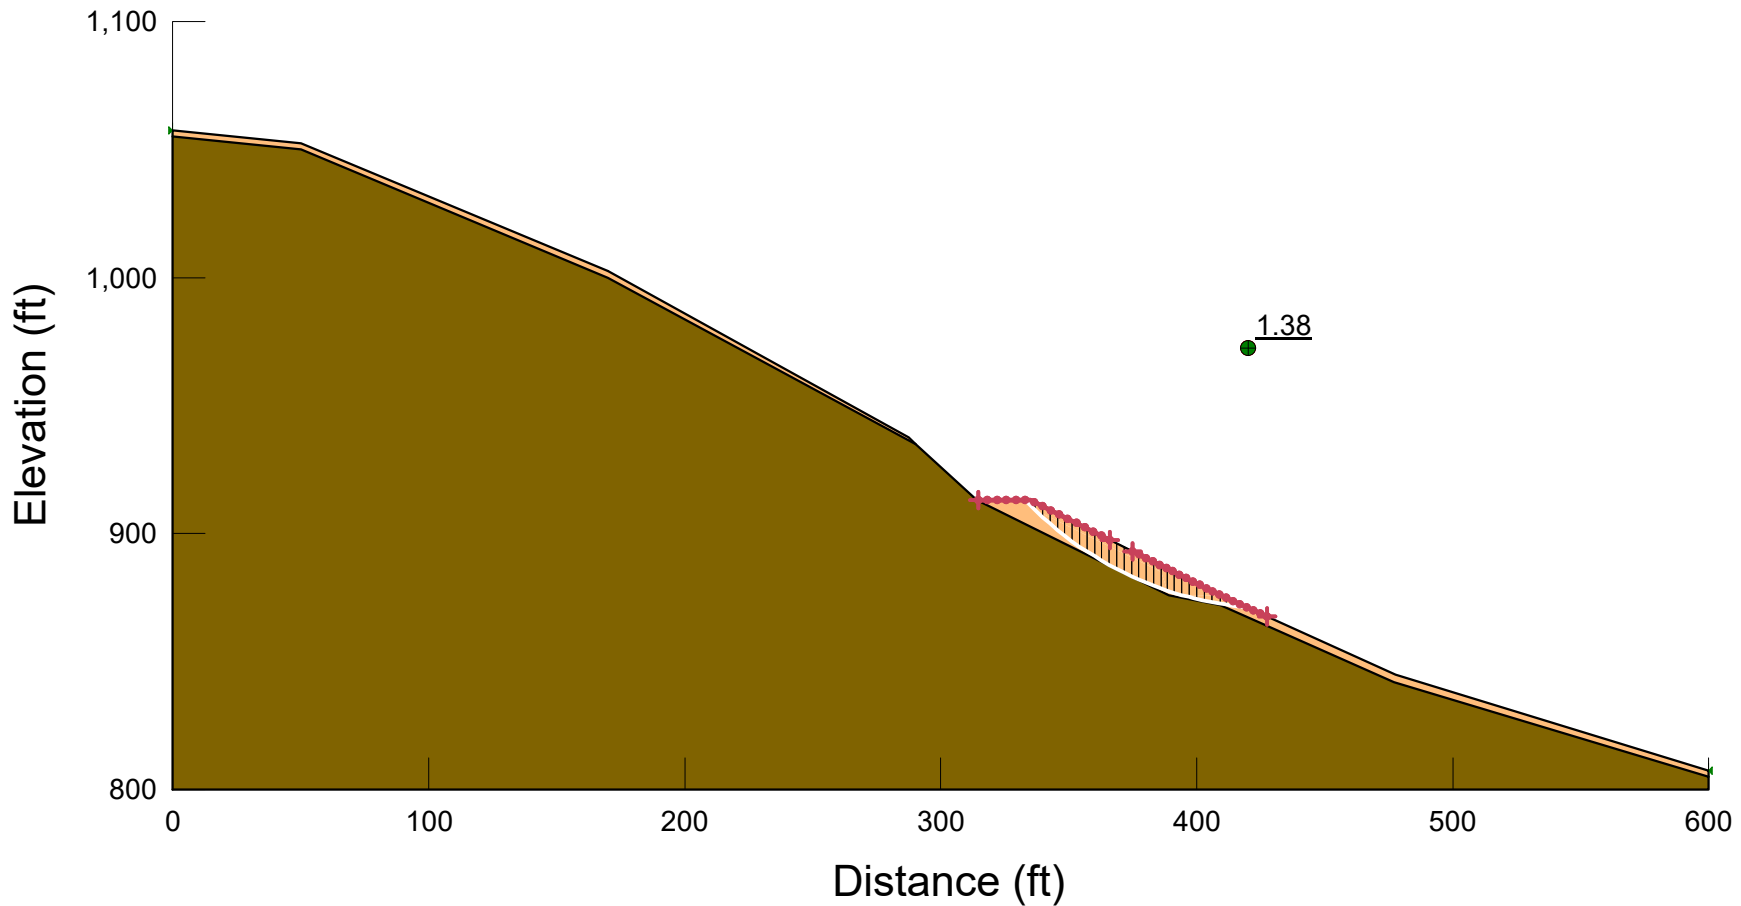
Factor of Safety: 1.38

Color	Name	Model	Unit Weight (pcf)	Cohesion (psf)	Phi (°)
Greenstone	Greenstone	Mohr-Coulomb	165	1,400	23
Residual Soil	Residual Soil	Mohr-Coulomb	120	200	30
