## appendix e: geologic and seismic hazards

The following definitions provide a more comprehensive discussion of the hazards that are described in the main body of the text of Chapter 7: Health and Safety Element.

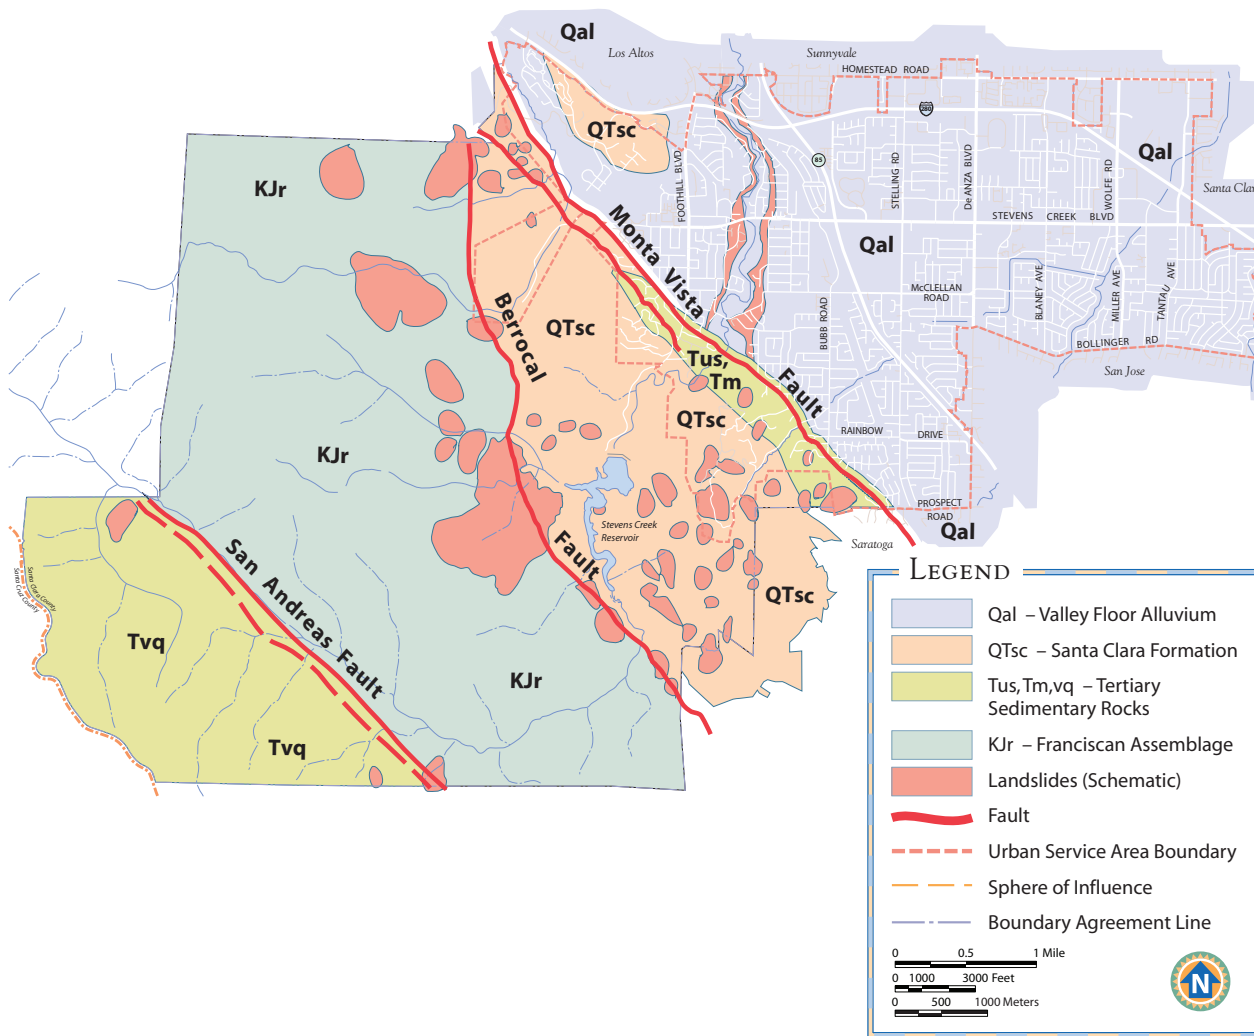
**FIGURE E-1  
CUPERTINO GEOLOGY**

**Figure E-1** on page 5 shows mapped landslide deposits within Cupertino. Geologic mapping in the hillsides shows that landslide deposits cover as much as 20 to 30 percent of the hillsides in the planning area. Landslides range from small, shallow deposits made up of soil and weak bedrock materials to large, deep landslides involving a large amount of bedrock.
