SANTA CLARA COUNTY, CALIFORNIA  
STEVENS CREEK QUARRY  
**MINE AND RECLAMATION DESCRIPTION  
FOR NEW USE PERMIT AND AMENDED RECLAMATION PLAN**

*CA MINE ID 91-43-0007*

**MAY** | 2019

Benchmark Resources

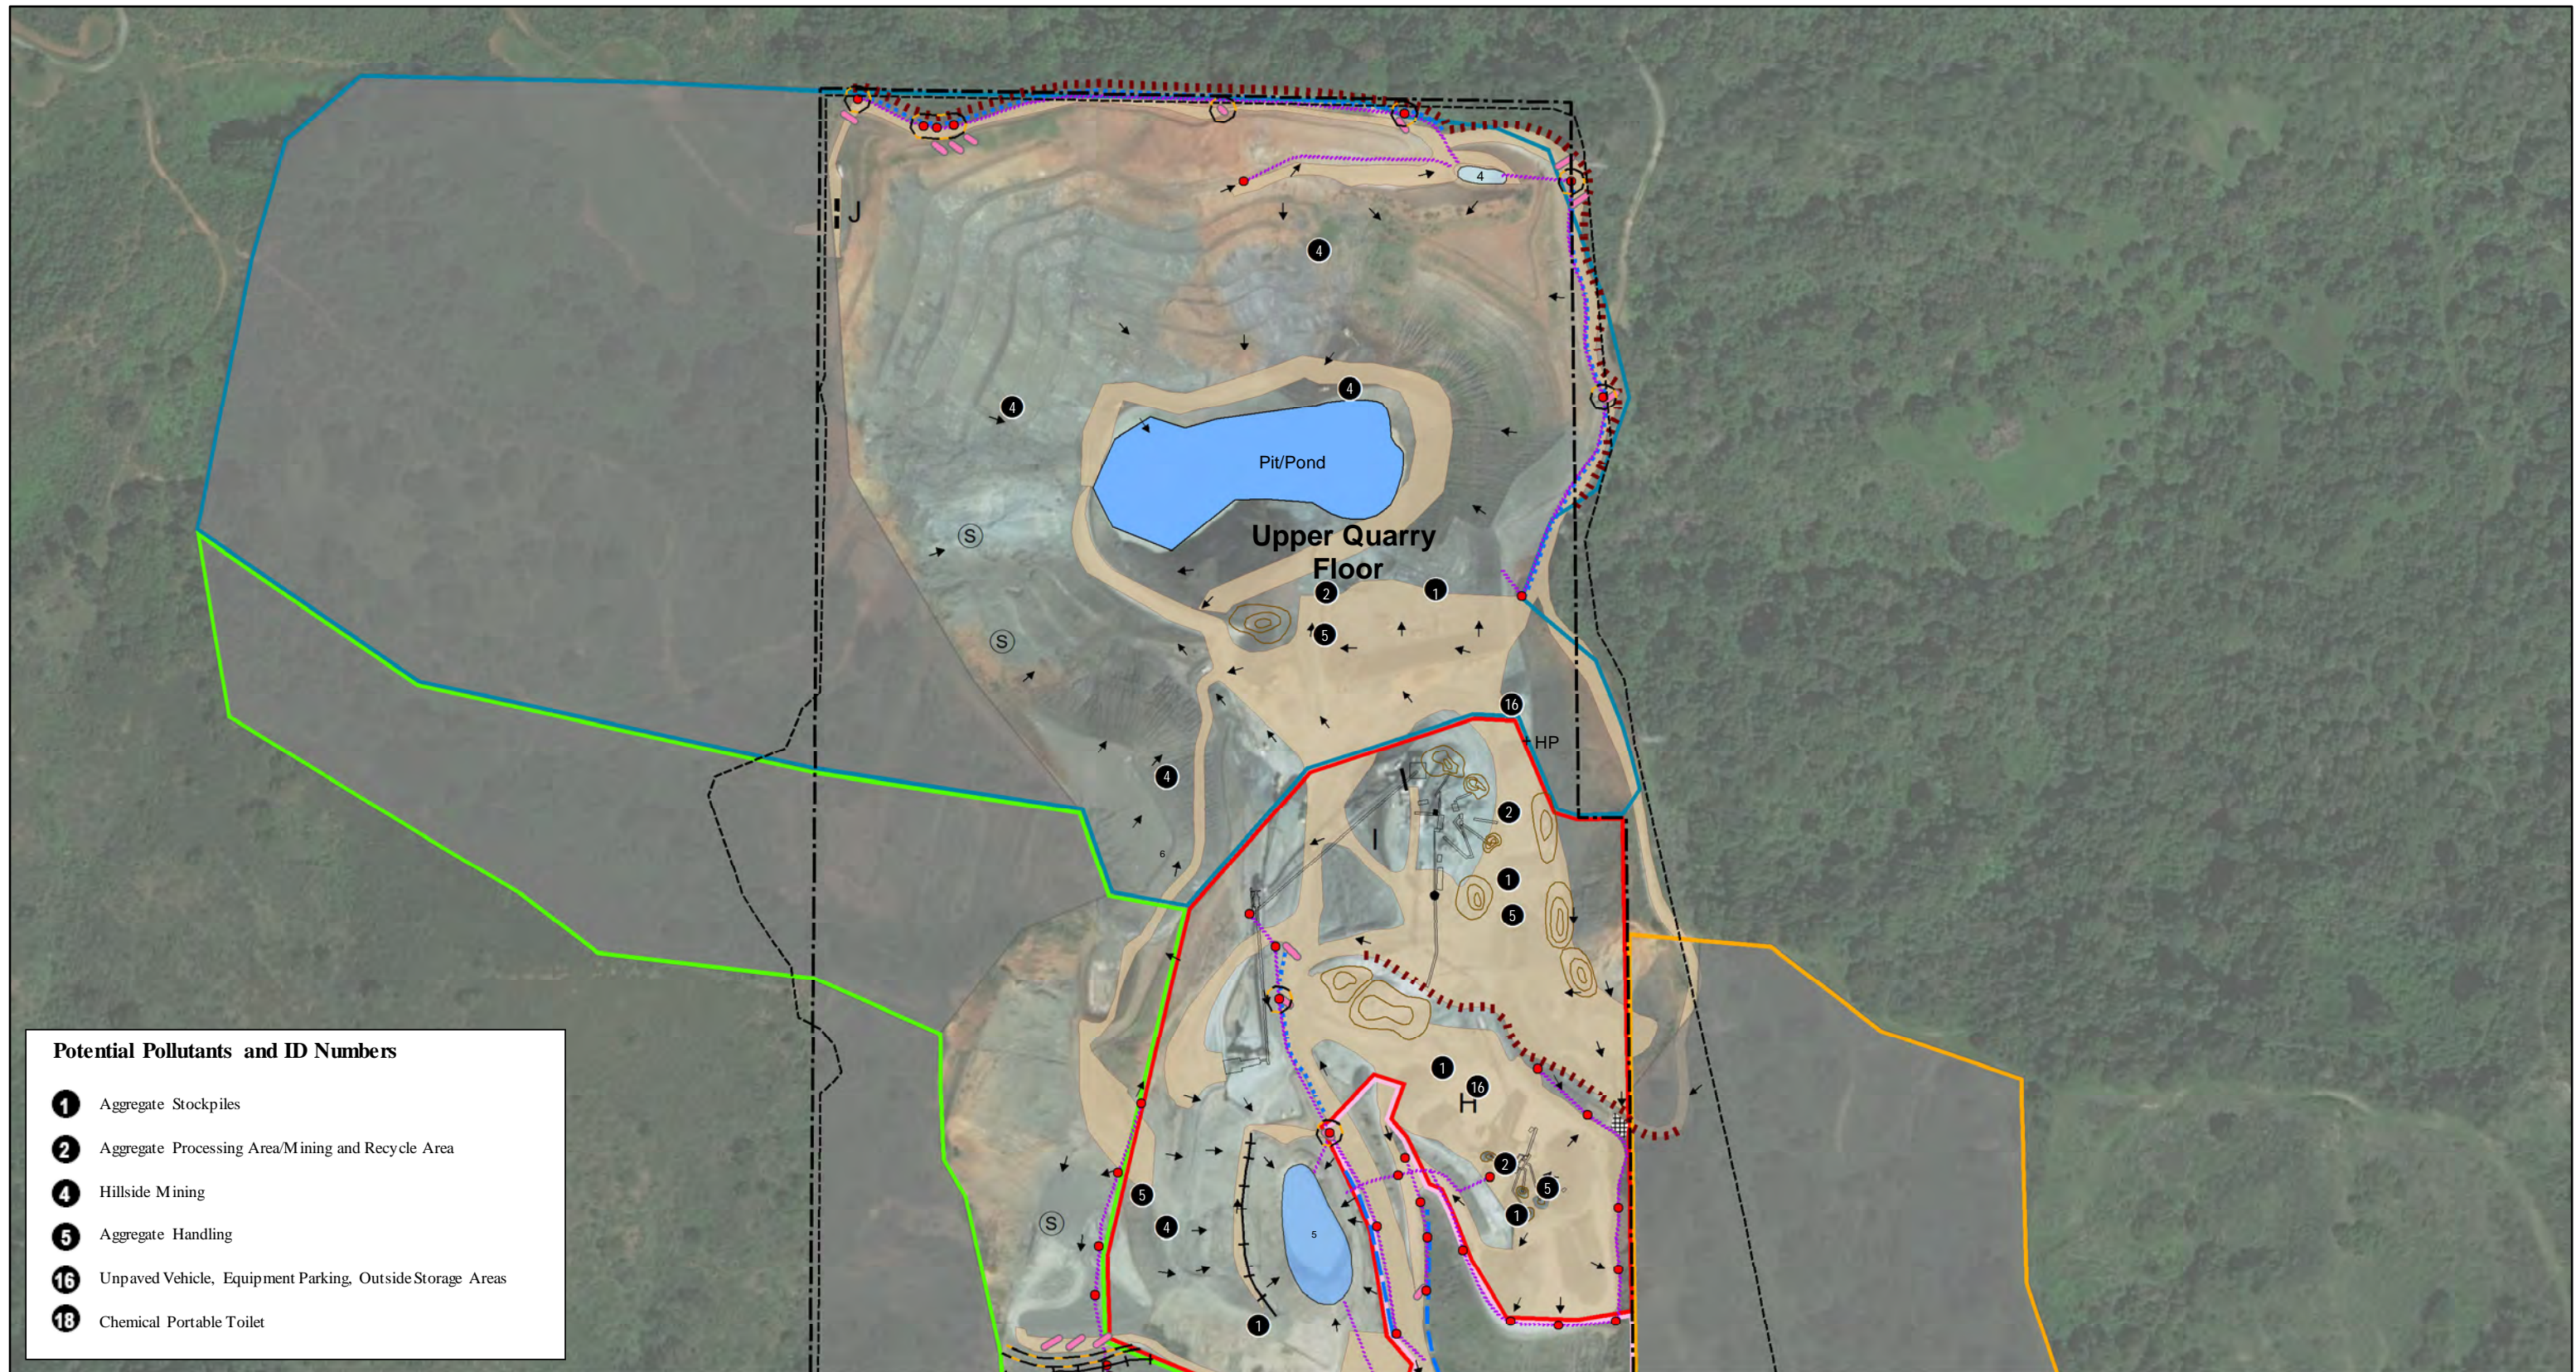
A Office, Scale House, Scale	F Voss Trucking	Building	Stockpile	Concrete Swale	Metal Stormwater Tank	Culvert	Silt Fence	Discharge Point (Color Matches Drainage Area)	<b>Drainage Areas</b>
B Recycle Plant	G Fueling Area and Fuel Tanks	Structure	Earth Berm	Direction of Flow	Drop Inlet	French Drain	Rock Dissipator	Sediment Trap 3 Monitoring Location	
C Topsoil Plant	Property Line	Paved Road	Paved Berm	Sediment Trap	Stand Pipe	Grate	Rock Lining	Background Monitoring Location	
D Garden Waste Recycle Center	Mining Limit Line	Unpaved Road	Gate	Sediment Pond	Weir	Portable Toilet	4x8 Rock	Receiving Water Monitoring Location	
E Quarry Maintenance/Storage	Ingress/Egress	Gravel/Rock Surface	Creek	Rattlesnake Creek Pond	Check Dam	Check Dam	Rock Berm		
		Non-Industrial Areas	Drainage Ditch	Concrete Drainage Box	Low Point	Coir Wattles

SOURCE: Google Earth (01/31/2016); Freeman Associates and Geosyntec Consultants.  
NOTES: The location of the property line is approximate. The site information and layout is based on site visits. Aerial imagery may not reflect current site conditions.

**Potential Pollutants and ID Numbers**

- 1 Aggregate Stockpiles
- 2 Aggregate Processing Area/Mining and Recycle Area
- 4 Hillside Mining
- 5 Aggregate Handling
- 16 Unpaved Vehicle, Equipment Parking, Outside Storage Areas
- 18 Chemical Portable Toilet

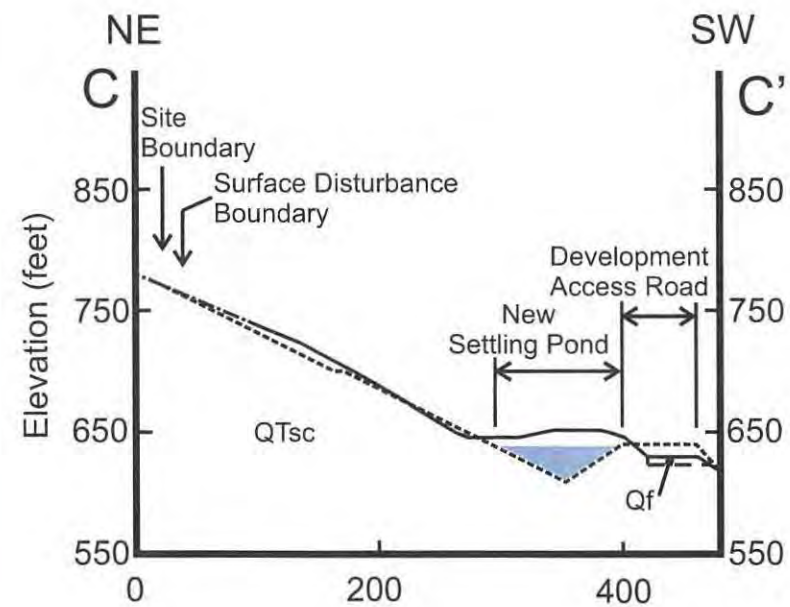
- EXISTING GROUND SURFACE, APPROXIMATE.
- - - - PROPOSED GROUND SURFACE AT 2:1 SLOPE W/ 8 FEET BENCH, APPROXIMATE.
- · - · - · INFERRED GROUND SURFACE
- - - - GEOLOGIC CONTACT, APPROXIMATE
- B-6 ↓ APPROX. BORING LOCATION, TYP.
- QTsc SANTA CLARA FORMATION
- Qf EXISTING FILL

- Perform geotechnical laboratory testing on some selected samples;
- Generate three geologic structural cross sections: A-A' through C-C';
- Evaluate the collected data and perform slope stability analyses under static and pseudo-static (seismic) loading conditions depicting several slope gradient scenarios;
