CITY OF CUPERTINO

AMERICANS WITH DISABILITIES ACT

self evaluation and transition plan

APPENDICES

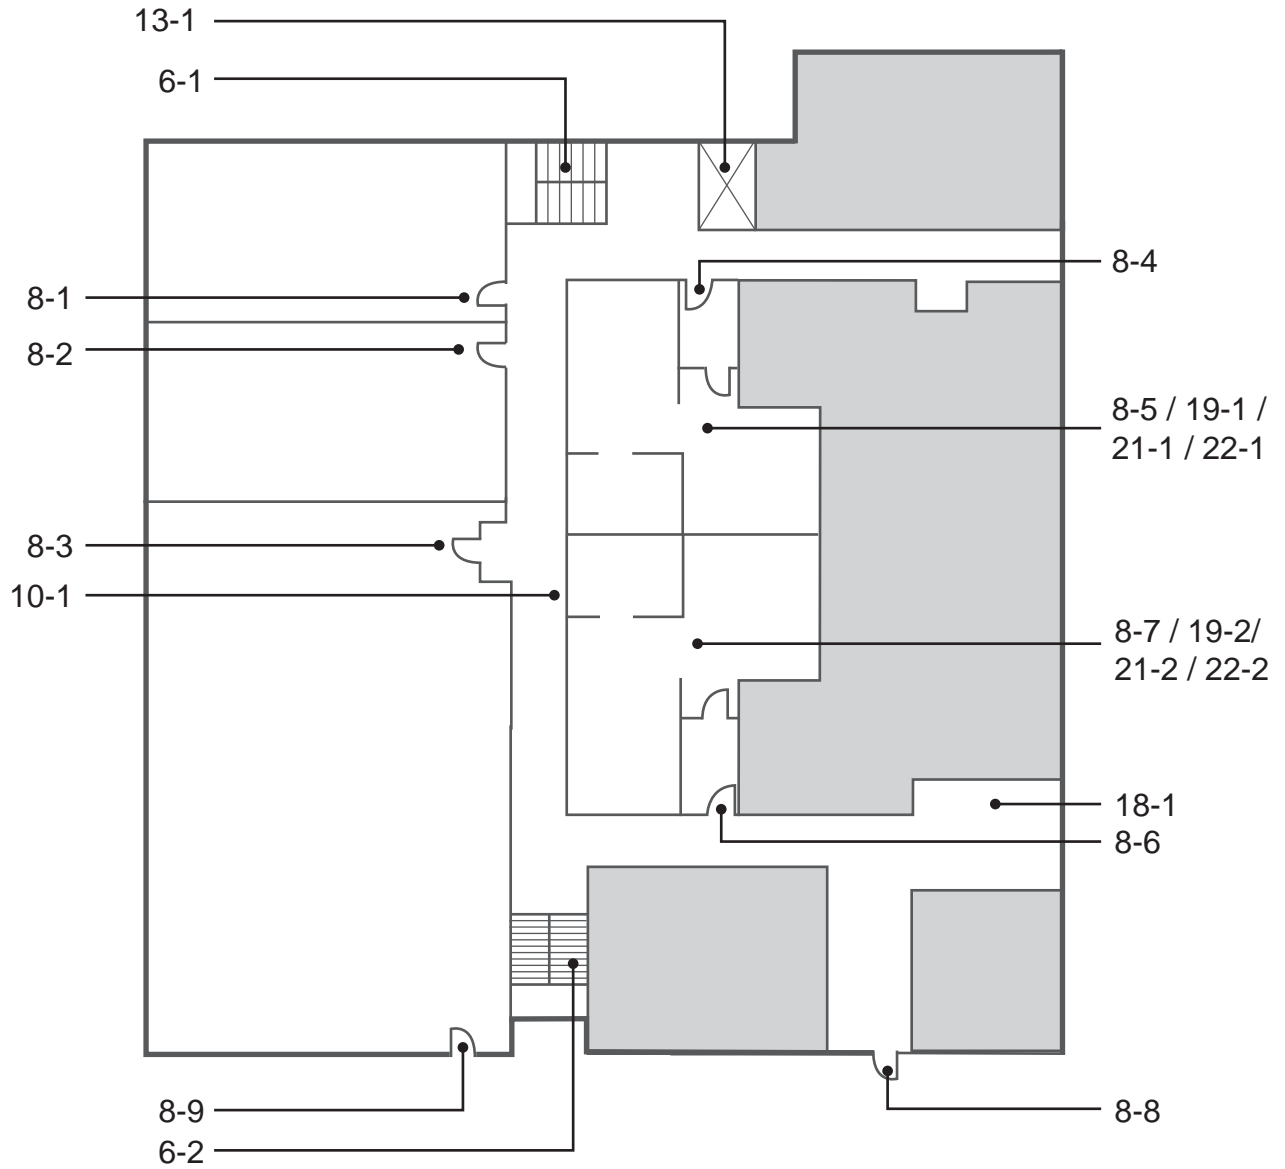
Sport Center - Floor 1
21111 Stevens Creek Blvd.
Cupertino, CA

Floor 1		
6 - 1	Stairway	Category: 2
Replace stairs		\$4,800
Notes: Stairway with 16 risers. Riser heights are 7.5" (4" min to 7" max).		
CBC: 11B-504.2		
Other: ADA 504.2, ADA 504.3		
Raise or lower existing handrail		\$500
Notes: Handrail top surface is mounted 42" above the stair nosing (34" min to 38" max).		
CBC: 11B-505.4		
Other: ADA 505.4		
Install a handrail		\$500
Notes: A parallel extension of 8.5" is provided at the top of the handrail before turning 90 degrees for 12" (12" min). A sloped extension is not provided on one bottom extension (one tread-width min).		
CBC: 11B-505.10.2, 11B-505.10.3		
Other: ADA 505.10.2, ADA 505.10.3		
6 - 2	Stairway	Category: 2
Install a handrail		\$500
Notes: Parallel extension at the top of the handrail extends 5" before turning 90 degrees for 10". Parallel extension in the bottom of the handrail is 9" (12" min). Parallel extension at the bottom of the handrail on the lower flight of stairs is 4.5" (12" min).

CBC: 11B-505.10.2, 11B-505.10.3		
Other: ADA 505.10.2, ADA 505.10.3		
Repair stair nosing		\$1,625
Notes: Tread nosing overhangs riser horizontally at 90 degrees (30 degrees max) at a depth of 1", 13 risers (rounded with a radius of 1/2" max).		
CBC: 11B-504.5		
Other: ADA 504.5		
Raise or lower existing handrail		\$500
Notes: Handrail top surface is mounted 39" above the stair tread at the upper flight and 40" above the stair tread at the lower flight (34" min to 38" max).		
CBC: 11B-505.4		
Other: ADA 505.4

Floor 1	
8 - 1	Door/Gate Category: 2
Modify door window or side light	\$500
Notes: Bottom of the door's window glazing is 55.75" AFF (43" max).	
CBC: 11B-404.2.11	
Other: ADA 404.2.11	
Replace door hardware	\$425
Notes: Inside door handle requires grasping and twisting to operate.	
CBC: 11B-309.4, 11B-404.2.7	
Other: ADA 309.4	
8 - 2	Door/Gate Category: 2
Modify door window or side light	\$500
Notes: Bottom of the door's window glazing is 55.75" AFF (43" max).	
CBC: 11B-404.2.11	
Other: ADA 404.2.11	
Replace door hardware	\$425
Notes: Inside door handle requires grasping and twisting to operate.	
CBC: 11B-309.4, 11B-404.2.7	
Other: ADA 309.4	
8 - 3	Door/Gate Category: 2
Provide strike edge clearance	\$0
Notes: Front approach strike-edge clearance on the pull side of the door is 4" due to movable trash can (18" min).	
CBC: 11B-404.2.4.1	
Other: ADA 404.2.4.1	
Modify door window or side light	\$500
Notes: Bottom of the door's window glazing is 55.25" AFF (43" max).

Floor 1	
19 - 1 Multiple User Restroom	Category: 2
Install restroom sign	\$250
Notes: Bottom of tactile lettering on the top line of text on federal sign is 62.5" AFF (60" min).	
CBC: -	
Other: ADA 703	
Modify lavatory or counter clearances	\$1,500
Notes: Knee space measured at 8" deep from the centerline of the lavatory is 22" AFF (27" min).	
CBC: 11B-306.3.3	
Other: ADA 306.3, ADA 306.3.3	
Provide or replace compartment door hardware	\$175
Notes: Compartment door is not self closing (compartment door must have U-shaped handles both inside and outside of the door and be self-closing).	
CBC: 11B-604.8.1.2	
Other: ADA 604.8.1.2	
Replace or modify grab bars	\$300
Notes: Side grab bar extends 52.5" from the rear wall (54" min).	
CBC: 11B-604.5.1	
Other: ADA 604.5.1	
Replace or reposition fixtures	\$1,250
Notes: Centerline of the water closet is 18.5" from side wall (17" min to 18" max).	
CBC: 11B-604.2	
Other: ADA 604.2

Replace or reposition dispenser	\$250
Notes: Hair dryer is 60" AFF (40" max). Centerline of toilet paper is flush with front of the water closet (7" min to 9" max).	
CBC: 11B-603.5	
Other: -

Floor 1	
19 - 2	Multiple User Restroom Category: 2
Provide or replace compartment door hardware	\$175
Notes: Compartment door is not self closing (compartment door must have U-shaped handles both inside and outside of the door and be self-closing).	
CBC: 11B-604.8.1.2 Other: ADA 604.8.1.2	
Replace or modify grab bars	\$600
Notes: Side grab bar extends 52.25" from the rear wall (54" min). Rear grab bar extends 11" from the centerline of the water closet (36" long min, extends 12" and 24" min from centerline of water closet).	
CBC: 11B-604.5.1, 11B-604.5.2 Other: ADA 604.5.1, ADA 604.5.2	
Reposition clothing hooks	\$125
Notes: Height of coat hooks is 56" (48" max).	
CBC: 11B-603.4 Other: ADA 308	
Replace or reposition dispenser	\$250
Notes: Hair dryer is 61" AFF (40" max). Centerline of toilet paper is flush with front of the water closet (7" min to 9" max).	
CBC: 11B-603.5 Other: -	
Install restroom sign	\$250

Notes: Bottom of the top line of tactile lettering on federal sign is 62.5" AFF (60" min).	
CBC: - Other: ADA 703	
21 - 1	Dressing, Fitting or Locker Room Category: 2
Provide accessible fixed bench	\$2,000
Notes: Back support in the fixed benches is not provided (48" long and 18" high). Bench is 36" long and 9.5" deep (48" long by 20" to 24" deep).	
CBC: 11B-903.3, 11B-903.4 Other: ADA 903.3, ADA 903.4	
Replace or reposition mirror	\$150
Notes: Full-length mirror is 11.5" wide by 47.5" long, and the bottom edge is 22.5" AFF (18" wide and 54" high min, 20" max AFF).	
CBC: 11B-803.6 Other: -

Floor 1	
21 - 2 Dressing, Fitting or Locker Room	Category: 2
Provide accessible fixed bench	\$2,000
Notes: Back support in the fixed benches is not provided (48" long and 18" high). Bench is 36" long and 9.5" deep (48" long by 20" to 24" deep).	
CBC: 11B-903.3, 11B-903.4	
Other: ADA 903.3, ADA 903.4	
Replace or reposition mirror	\$150
Notes: Full-length mirror is 11.5" wide by 47.5" long, and the bottom edge is 22.5" AFF (18" wide and 54" high min, 20" max AFF).	
CBC: 11B-803.6	
Other: -	
22 - 1 Bathing Facility	Category: 2
Provide an accessible shower	\$10,000
Notes: Shower seat does not stay folded.	
CBC: 11B-610.3	
Other: ADA 610.3	
22 - 2 Bathing Facility	Category: 2
Modify an accessible shower seat	\$125
Notes: Seat is mounted 2.5" from the side wall (1.5" max).	
CBC: 11B-610.3	
Other: ADA 610.3

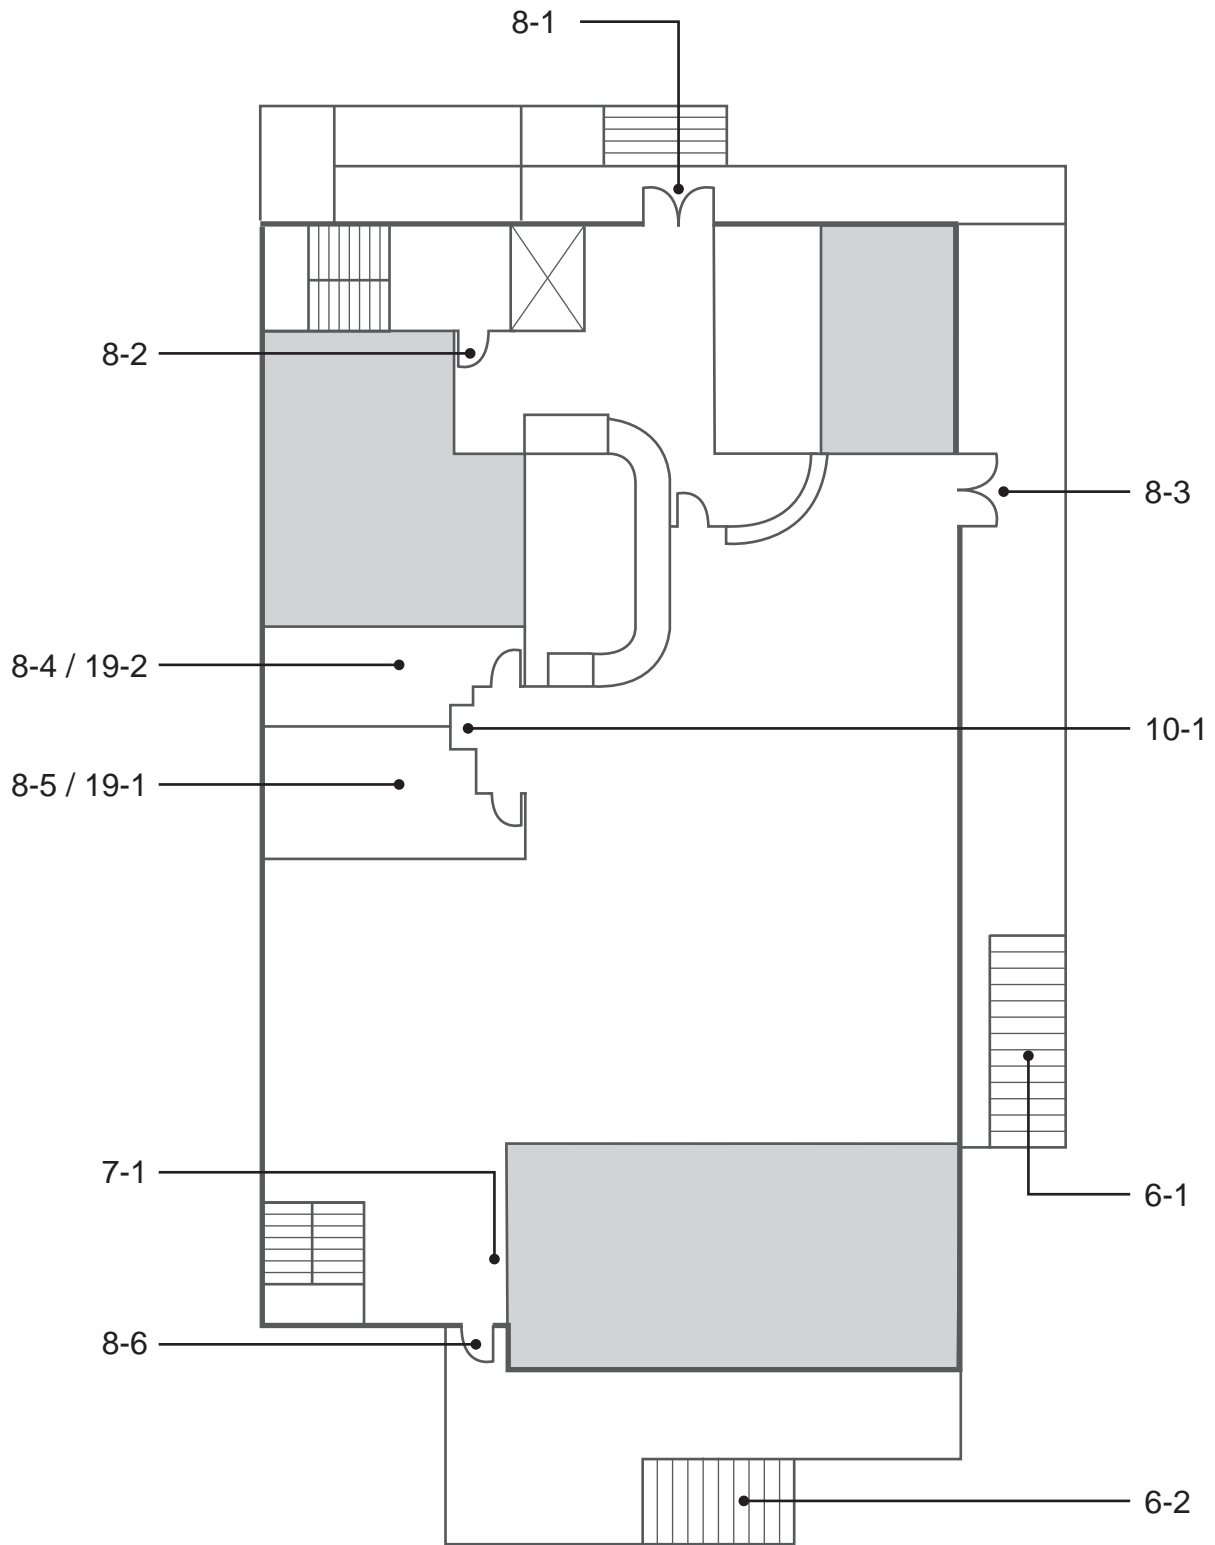
Sport Center - Floor 2
21111 Stevens Creek Blvd.
Cupertino, CA

Floor 2		
6 - 1	Stairway	Category: 1
Replace stairs		\$3,600
Notes: Risers height range from 6.75" to 7.25" (4" min to 7" max, uniform height required).		
CBC: 11B-504.2		
Other: ADA 504.2, ADA 504.3		
6 - 2	Stairway	Category: 1
Replace stairs		\$3,600
Notes: Riser heights range from 7" to 8" (4" min to 7" max, uniform heights req). 3/8" change in level in a few risers due to warped wood.		
CBC: 11B-504.2		
Other: ADA 504.2, ADA 504.3		
Install a handrail		\$125
Notes: A parallel extension of 8" is provided at the top of the handrail (12" min).		
CBC: 11B-505.10.2		
Other: ADA 505.10.2		
7 - 1	Hazard	Category: 2
Remove overhanging or protruding objects		\$125
Notes: Fire alarm protrudes 6.5" from the wall at 32" AFF (80" min).		
CBC: 11B-307.4		
Other: ADA 307.4		
8 - 1	Door/Gate	Category: 1
Adjust door closer		\$125
Notes: Double door opening force is 14 lbs and 10 lbs (5 lbs max).		
CBC: 11B-404.2.9		
Other: ADA 404.2.9

Floor 2	
10 - 1	Drinking Fountain Category: 3
Raise or lower fountain	\$1,500
Notes: Space between floor and bottom of fountain is 25-3/8" (27" min).	
CBC: 11B-306.3	
Other: ADA 306.3, ADA 306.3.1	
Install an additional high or low fountain	\$3,000
Notes: A higher standing person fountain is not provided.	
CBC: 11B-211.2	
Other: ADA 211.2	
19 - 1	Multiple User Restroom Category: 2
Reposition clothing hooks	\$125
Notes: Height of coat hook is 56.25" (48" max).	
CBC: 11B-603.4	
Other: ADA 308	
Replace or reposition mirror	\$150
Notes: Bottom of the mirror's reflecting surface is 41.25" AFF (40" max).	
CBC: 11B-603.3	
Other: ADA 603.3	
Provide or replace compartment door hardware	\$175
Notes: Compartment door is not self closing (compartment door must have U-shaped handles both inside and outside of the door and be self-closing).	
CBC: 11B-604.8.1.2	
Other: ADA 604.8.1.2	
Replace or modify grab bars	\$300
Notes: Side grab bar extends 53.25" from the rear wall (54" min).

CBC: 11B-604.5.1	
Other: ADA 604.5.1	
Replace or reposition dispenser	\$125
Notes: Centerline of toilet paper is 12" in front of the water closet (7" min to 9" max).	
CBC: 11B-604.7	
Other: ADA 604.7	
Install restroom sign	\$250
Notes: Bottom of top row of tactile lettering on federal sign is 62" AFF (60" max). Clear floor space in front of the tactile and Braille sign is 16" (18" min).	
CBC: -	
Other: ADA 703

Floor 2	
19 - 2 Multiple User Restroom	Category: 2
Reposition clothing hooks	\$125
Notes: Height of coat hook is 57" (48" max).	
CBC: 11B-603.4	
Other: ADA 308	
Replace or reposition mirror	\$150
Notes: Bottom of the mirror's reflecting surface is 41.5" AFF (40" max).	
CBC: 11B-603.3	
Other: ADA 603.3	
Provide or replace compartment door hardware	\$175
Notes: Compartment door is not self closing (compartment door must have U-shaped handles both inside and outside of the door and be self-closing).	
CBC: 11B-604.8.1.2	
Other: ADA 604.8.1.2	
Replace or reposition dispenser	\$250
Notes: Centerline of toilet paper is 12" in front of the water closet (7" min to 9" max). Paper towel dispenser is located 41" AFF (40" max).	
CBC: 11B-604.7	
Other: ADA 604.7	
Provide clear floor or turning space	\$3,000
Notes: Clear floor space in front of the tactile and Braille sign is 16" (18" min).	
CBC: 11B-305.5	
Other: ADA 305.3, ADA 305.5

Install restroom sign	\$250
Notes: Bottom of top row of tactile lettering on federal sign is 62.5" AFF (60" max).	
CBC: -	
Other: ADA 703

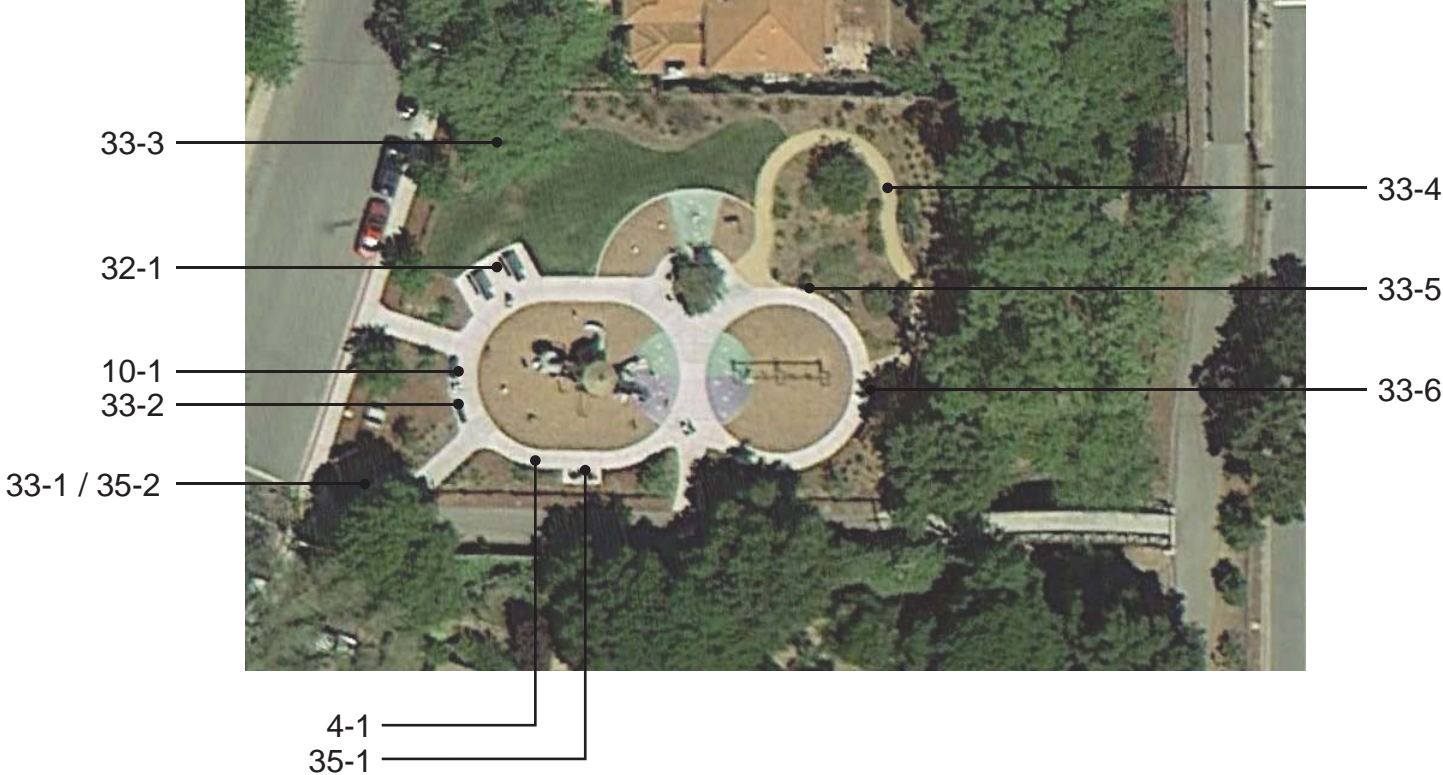
Sterling/Barnhart Park
10486 Sterling Boulevard
Cupertino, CA

4 - 1 Walk			Category: 2
Regrade surface			\$400
Notes: Cross slope of concrete path is up to 2.9% for 10 linear feet (2.0% max).			
CBC: 11B-403.3			
Other: ADA 403.3			
10 - 1 Drinking Fountain			Category: 3
Increase or provide maneuvering or clear floor area			\$1,000
Notes: Clear floor space of the drinking fountain overlaps the path of travel (30" by 48" min)			
CBC: 11B-305, 11B-306, 11B-602.2			
Other: ADA 305.1, ADA 305.3, ADA 305.5, ADA 306.1			
Provide wing walls			\$1,000
Notes: Drinking fountain protrudes 18.5" from vertical support at 27" AFF (protrusion more than 4" must be mounted below 27" or above 80").			
CBC: 11B-602.8, 11B-602.9			
Other: ADA 307			
Replace or adjust water controls			\$125
Notes: Operating effort of control on the accessible drinking fountain is 15 lbs (5 lbs max). Operating effort of control in standing person drinking fountain is 10 lbs (5 lbs max).			
CBC: 11B-309

Notes: A clear floor space is not provided adjacent to the bench (36" by 48" min).		
CBC: -		
Other: AGODA 1011.2.1		
35 - 1 Other		Category: 2
Increase or provide maneuvering or clear floor area		\$1,000
Notes: Clear floor space is not provided at chess table (36" by 48"). Clear floor space overlaps with path of travel.		
CBC: 11B-305.5		
Other: ADA 305.3, ADA 305.5		
35 - 2 Other		Category: 3
Reposition controls		\$200
Notes: Mutt Mitt is 51.5" AFF (15" min to 48" max).		
CBC: 11B-308.2.1, 11B-308.3		
Other: ADA 308.2, ADA 308.2.1, ADA 308.3, ADA 308.3.1, ADA 308.3.2

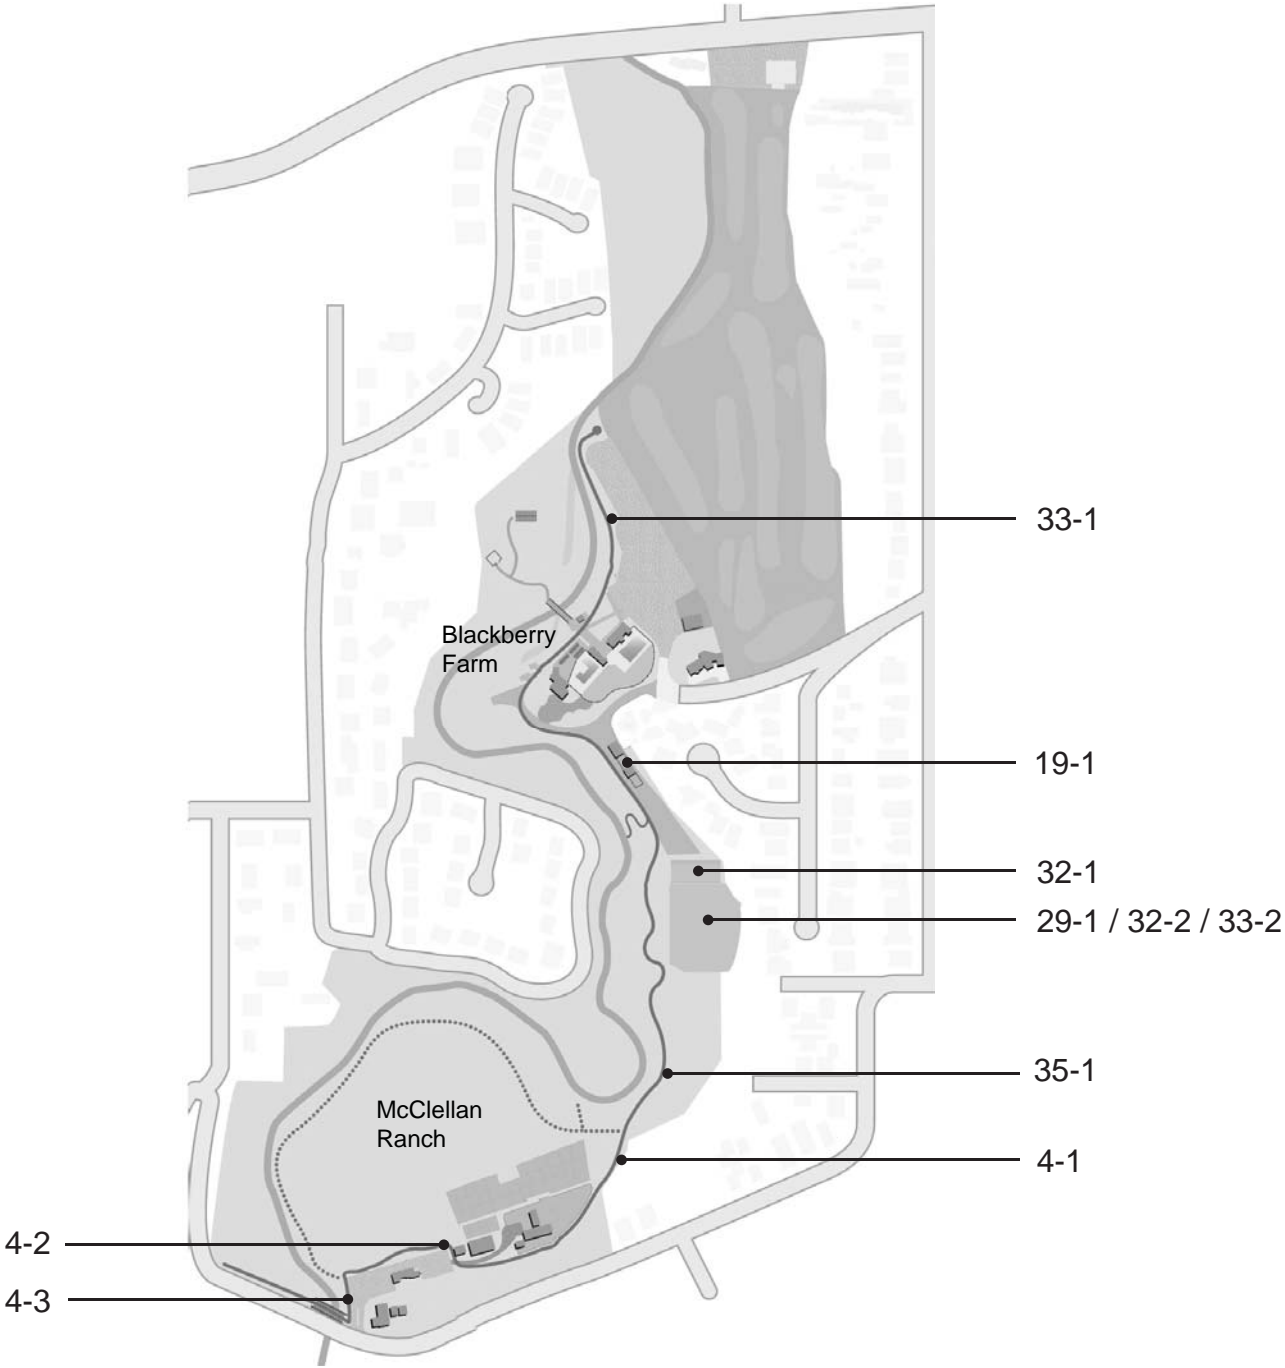
Stevens Creek Trail
21975 San Fernando Avenue
Cupertino, CA

4 - 1	Walk	Category: 2
Regrade surface		\$960
Notes: Cross slope of path is up to 3.5% for 24 linear feet from public right-of-way (2.0% max).		
CBC: 11B-403.3		
Other: ADA 403.3		
4 - 2	Walk	Category: 2
Regrade surface		\$320
Notes: Cross slope of path is up to 2.8% for 8 linear feet under redwood tree (2.0% max).		
CBC: 11B-403.3		
Other: ADA 403.3		
4 - 3	Walk	Category: 2
Regrade surface		\$1,400
Notes: Cross slope of path is up to 6.4% for 35 linear feet along curve in walk (2.0% max).		
CBC: 11B-403.3		
Other: ADA 403.3		
4 - 4	Walk	Category: 2
Regrade surface		\$400
Notes: Cross slope of path is up to 2.6% for 10 linear feet under oak tree (2.0% max).		
CBC: 11B-403.3		
Other: ADA 403.3		
4 - 5	Walk	Category: 2
Regrade surface		\$540
Notes: Cross slope of path is up to 2.6% for 13.5 linear feet under oak tree (2.0% max).		
CBC: 11B-403.3		
Other: ADA 403.3		
4 - 6	Walk	Category: 2
Regrade surface		\$720
Notes: Cross slope of path is up to 3% for 18 linear feet near recycling containers (2.0% max).

Increase or provide clear floor area		\$700
Notes: A clear floor space is not provided adjacent to two benches (36" by 48" min).		
CBC: -		
Other: AGODA 1011.2.1		
33 - 2	Outdoor Constructed Features	Category: 2
Provide an accessible path of travel		\$800
Notes: An accessible route to six fixed bench is not provided, due to natural surface.		
CBC: -		
Other: AGODA 1011.2.1		
35 - 1	Other	Category: 3
Provide an accessible path of travel		\$240
Notes: An accessible route to the Mutt Mitt is not provided. Route is 6 linear feet over sandy surface.		
CBC: 11B-206.2		
Other: ADA 206.2

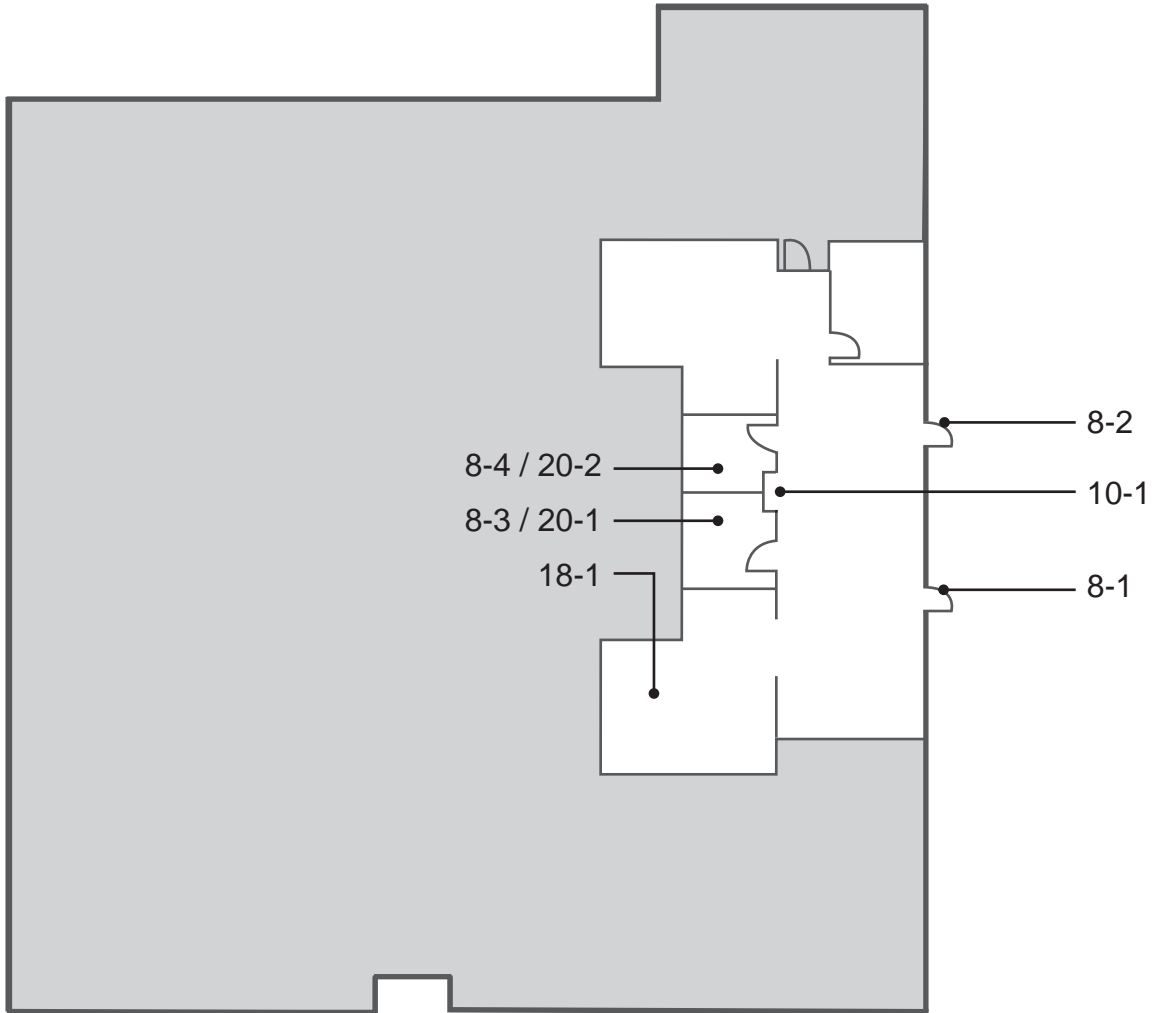
Teen Center
21111 Stevens Creek Blvd.
Cupertino, CA

20 - 1 Single User Restroom		Category: 2
Install restroom sign		\$250
Notes: Bottom of top row of tactile lettering on federal sign is 62.5" AFF (60" max).		
CBC: -		
Other: ADA 703		
Replace or modify grab bars		\$300
Notes: Side grab bar ends 52.5" from the rear wall (54" min).		
CBC: 11B-604.5.1		
Other: ADA 604.5.1		
Replace or reposition dispenser		\$250
Notes: Height of soap dispenser is 41.5" AFF (40" max). Centerline of toilet paper dispenser is flush with the front edge of the water closet (7" min to 9" max).		
CBC: 11B-603.5		
Other: -		
20 - 2 Single User Restroom		Category: 2
Install restroom sign		\$250
Notes: Bottom of the top row of tactile lettering on federal sign is 62.5" AFF (60" max).		
CBC: -		
Other: ADA 703		
Replace or modify grab bars		\$600
Notes: Side grab bar extends 52" from the rear wall (54" min). Rear grab bar extends 11.5" from the centerline of the water closet (36" long min, extends 12" min and 24" min from centerline of water closet)

CBC: 11B-604.5.1, 11B-604.5.2		
Other: ADA 604.5.1, ADA 604.5.2

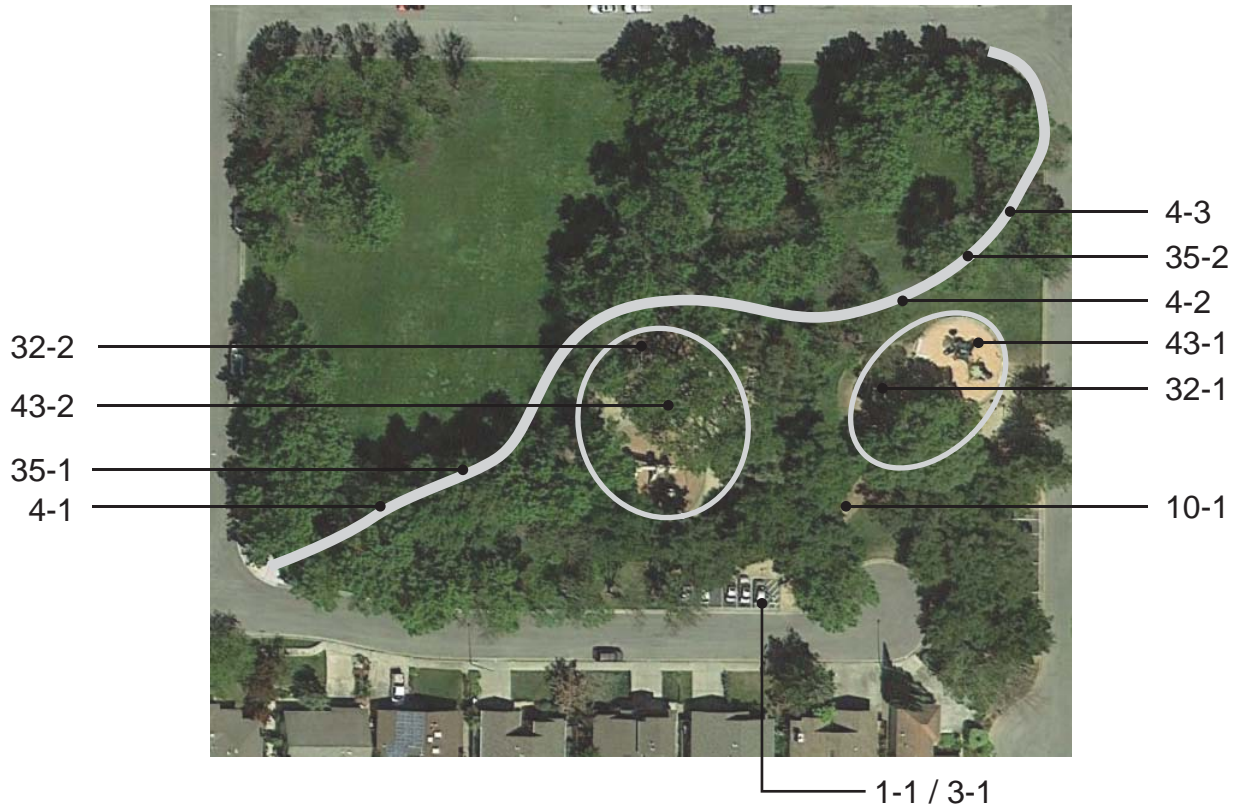
Three Oaks Park
Candlelight Way near Rainbow
Cupertino, CA

4 - 3 Walk			Category: 1
Regrade surface			\$240
Notes: Running slope of asphalt path is up to 7% for 12 linear feet (5.0% max).			
CBC: 11B-403.3			
Other: ADA 403.3			
10 - 1 Drinking Fountain			Category: 3
Increase or provide maneuvering or clear floor area			\$1,000
Notes: Slope of clear space in front of the water fountain is 3.4% (2.0% max).			
CBC: 11B-305, 11B-306, 11B-602.2			
Other: ADA 305.1, ADA 305.3, ADA 305.5, ADA 306.1			
Replace fountain			\$3,000
Notes: Bubbler height is 36.5" AFF (36" max for an accessible fountain).			
CBC: 11B-602.4			
Other: ADA 602.4			
Install an additional high or low fountain			\$3,000
Notes: A higher standing person fountain is not provided.			
CBC: 11B-211.2			
Other: ADA 211.2			
32 - 1 Picnic Area			Category: 4
Provide an accessible path of travel			\$4,920
Notes: An accessible route to the picnic area is not provided. Route is 123 linear feet over muddy natural surface. Surface is compacted natural surface- not decomposed granite but firm and stable. Observed to be muddy in a few locations.

43 - 1	Play Equipment Area	Category: 2
Regrade or replace ramp		\$4,250
Notes: Ramp connecting the surface ground and the play area has a slope of 8.3% (6.25% max).		
CBC: 11B-1008.2.5.1		
Other: ADA 1008.2.5.1

43 - 2 Play Equipment Area		Category: 2
Provide an accessible path of travel		\$900
Notes: An accessible route to the swing area is not provided due to 12" curb (1/4" max, up to 1/2" with a bevel). No accessible route to play area is provided. Route is 16 linear feet over sand and has 2" change in level from asphalt to natural sand surface.		
CBC: 11B-206.2.17		
Other: ADA 206.2.17		
Regrade or replace ramp		\$4,250
Notes: Ramp from surface to play area has a slope of 12.6% (6.25% max).		
CBC: 11B-1008.2.5.1		
Other: ADA 1008.2.5.1

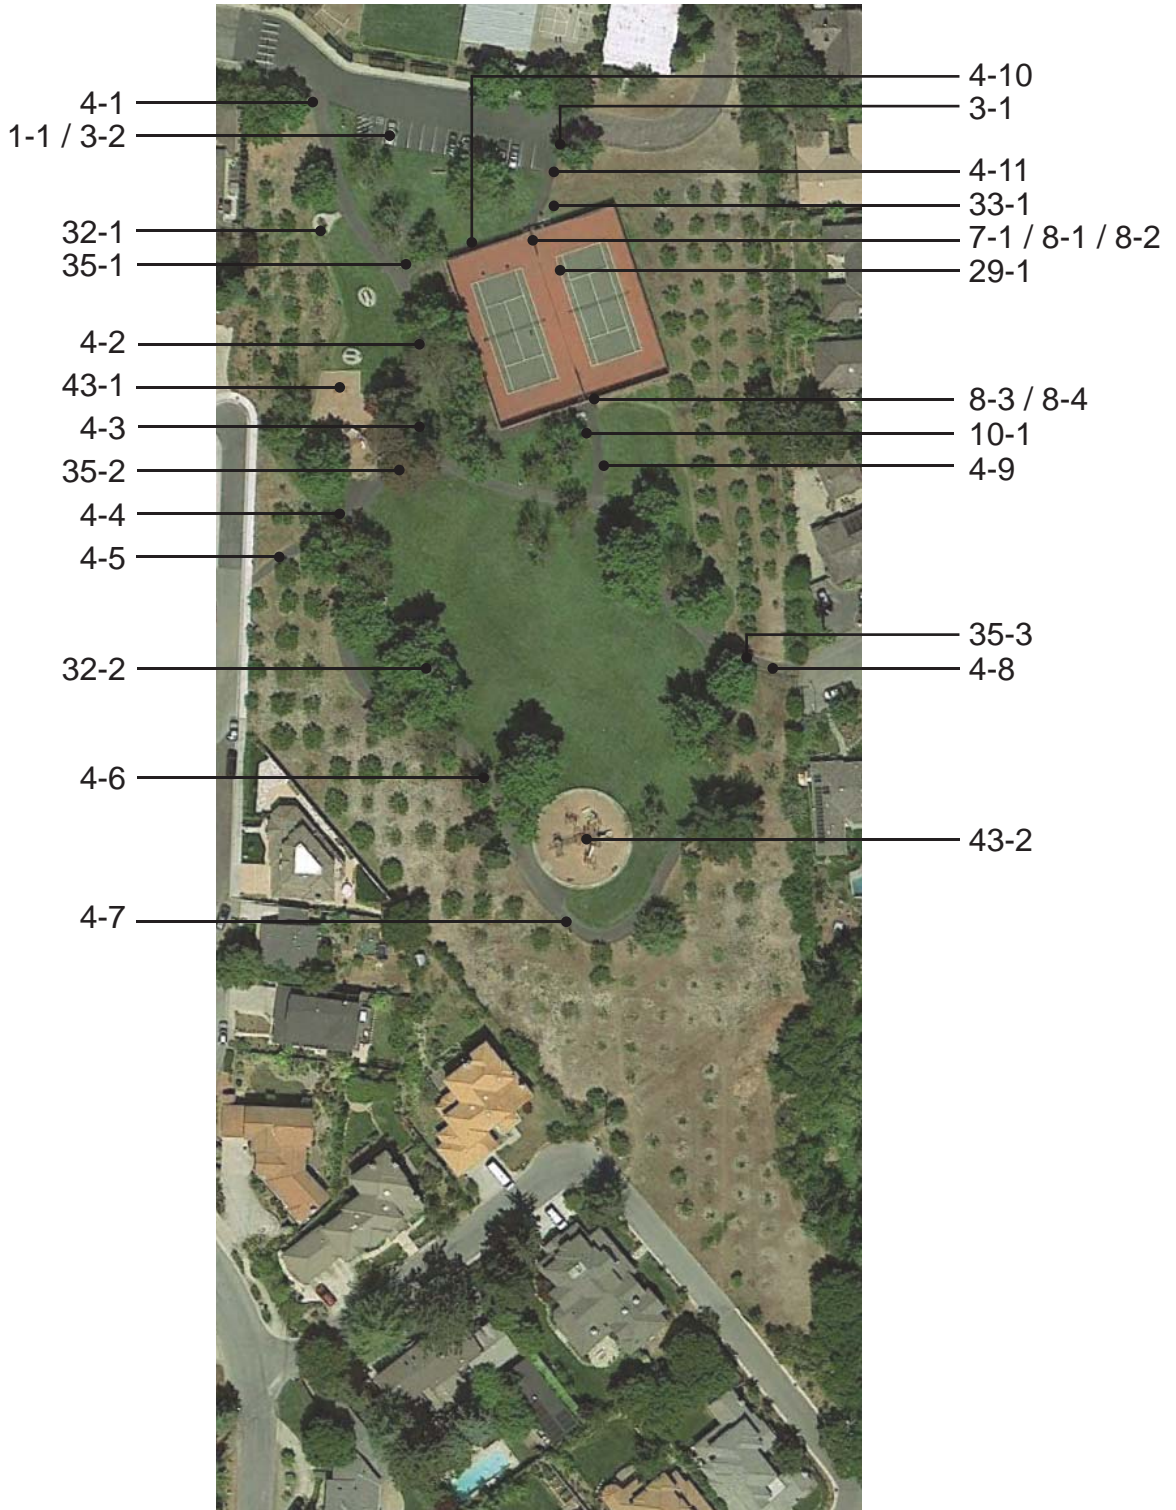
Varian Park
Ainsworth Drive
Cupertino, CA

4 - 9	Walk	Category: 2
Regrade surface		\$980
Notes: Cross slope of asphalt path is up to 4.2% for 49 linear feet (2.0% max).		
CBC: 11B-403.3		
Other: ADA 403.3		
4 - 10	Walk	Category: 2
Regrade surface		\$380
Notes: Running slope of asphalt path is up to 9.5% for 19 linear feet (5.0% max).		
CBC: 11B-403.3		
Other: ADA 403.3		
4 - 11	Walk	Category: 1
Regrade surface		\$1,060
Notes: Running slope of asphalt path is up to 10% (5.0% max) and cross slope is up to 5% (2.0% max) for 53 linear feet.		
CBC: 11B-403.3		
Other: ADA 403.3		
7 - 1	Hazard	Category: 2
Remove overhanging or protruding objects		\$125
Notes: Tennis court play order board protrudes 9" from the wall at 40" AFF (protrusion more than 4" must be mounted below 27" or above 80").		
CBC: 11B-307.4		
Other: ADA 307.4		
8 - 1	Door/Gate	Category: 2
Regrade surface		\$2,500
Notes: Slope on the swing side of the door is 9% (2.0% max).		
CBC: 11B-404.2.4.4

43 - 1 Play Equipment Area		Category: 2
Regrade or replace ramp		\$4,250
Notes: Ramp from ground surface to the play area has a running slope of 8.5% (6.25% max).		
CBC: 11B-1008.2.5.1		
Other: ADA 1008.2.5.1		
43 - 2 Play Equipment Area		Category: 2
Regrade or replace ramp		\$4,250
Notes: Ramp to play area has a running slope of 20.2% (6.25% max).		
CBC: 11B-1008.2.5.1		
Other: ADA 1008.2.5.1		
Provide play components		\$5,000
Notes: There are 8 elevated play components and no ground play components (3 min components, each a different type).		
CBC: 11B-240.2.1.2		
Other: ADA 240.2.1.2

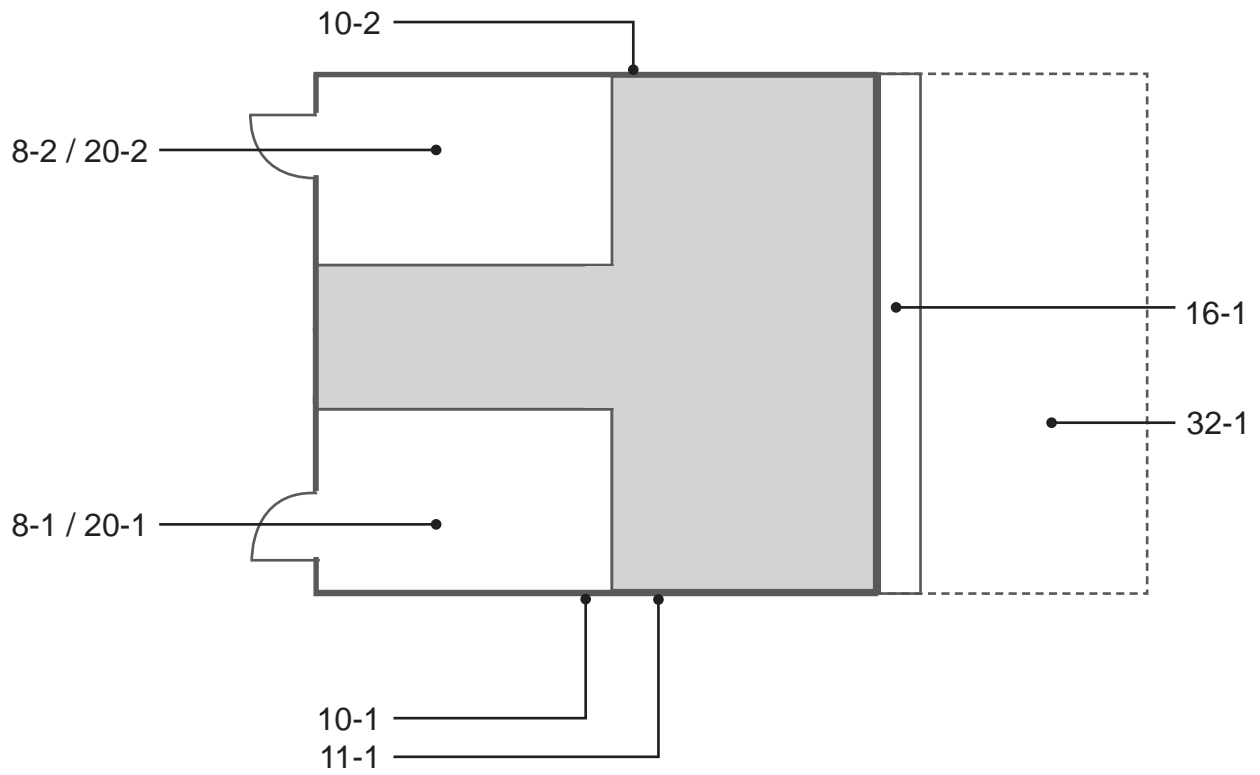
Wilson Park- Baseball Fields Building
19784 Wintergreen Dr
Cupertino, CA

Building 1	
20 - 2	Single User Restroom Category: 2
Modify lavatory or counter clearances	\$1,500
Notes: Lavatory front apron is located 28" AFF (29" min). Knee space is 26.5" AFF measured at 8" deep from the front of the lavatory (27" min).	
CBC: 11B-306.3.1, 11B-306.3.3	
Other: ADA 306.3, ADA 306.3.3	
Install restroom sign	\$250
Notes: Federal required sign is not provided.	
CBC: -	
Other: ADA 703	
Reposition toilet flush controls	\$750
Notes: Flush control is not located on the wide side.	
CBC: 11B-604.6	
Other: ADA 604.6	
Replace or reposition fixtures	\$1,250
Notes: Centerline of water closet is 21" from the side wall (17" min to 18" max).	
CBC: 11B-604.2	
Other: ADA 604.2	
Replace or reposition dispenser	\$125
Notes: Height of toilet seat cover is 48" AFF (40" max).	
CBC: 11B-603.5	
Other: -	
Replace or modify grab bars	\$300
Notes: Side grab bar is 36" long and extends 46" from the rear wall (42" long min and 54" min from side wall). Rear grab bar is 43" long (36" long min, extends 12" and 24" min from centerline of water closet). (Switch grab bars).

CBC: 11B-604.5.1, 11B-604.5.2	
Other: ADA 604.5.1, ADA 604.5.2	
32 - 1	Picnic Area Category: 2
Provide an accessible table	\$500
Notes: Knee clearance is 26" measured at 8" horizontally from the front face of the tabletop (27" min). Picnic table is 27.75" AFF (28" min to 34" max).	
CBC: 11B-306.3, 11B-902.3	
Other: AGODA 1011.4.1

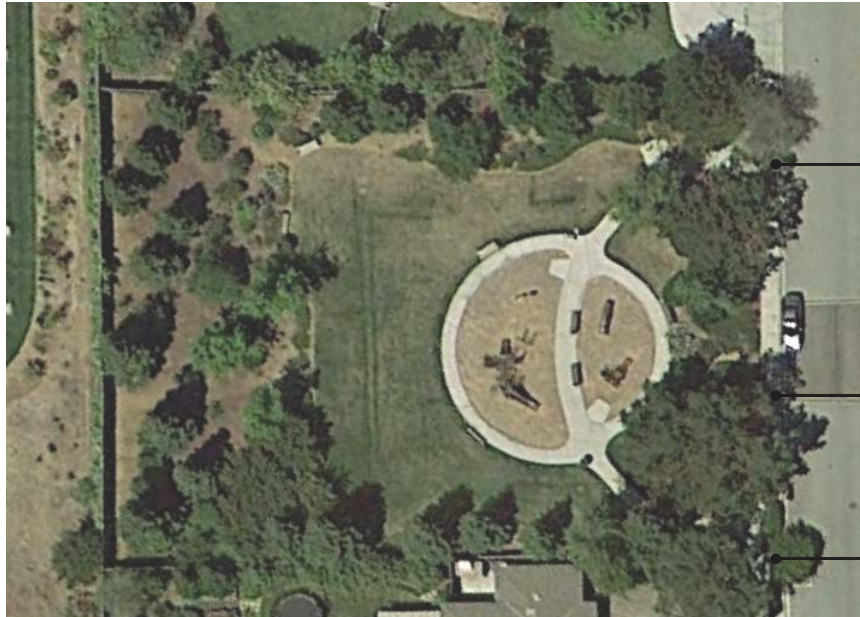
Canyon Oaks Park
21140-21150 Canyon Oak Way
Cupertino, CA

4 - 1		
Walk	Category:	
Regrade surface		\$400
Notes: Cross slope of concrete path is up to 2.6% for 10 linear feet (2.0% max).		
CBC: 11B-403.3		
Other: ADA 403.3		
4 - 2		
Walk	Category:	
Install curb, barrier, or guardrail		\$250
Notes: No warning curb provided at abrupt drop off of 9" near drain (6" warning curb required).		
CBC: 11B-303.5		
Other: -		
4 - 3		
Walk	Category:	
Regrade surface		\$1,000
Notes: Cross slope of concrete path is up to 4.5% for 25 linear feet (2.0% max).		
CBC: 11B-403.3		
Other: ADA 403.3

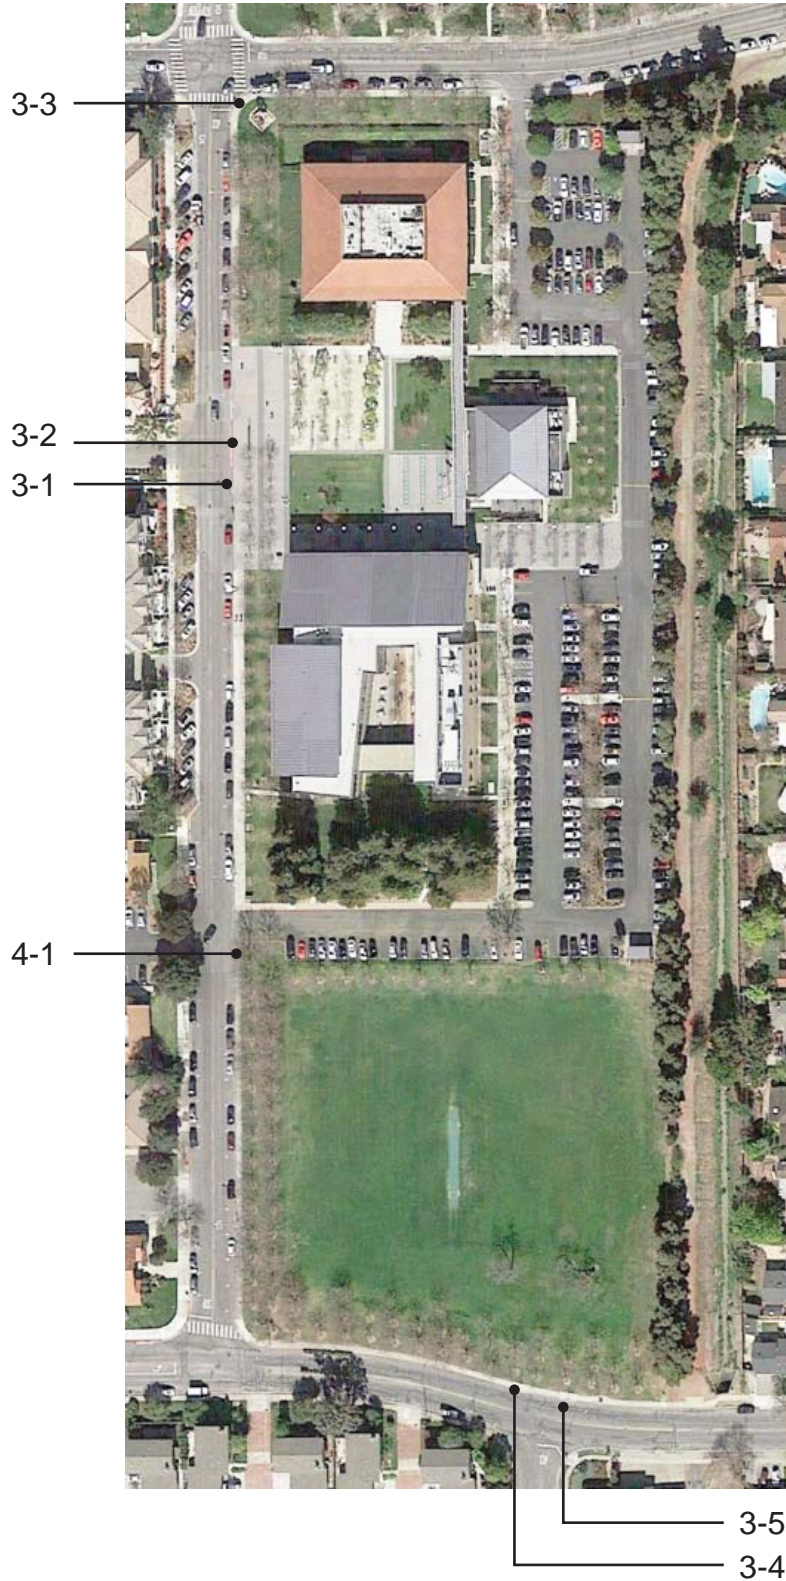
Civic Center Complex
10800 Torre Ave
Cupertino, CA

3 - 1		Curb Ramp	Category:
Provide detectable warnings			\$1,000
Notes: Detectable warnings not provided.			
CBC: 11B-247.1.2, 11B-406.5.12			
Other: -			
3 - 2		Curb Ramp	Category:
Provide detectable warnings			\$1,000
Notes: Detectable warnings not provided.			
CBC: 11B-247.1.2, 11B-406.5.12			
Other: -			
3 - 3		Curb Ramp	Category:
Provide detectable warnings			\$0
Notes: Detectable warnings not provided.			
CBC: 11B-247.1.2, 11B-406.5.12			
Other: -			
Install, replace or modify curb ramp			\$2,460
Notes: Slope of one flared side is 16.5% (10.0% max). Slope of the curb ramp is 9.1% (8.33% max).			
CBC: 11B-405.2, 11B-406, 11B-406.2.2			
Other: ADA 405.2, ADA 406.1, ADA 406.3			
Provide a level landing			\$0
Notes: A level landing is not provided at the top of the ramp (48" x 48" min).			
CBC: 11B-406.5.3			
Other: ADA 406.4, ADA 406.7			
3 - 4		Curb Ramp	Category:
Provide detectable warnings			\$0
Notes: Detectable warnings not provided.

Category:
3 - 5	Curb Ramp	
Provide detectable warnings		\$0
Notes: Detectable warnings not provided.		
CBC: 11B-247.1.2, 11B-406.5.12		
Other: -		
Install, replace or modify curb ramp		\$2,460
Notes: Cross slope of the parallel curb ramp is 8.8% (2.0% max).		
CBC: 11B-406		
Other: ADA 405.3, ADA 406.1		
4 - 1	Walk	Category:
Regrade surface		\$1,200
Notes: Cross slope of concrete path is up to 11% for 30 linear feet across drive (2.0% max).		
CBC: 11B-403.3		
Other: ADA 403.3

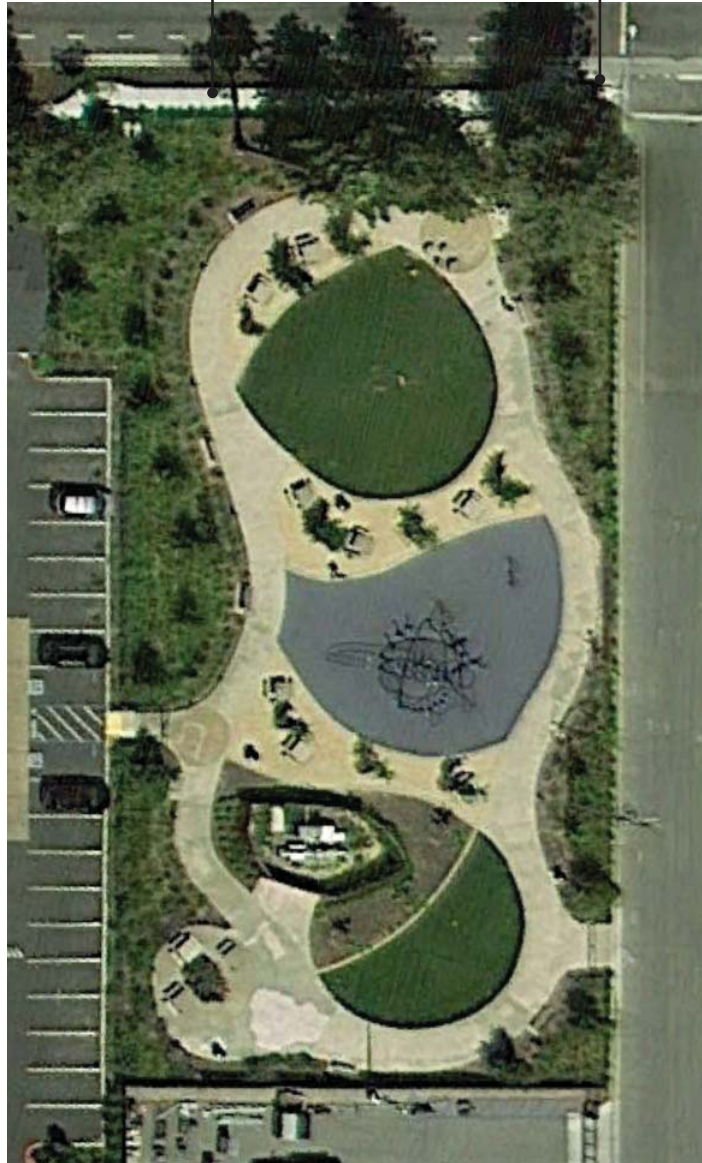
3 - 1	Curb Ramp	Category:
Provide a level landing		\$90
Notes: Top landing has a slope of 2.8% (2%max).		
CBC: 11B-406.5.3		
Other: ADA 406.4, ADA 406.7		
4 - 1	Walk	Category:
Regrade surface		\$600
Notes: Cross slope of concrete path is up to 2.4% for 15 linear feet (2.0% max).		
CBC: 11B-403.3		
Other: ADA 403.3

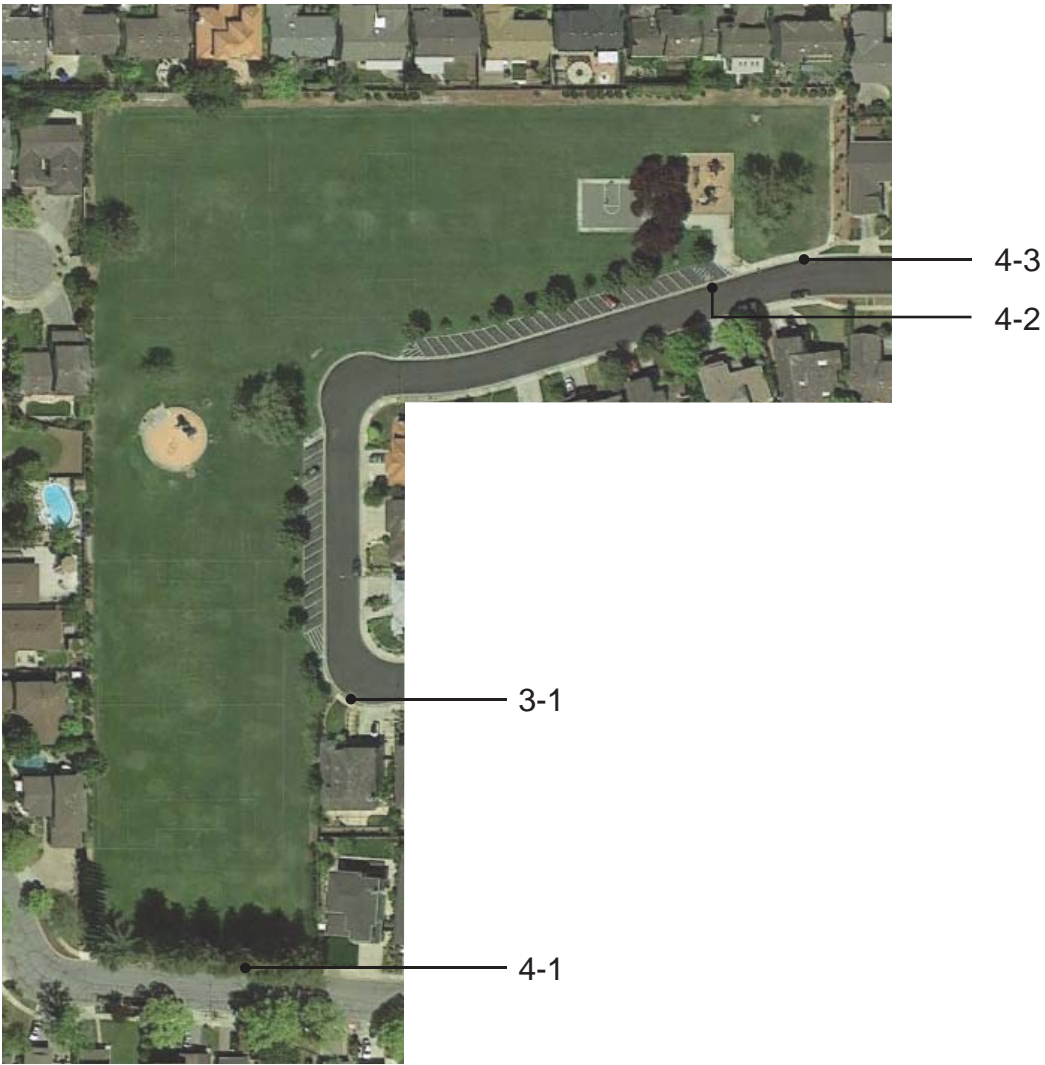
Hoover Park
Leeds Avenue and Donegal Avenue
Cupertino, CA

4 - 2	Walk	Category:
Regrade surface		\$1,440
Notes: Running slope of concrete path is up to 6.9% for 36 linear feet (5.0% max).		
CBC: 11B-403.3		
Other: ADA 403.3		
4 - 3	Walk	Category:
Regrade surface		\$3,080
Notes: Cross slope of concrete path is up to 3.3% for 77 linear feet (2.0% max).		
CBC: 11B-403.3		
Other: ADA 403.3

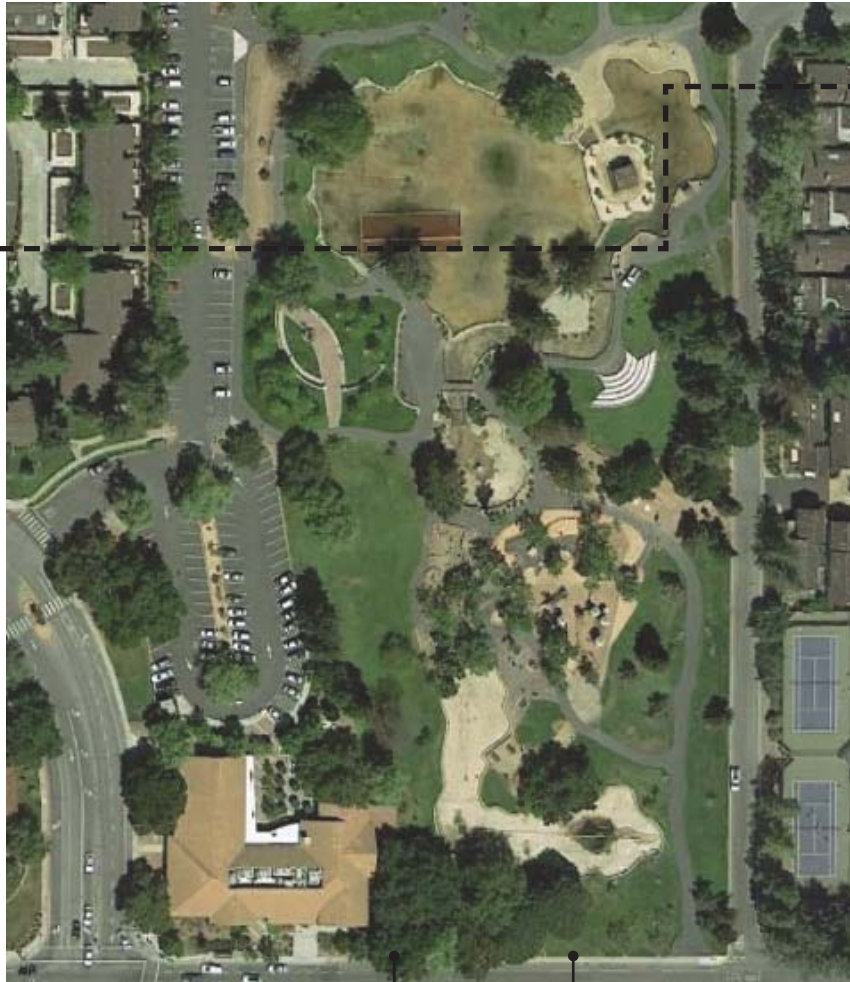
Memorial Park
21121 Stevens Creek Boulevard
Cupertino, CA

4 - 1	Walk	Category:	
Regrade surface			\$3,080
Notes: Cross slope of concrete path is up to 5.7% for 77 linear feet (2.0% max).			
CBC: 11B-403.3			
Other: ADA 403.3			
4 - 2	Walk	Category:	
Regrade surface			\$11,720
Notes: Cross slope of concrete path is up to 5% for 293 linear feet (2.0% max).			
CBC: 11B-403.3			
Other: ADA 403.3			
4 - 3	Walk	Category:	
Regrade surface			\$800
Notes: Cross slope of concrete path is up to 6% for 188 linear feet and 18% across ramp for 20 linear feet (2.0% max).			
CBC: 11B-403.3			
Other: ADA 403.3			
4 - 4	Walk	Category:	
Regrade surface			\$6,400
Notes: Cross slope of concrete path is up to 3.7% for 160 linear feet (2.0% max).			
CBC: 11B-403.3			
Other: ADA 403.3
