CITY OF CUPERTINO

AMERICANS WITH DISABILITIES ACT

self evaluation and transition plan

APPENDICES

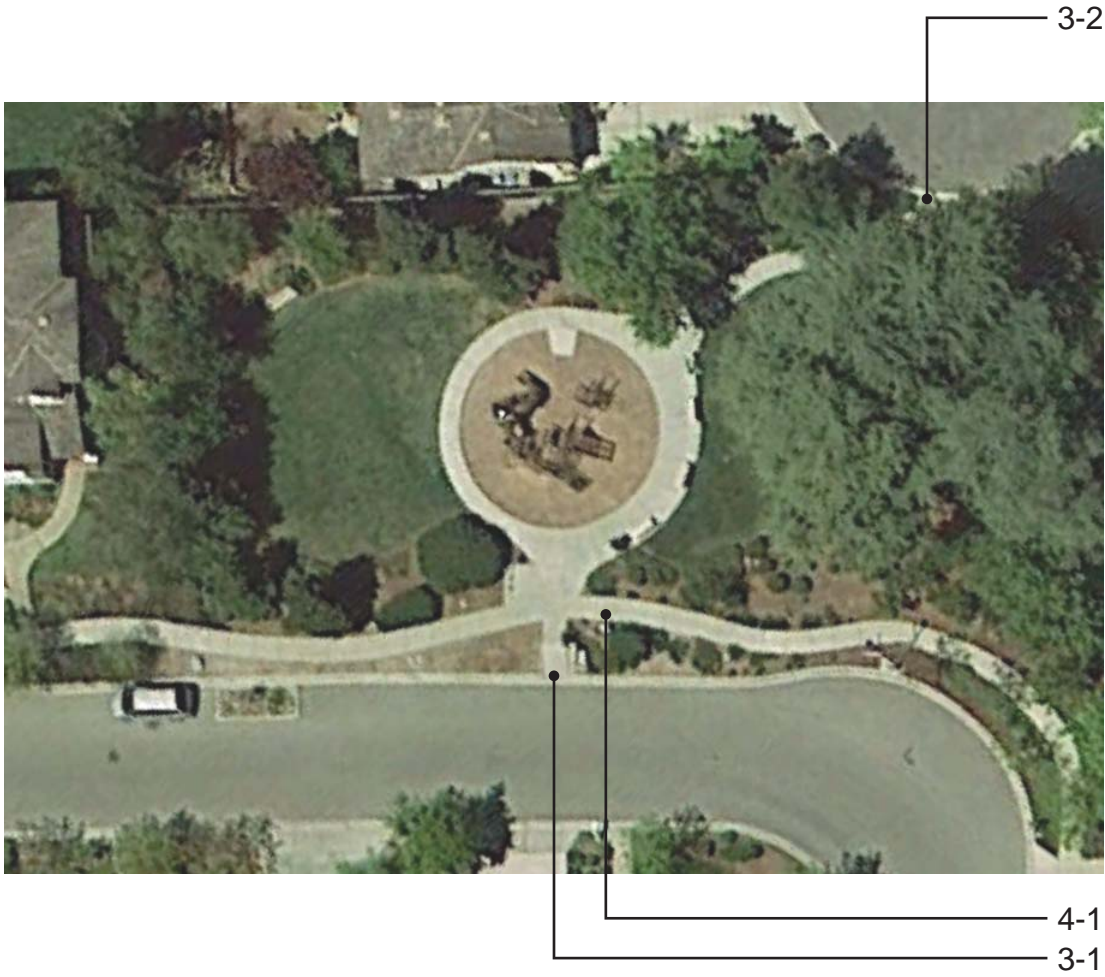
Oak Valley Park
23625-23645 Oak Valley Road
Cupertino, CA

Category:
3 - 2	Curb Ramp	
Provide a level landing		\$2,500
Notes: Counter slope at the base of the curb ramp is 8.9% (5.0% max).		
CBC: 11B-406.5.8		
Other: ADA 406.2		
Provide surface texture		\$0
Notes: No grooved border provided.		
CBC: 11B-406.5.11		
Other: -		
Provide detectable warnings		\$0
Notes: Detectable warnings not provided.		
CBC: 11B-247.1.2, 11B-406.5.12		
Other: -		
Provide a level landing		\$0
Notes: A level landing is not provided at the top of the ramp (48" x 48" min).		
CBC: 11B-406.5.3		
Other: ADA 406.4, ADA 406.7		
Install, replace or modify curb ramp		\$2,460
Notes: Slope of the curb ramp is 15.2% (8.33% max).		
CBC: 11B-405.2, 11B-406		
Other: ADA 405.2, ADA 406.1		
4 - 1	Walk	Category:
Regrade surface		\$1,000
Notes: Cross slope of concrete path is up to 2.5% for 25 linear feet (2.0% max).		
CBC: 11B-403.3		
Other: ADA 403.3

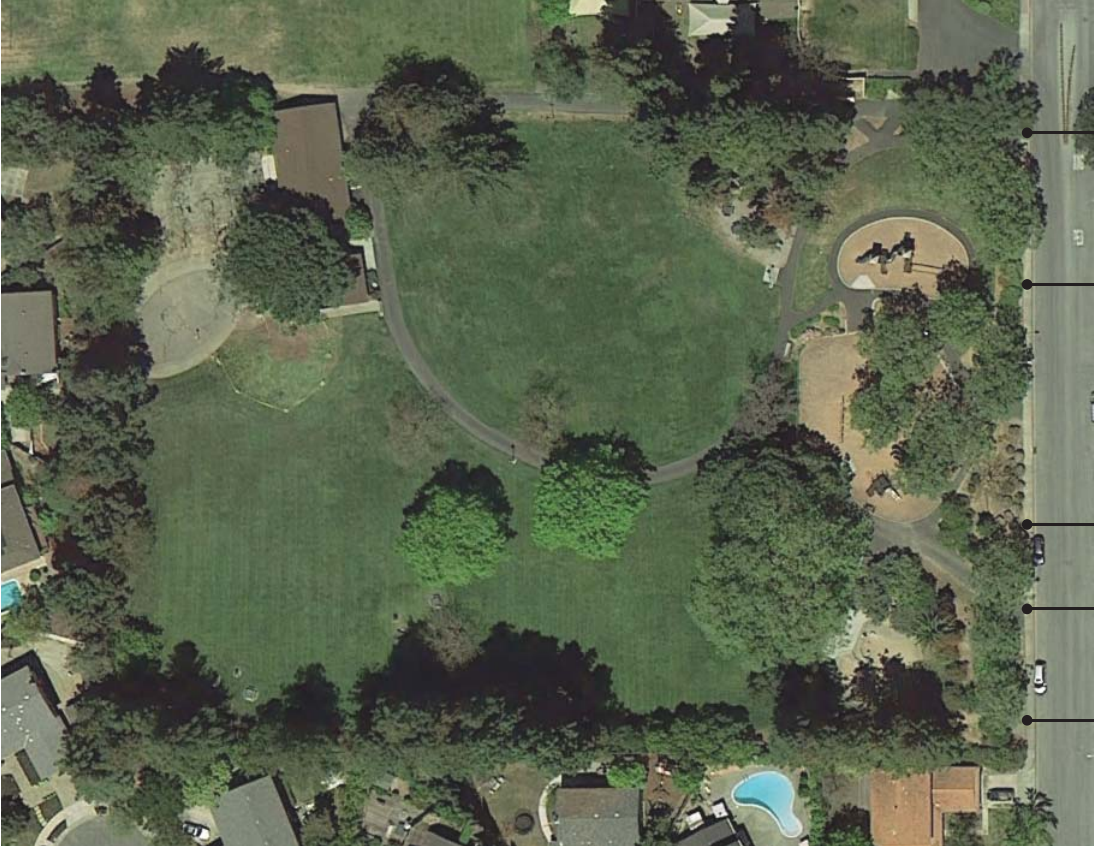
Portal Park
19810 North Portal Road
Cupertino, CA

4 - 1	Walk	Category:	
Regrade surface			\$640
Notes: Cross slope of concrete path is up to 2.5% for 16 linear feet (2.0% max).			
CBC: 11B-403.3			
Other: ADA 403.3			
4 - 2	Walk	Category:	
Regrade surface			\$1,840
Notes: Cross slope of concrete path is up to 2.5% for 46 linear feet (2.0% max).			
CBC: 11B-403.3			
Other: ADA 403.3			
Grind or patch vertical change of grade			\$250
Notes: 1/2" change in level at concrete joint across walk in front of pathway into park (1/4" max, up to 1/2" with a bevel).			
CBC: 11B-303.2			
Other: ADA 303.2, ADA 303.3			
4 - 3	Walk	Category:	
Regrade surface			\$3,000
Notes: Cross slope of concrete path is up to 3.7% for 75 linear feet (2.0% max).			
CBC: 11B-403.3			
Other: ADA 403.3			
Grind or patch vertical change of grade			\$0
Notes: 1/2" change in level due to deteriorated concrete at joint, 1.5 sf (1/4" max, up to 1/2" with a bevel).			
CBC: 11B-303.2			
Other: ADA 303.2, ADA 303.3

4 - 4	Walk	Category:	
Grind or patch vertical change of grade			\$250
Notes: 1/2" change in level due to deteriorated concrete at joint, 1 sf (1/4" max, up to 1/2" with a bevel).			
CBC: 11B-303.2			
Other: ADA 303.2, ADA 303.3			
4 - 5	Walk	Category:	
Regrade surface			\$3,000
Notes: Cross slope of concrete path is up to 2.3% for 75 linear feet and up to 4.4% for last 30 feet before drive (2.0% max).			
CBC: 11B-403.3			
Other: ADA 403.3

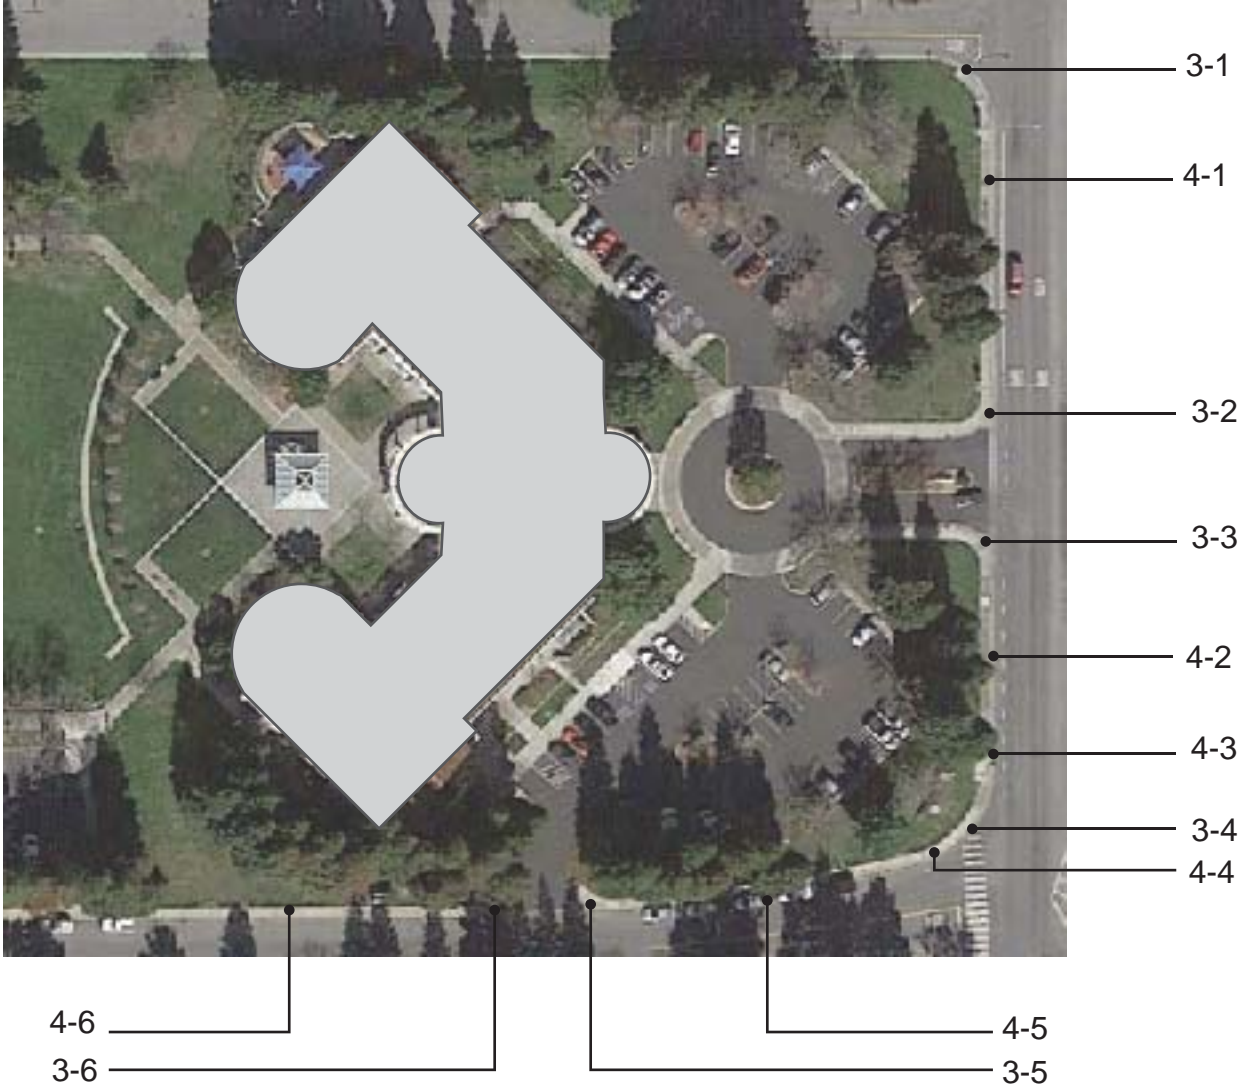
Quinlan Community Center
10350 Torre Ave
Cupertino, CA

4 - 5		Walk	Category:
Regrade surface			\$4,600
Notes: Cross slope of concrete path is up to 3.3% for 115 linear feet (2.0% max).			
CBC: 11B-403.3			
Other: ADA 403.3			
4 - 6		Walk	Category:
Regrade surface			\$11,720
Notes: Cross slope of concrete path is up to 5% for 293 linear feet (2.0% max).			
CBC: 11B-403.3			
Other: ADA 403.3

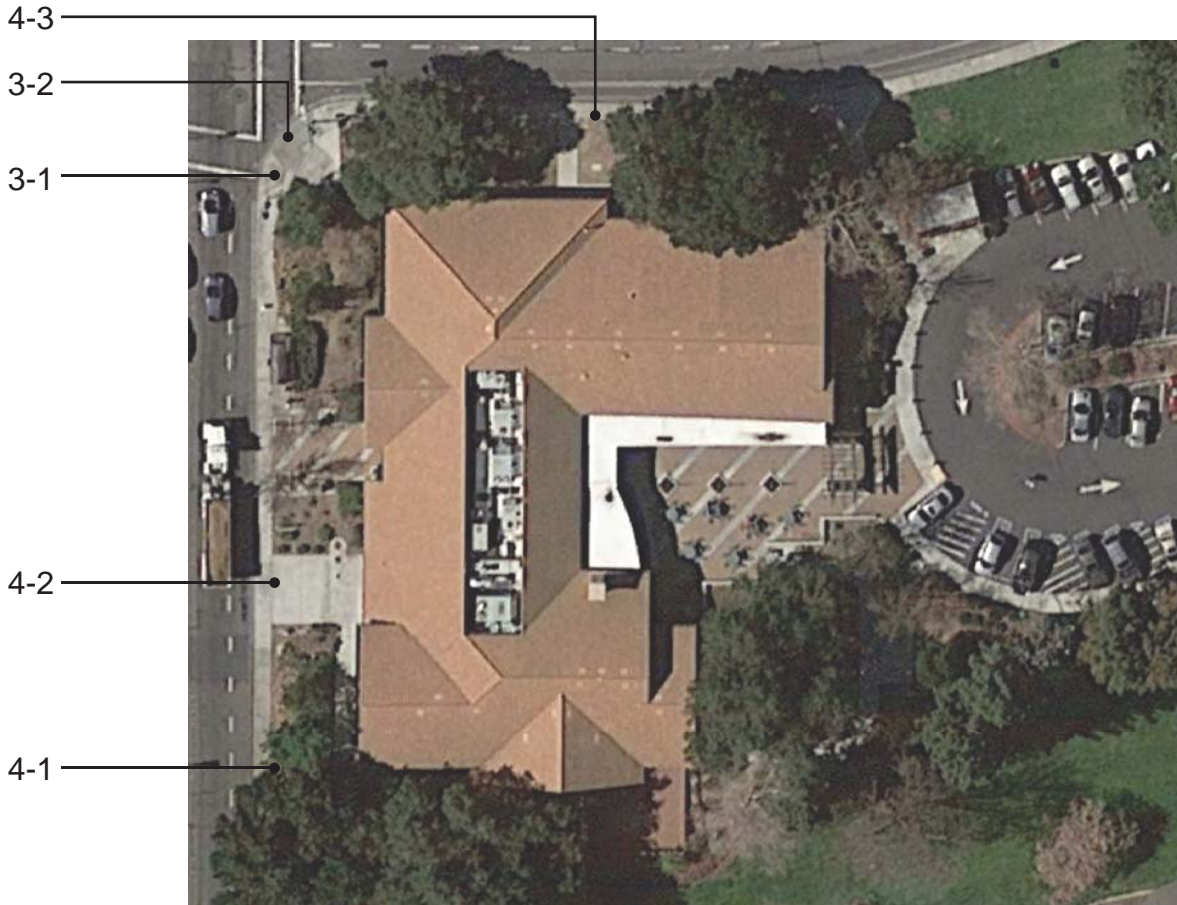
Senior Center
21251 Stevens Creek Blvd.
Cupertino, CA

3 - 1 Curb Ramp			Category:
Provide a level landing			\$2,500
Notes: Counter slope at the base of the curb ramp is 12.6% (5.0% max).			
CBC: 11B-406.5.8			
Other: ADA 406.2			
3 - 2 Curb Ramp			Category:
Provide a level landing			\$2,500
Notes: Counter slope at the base of the curb ramp is 6.8% (5.0% max).			
CBC: 11B-406.5.8			
Other: ADA 406.2			
4 - 1 Walk			Category:
Regrade surface			\$480
Notes: Cross slope of concrete path is up to 2.9% for 12 linear feet (2.0% max).			
CBC: 11B-403.3			
Other: ADA 403.3			
4 - 2 Walk			Category:
Regrade surface			\$1,560
Notes: Cross slope of concrete path is up to 7.1% for 39 linear feet across drive (2.0% max).			
CBC: 11B-403.3			
Other: ADA 403.3			
4 - 3 Walk			Category:
Regrade surface			\$6,520
Notes: Cross slope of concrete path is up to 3.6% for 163 linear feet (2.0% max).			
CBC: 11B-403.3			
Other: ADA 403.3

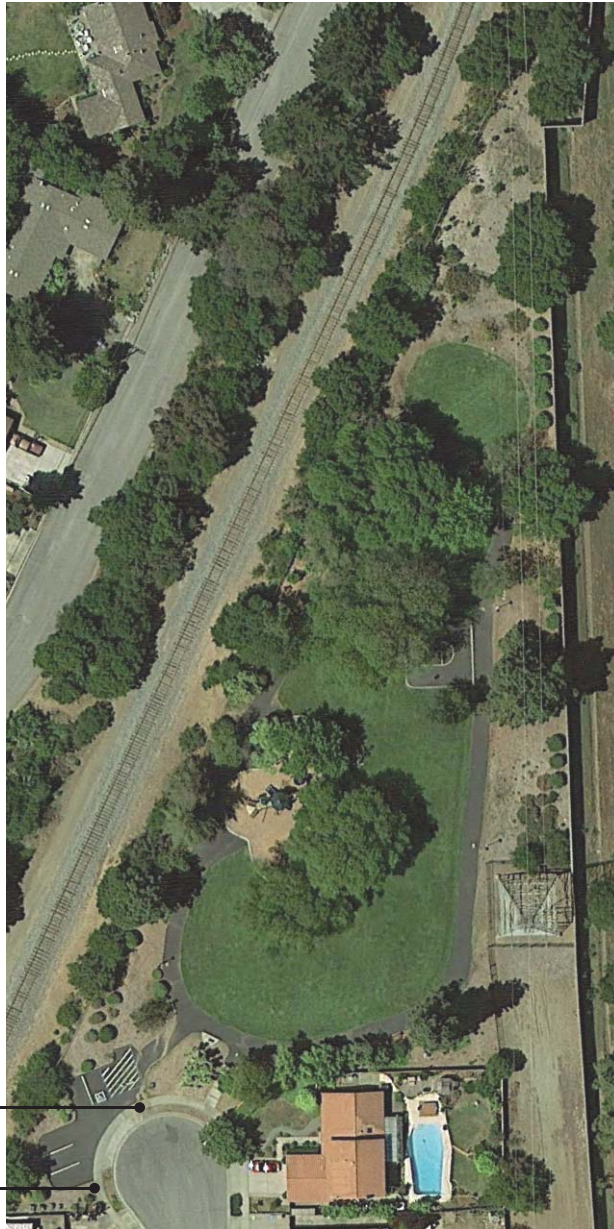
Somerset Park
10710 Stokes Avenue
Cupertino, CA

4 - 1	Walk	Category:
Regrade surface		\$1,200
Notes: Cross slope of concrete path is up to 2.6% for 30 linear feet (2.0% max).		
CBC: 11B-403.3		
Other: ADA 403.3		
4 - 2	Walk	Category:
Regrade surface		\$1,200
Notes: Cross slope of concrete path is up to 3% for 30 linear feet (2.0% max).		
CBC: 11B-403.3		
Other: ADA 403.3

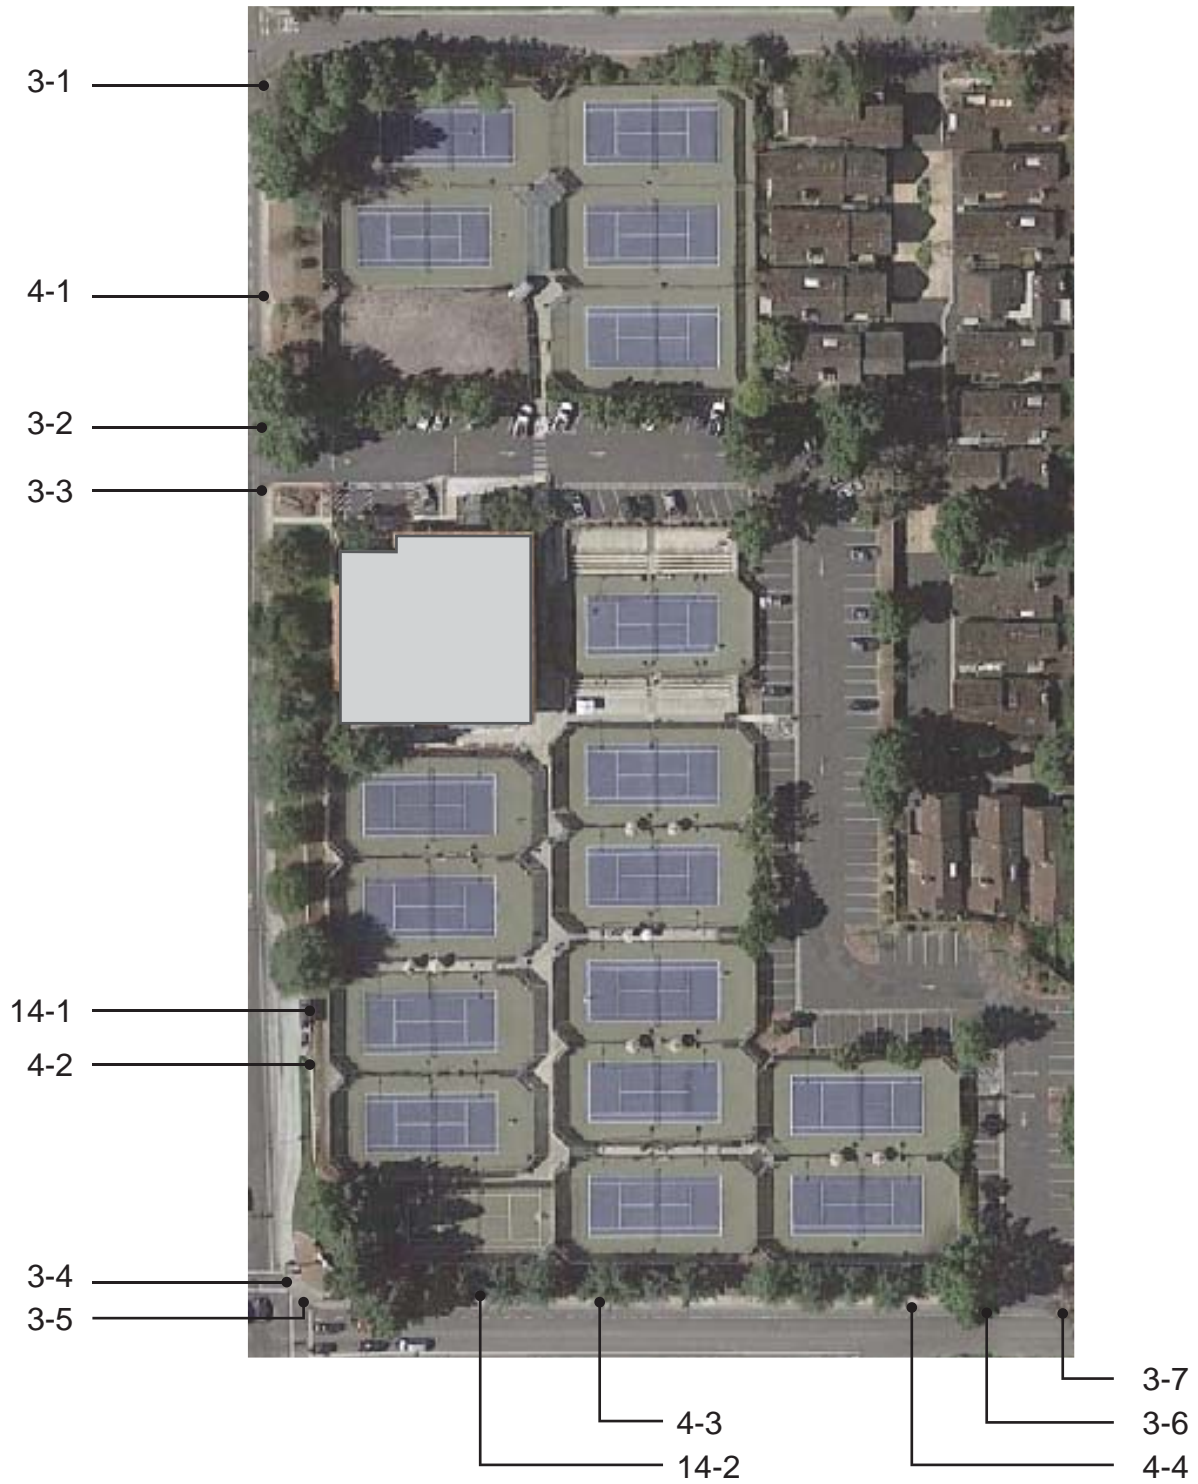
Cupertino ADA
Sport Center - PROW

3 - 1 Curb Ramp		Category:
Provide surface texture		\$0
Notes: No grooved border provided.		
CBC: 11B-406.5.11		
Other: -		
Provide a level landing		\$2,500
Notes: Counter slope at the base of the curb ramp is 7.3% (5.0% max).		
CBC: 11B-406.5.8		
Other: ADA 406.2		
Provide a level landing		\$90
Notes: Top landing has a slope of 2.3% (2% max).		
CBC: 11B-406.5.3		
Other: ADA 406.4, ADA 406.7		
3 - 2 Curb Ramp		Category:
Provide a level landing		\$90
Notes: Top landing has a slope of up to 3.5% (2% max).		
CBC: 11B-406.5.3		
Other: ADA 406.4, ADA 406.7		
Provide surface texture		\$0
Notes: Grooved border is 11.5" wide (12" min).		
CBC: 11B-406.5.11		
Other: -		
Provide a level landing		\$2,500
Notes: Counter slope at the base of the curb ramp is 6.1% (5.0% max).		
CBC: 11B-406.5.8		
Other: ADA 406.2		
3 - 3 Curb Ramp		Category:
Provide surface texture		\$0
Notes: Grooved border is 11.5" wide (12" min).		
CBC: 11B-406.5.11

3 - 6	Curb Ramp	Category:
Provide a level landing		\$0
Notes: Top landing has a slope of 4.5% (2% max).		
CBC: 11B-406.5.3		
Other: ADA 406.4, ADA 406.7		
Provide a level landing		\$2,500
Notes: Counter slope at the base of the curb ramp is 5.8% (5.0% max).		
CBC: 11B-406.5.8		
Other: ADA 406.2		
Provide surface texture		\$0
Notes: No grooved border provided.		
CBC: 11B-406.5.11		
Other: -		
Provide detectable warnings		\$0
Notes: Detectable warnings not provided.		
CBC: 11B-247.1.2, 11B-406.5.12		
Other: -		
Install, replace or modify curb ramp		\$2,460
Notes: Width of ramp, not including flared sides, is 44" (48" min). Slope of the curb ramp is 12.4% (8.33% max).		
CBC: 11B-405.2, 11B-406, 11B-406.5.2		
Other: ADA 405.2, ADA 405.5, ADA 406.1

3 - 7		Curb Ramp	Category:
Provide a level landing			\$0
Notes: Top landing has a slope of 6.2% (2% max).			
CBC: 11B-406.5.3			
Other: ADA 406.4, ADA 406.7			
Provide surface texture			\$0
Notes: No grooved border provided.			
CBC: 11B-406.5.11			
Other: -			
Provide detectable warnings			\$0
Notes: Detectable warnings not provided.			
CBC: 11B-247.1.2, 11B-406.5.12			
Other: -			
Install, replace or modify curb ramp			\$2,460
Notes: Width of ramp, not including flared sides, is 36" (48" min). Slope of the curb ramp is 11.8% (8.33% max).			
CBC: 11B-405.2, 11B-406, 11B-406.5.2			
Other: ADA 405.2, ADA 405.5, ADA 406.1			
4 - 1		Walk	Category:
Regrade surface			\$7,320
Notes: Cross slope of concrete path is up to 3.8% for 183 linear feet, with two flags of up to 5.5% (2.0% max).			
CBC: 11B-403.3			
Other: ADA 403.3			
4 - 2		Walk	Category:
Regrade surface			\$17,840
Notes: Cross slope of concrete path is up to 5.5% for 446 linear feet (2.0% max).

4 - 4 Walk			Category:
Regrade surface		\$11,280	
Notes: Cross slope of concrete path is up to 3.6% for 282 linear feet (2.0% max).			
CBC: 11B-403.3			
Other: ADA 403.3			
14 - 1 Bus Stop			Category:
Regrade bus stop pad or light rail platform		\$500	
Notes: Clear floor space at the bus stop has a slope of up to 2.4% (2% max).			
CBC: 11B-810.2.4			
Other: ADA 810.2.4			
14 - 2 Bus Stop			Category:
Regrade bus stop pad or light rail platform		\$500	
Notes: Clear floor space at the bus stop has a slope of up to 3.4% (2% max).			
CBC: 11B-810.2.4			
Other: ADA 810.2.4

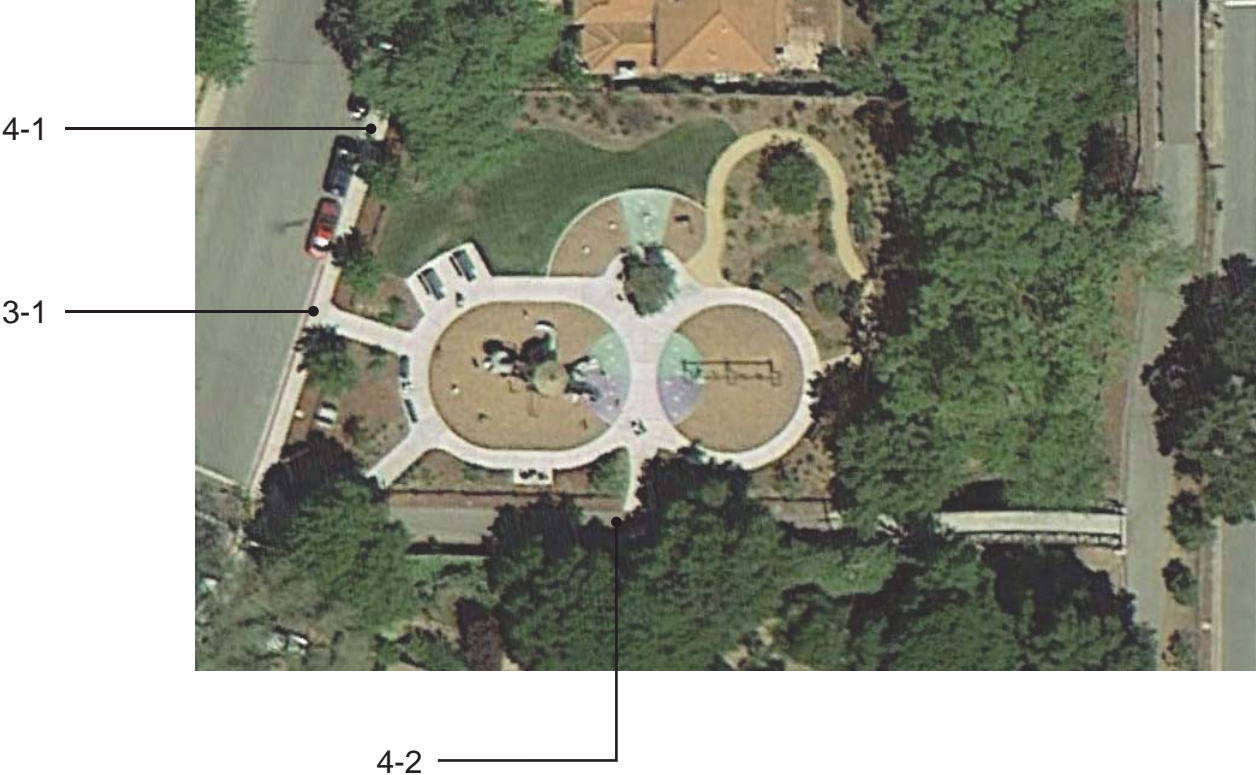
Sterling/Barnhart Park
10486 Sterling Boulevard
Cupertino, CA

Category:
3 - 1	Curb Ramp	
Provide a level landing		\$2,500
Notes: Counter slope at the base of the curb ramp is 11.6% (5.0% max).		
CBC: 11B-406.5.8		
Other: ADA 406.2		
Grind or patch vertical change of grade		\$0
Notes: 1/2" change in level at the bottom of the curb ramp (curb ramps must be free from any changes in level).		
CBC: 11B-303.2.3, 11B-405.4		
Other: ADA 405.4		
Install, replace or modify curb ramp		\$2,460
Notes: Slope of one flared side is 10.7% (10.0% max).		
CBC: 11B-406.2.2		
Other: ADA 406.3		
Provide surface texture		\$0
Notes: Grooved border is 11" wide (12" min).		
CBC: 11B-406.5.11		
Other: -		
4 - 1	Walk	Category:
Regrade surface		\$800
Notes: Cross slope of concrete path is up to 2.8% for 20 linear feet (2.0% max).		
CBC: 11B-403.3		
Other: ADA 403.3		
4 - 2	Walk	Category:
Regrade surface		\$3,920
Notes: Cross slope of concrete path is up to 4% for 98 linear feet (2.0% max).		
CBC: 11B-403.3

Other: ADA 403.3

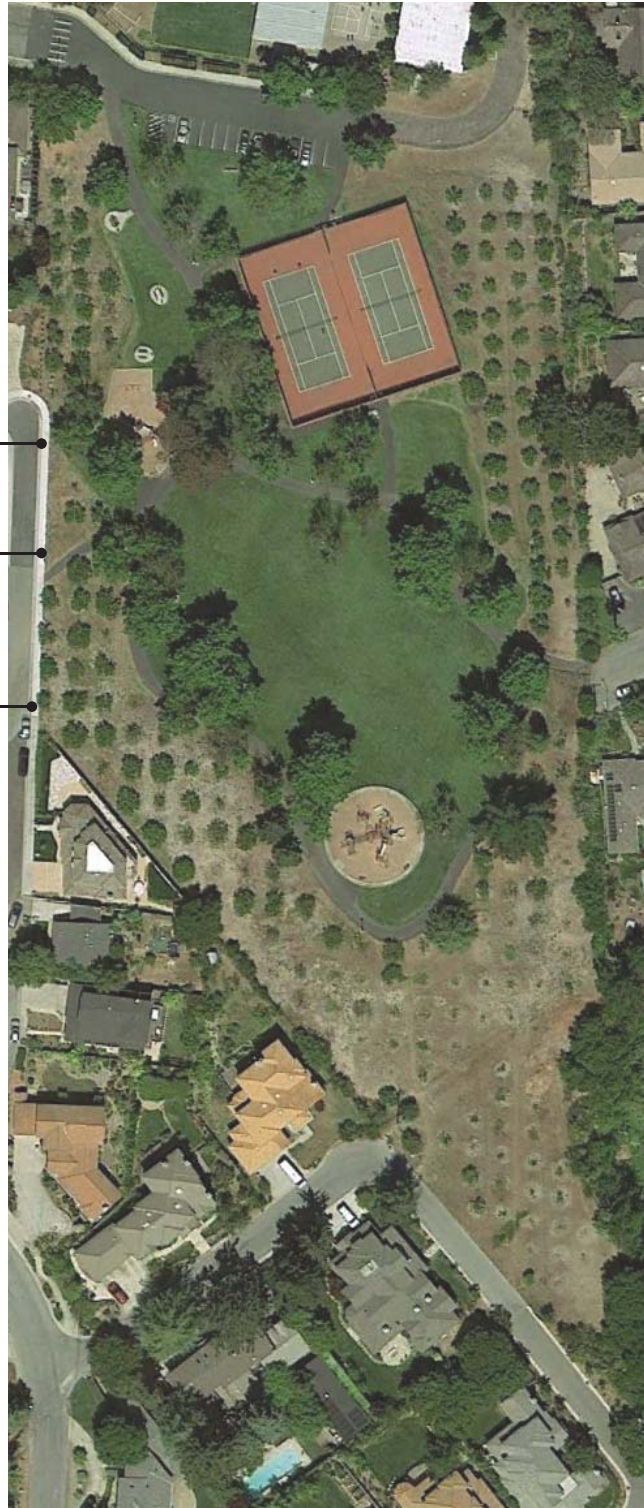
Cupertino ADA
 Varian Park - PROW

4 - 1	Walk	Category:
Regrade surface		\$600
Notes: Cross slope of concrete path is up to 2.7% for 15 linear feet (2.0% max).		
CBC: 11B-403.3		
Other: ADA 403.3		
4 - 2	Walk	Category:
Regrade surface		\$3,240
Notes: Cross slope of concrete path is up to 3.2% for 81 linear feet (2.0% max). Cross slope at the fire hydrant is 5% (2% max).		
CBC: 11B-403.3		
Other: ADA 403.3		
Remove overhanging or protruding objects		\$125
Notes: 4 trees overhang fence by 20" at 60" AFF (80" min).		
CBC: 11B-307.4		
Other: ADA 307.4		
4 - 3	Walk	Category:
Regrade surface		\$880
Notes: Cross slope of concrete path is up to 2.9% for 22 linear feet (2.0% max).		
CBC: 11B-403.3		
Other: ADA 403.3

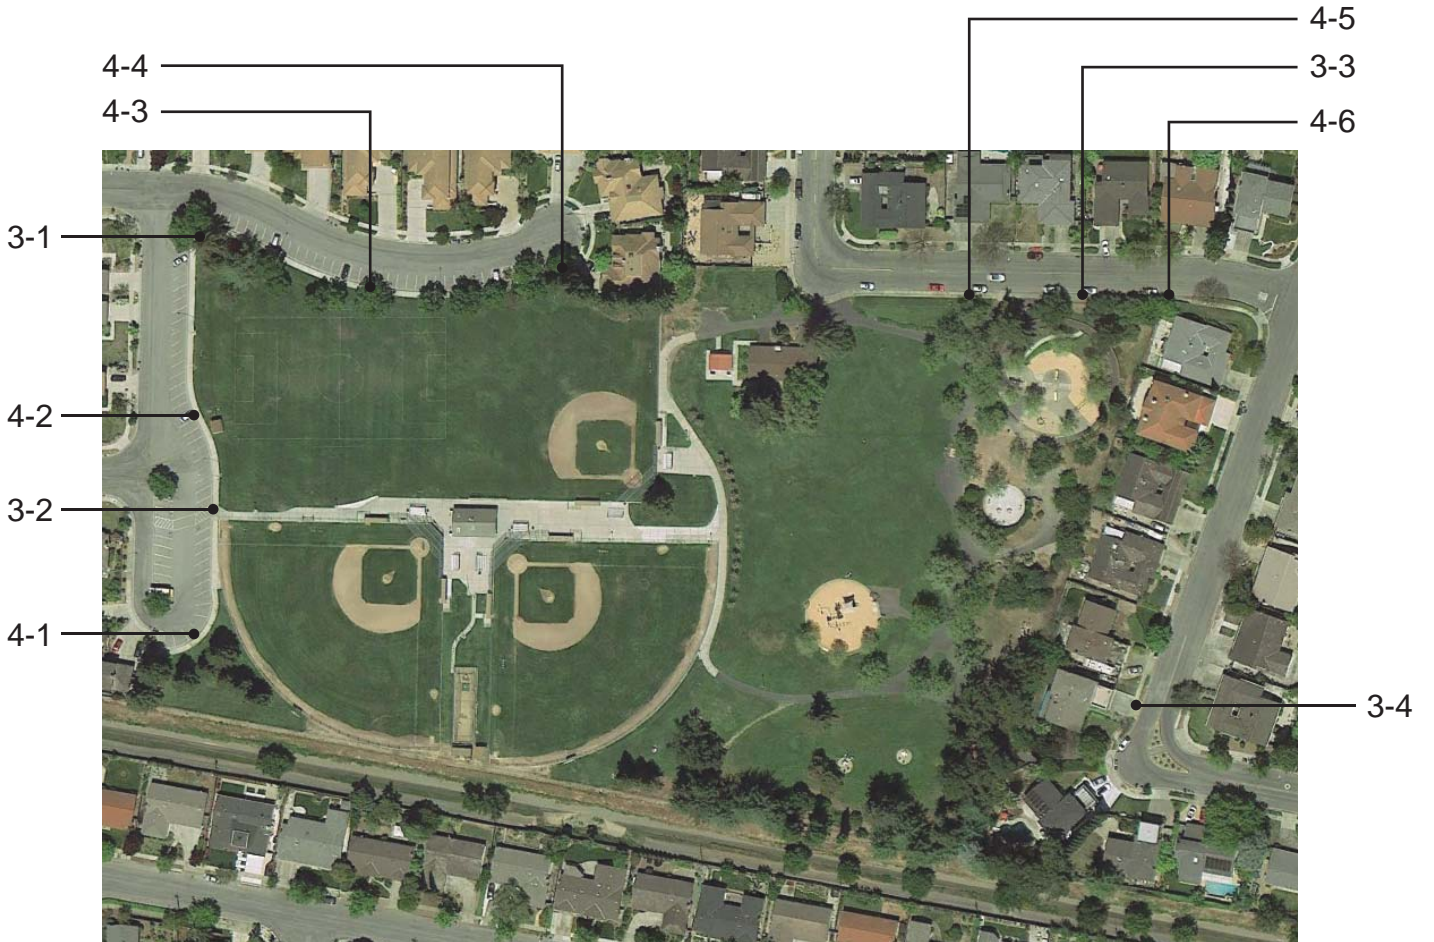
Wilson Park
19784 Wintergreen Avenue
Cupertino, CA

3 - 1 Curb Ramp		Category:
Provide surface texture		\$0
Notes: Grooved border is 10" wide (12" min).		
CBC: 11B-406.5.11		
Other: -		
Grind or patch vertical change of grade		\$250
Notes: 1/4" change in level at bottom of the curb ramp (curb ramps must be free from any changes in level).		
CBC: 11B-303.2.3, 11B-405.4		
Other: ADA 405.4		
Provide detectable warnings		\$1,000
Notes: Detectable warnings not provided.		
CBC: 11B-247.1.2, 11B-406.5.12		
Other: -		
Provide a level landing		\$2,500
Notes: Counter slope at the base of the curb ramp is 9.1% (5.0% max).		
CBC: 11B-406.5.8		
Other: ADA 406.2		
Provide a level landing		\$90
Notes: Top landing has a slope of 3.6% (2% max).		
CBC: 11B-406.5.3		
Other: ADA 406.4, ADA 406.7		
3 - 2 Curb Ramp		Category:
Provide detectable warnings		\$1,000
Notes: No detectable warning provided at blended transition.		
CBC: 11B-247.1.2, 11B-406.5.12		
Other: -		
Grind or patch vertical change of grade		\$250
